# **PROCEEDINGS** OF THE MARINE SAFETY COUNCIL

Vol. 32, No. 11

November 1975

# FOR WANT OF A NAIL . . .

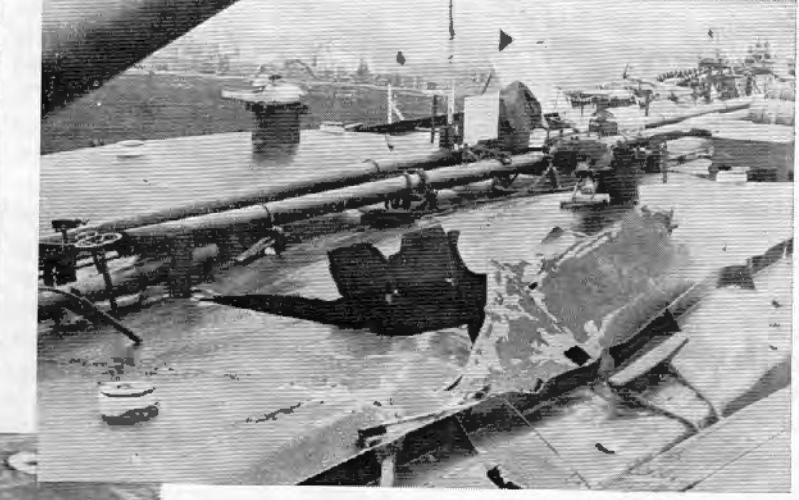
This rupture was the avenue for venting the forces of the internal explosions.

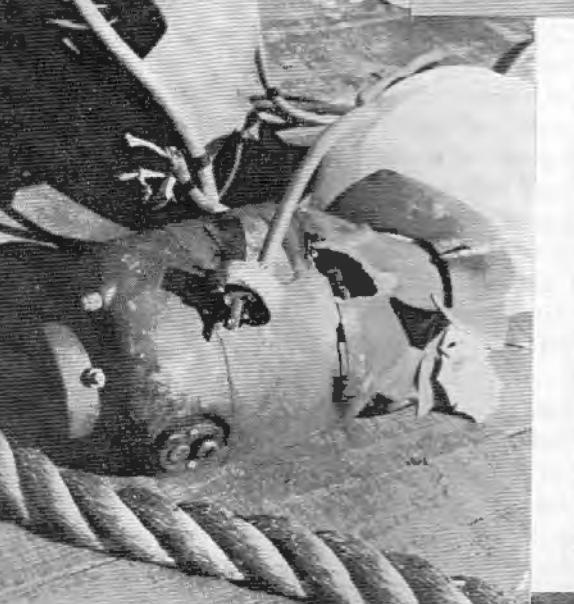
When the blower landed on the dock its housing fractured allowing the internal motor to be torn loose. The motor casing was damaged from the impact and the electrical cord was severed. Notice the male plug with shielding missing.

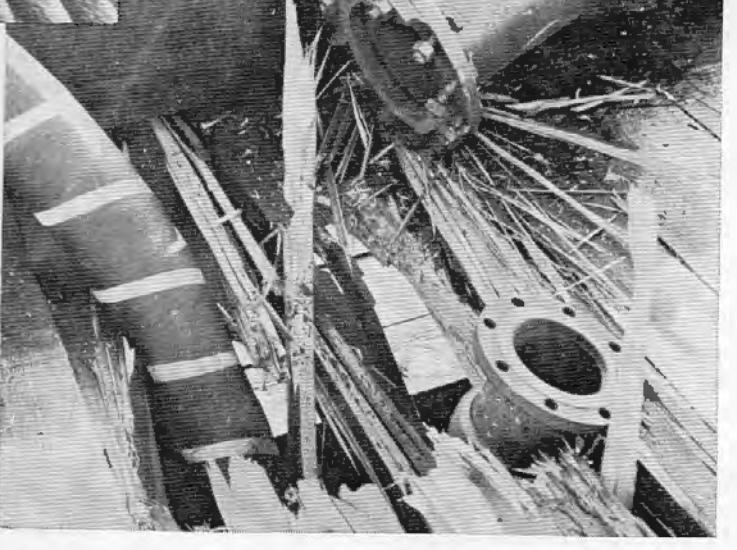
As a result of the force of the explosions these hoses were thrown into the air and landed on the dock.
