# MACONDO WELL INCIDENT Transocean Investigation Report Volume I

June 2011

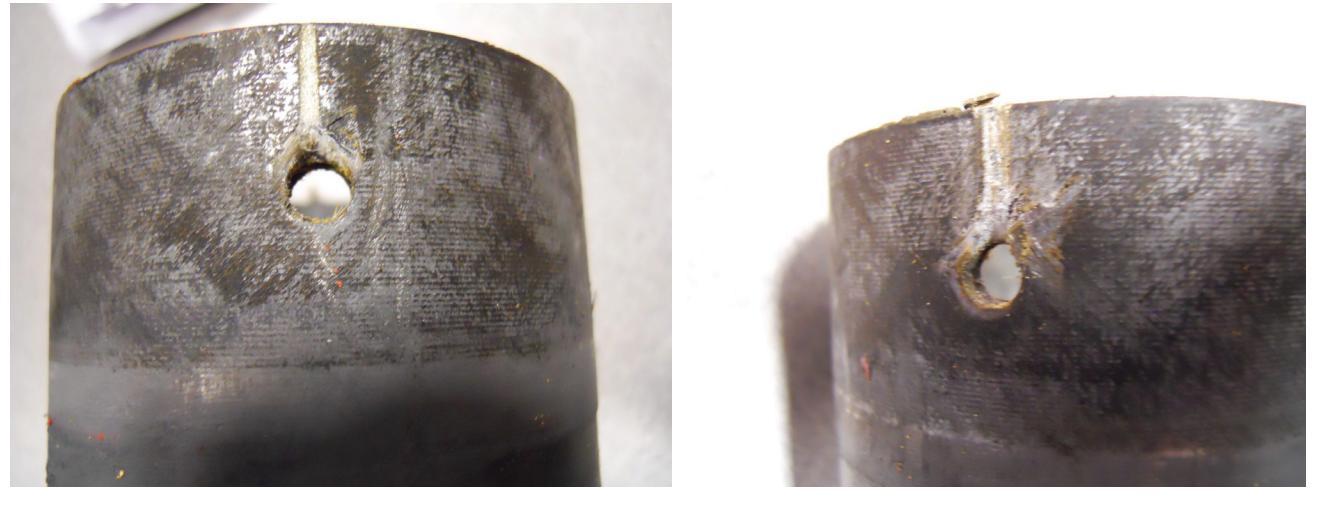
The first test checked the pressure at which the float collar normally would convert. A load was applied to the conversion ball at the seat position in an attempt to force the failure of the retaining screws and thus activate the floats. The screws did not fail; instead, the collar holding the screws in place failed under the applied load. The collar failure occurred at almost the same pressure on both floats tested: 410 psi and 406 psi, respectively. *See Figures 14 and 15.*

Figures 14 and 15 Flow Tube Damage During "Normal" Float Conversion Test

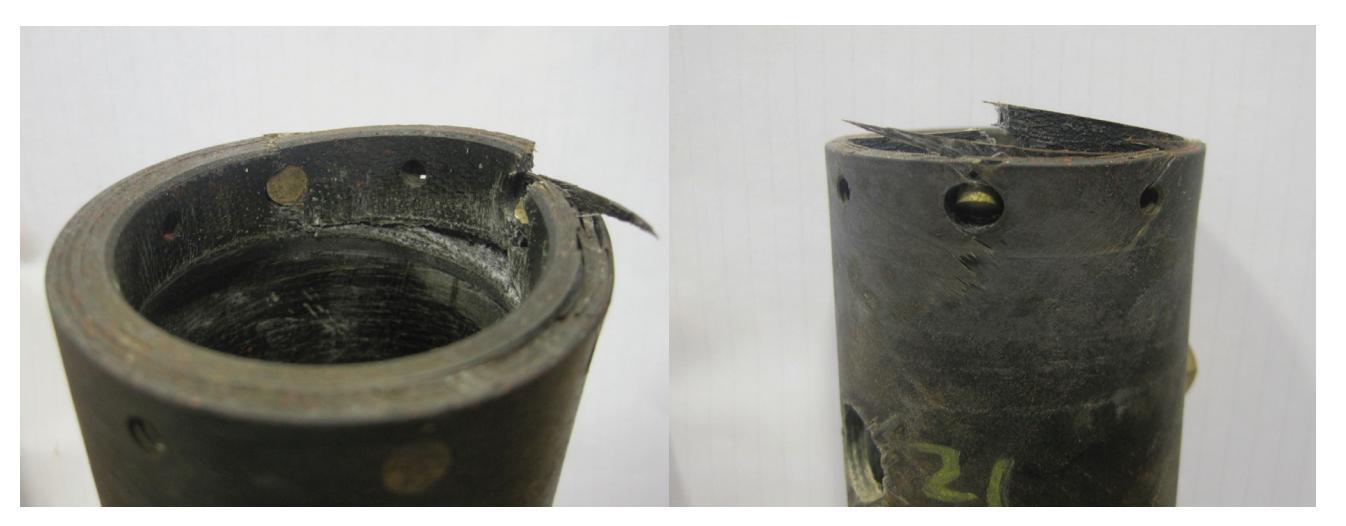
The second test checked the pressure at which the ball would be ejected from the tube (i.e., the pressure at which the ball seat in the tube would fail), and thus prevent the float collar from converting. The tube was installed in a plate and glued in place, and a load was applied to the 2-in. ball until it broke through the smaller 1.93-in. seat. The ball broke through at 1,477 psi on the first float and 1,840 psi on the second. This generally confirms the Weatherford representative's assertion that the setting ball would pass through the tube without converting the floats if the pressure reached or exceeded 1,300 psi.<sup>33</sup> See Figures 16 and 17.

Figures 16 and 17 Actuation Ball Ejected Through Seat of Flow Tube

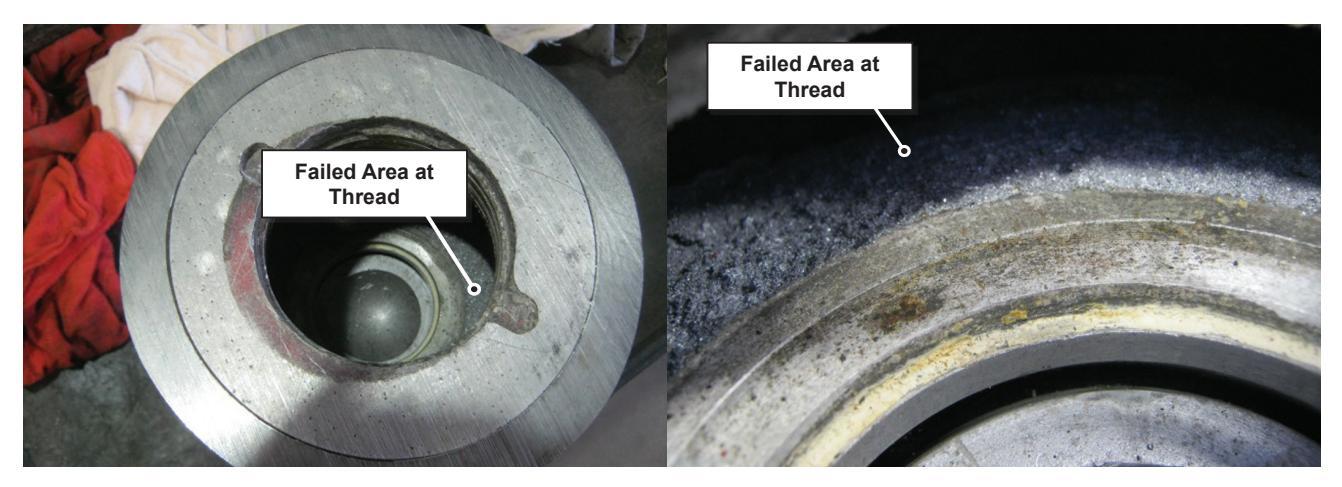
In the fourth test, the internal flapper assembly was exposed to a load from above to check the pressure required to cause the failure of the internal assembly, which was threaded into the collar. In this scenario, only one float was tested. It took a total of 10,155 psi (or 81,800 lb.) to cause the assembly to fail at the threaded connection. *See Figures 18 and 19.*

Figures 18 and 19 Damaged Internal Float Assembly

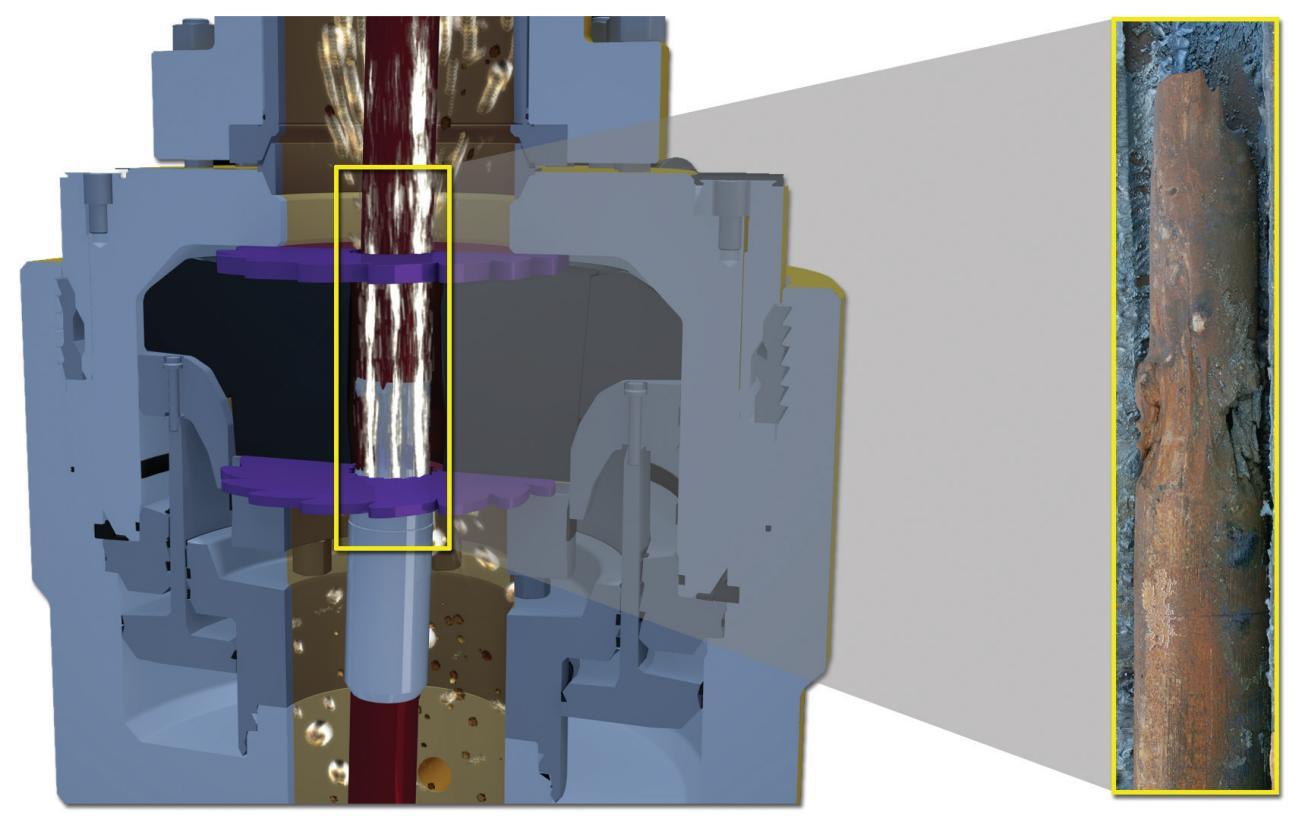
Figure 12 Drill Pipe Erosion

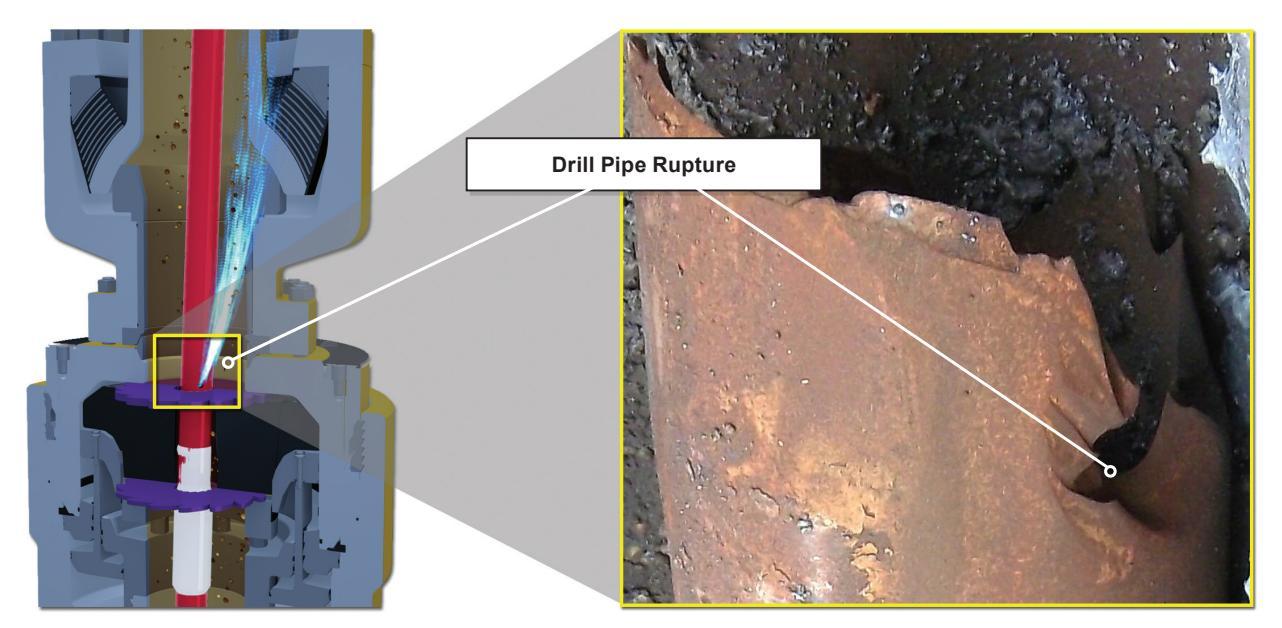
Post-incident examination indicates that the eroded drill pipe located in the upper annular BOP burst under the increasing drill pipe pressure, which allowed hydrocarbons to flow through the ruptured drill pipe into the riser. As the rig began to drift away from the wellhead, the drill pipe was stretched between the rig and the BOP stack, where it was being held by the upper annular BOP and VBRs. The rig traveling block fell at approximately 10:20 p.m.; by then the weakened drill pipe had parted under strain in the area of the upper annular BOP, increasing the flow of hydrocarbons through the drill pipe and up the riser.

Figure 14 Rupture of Drill Pipe at Upper Annular BOP

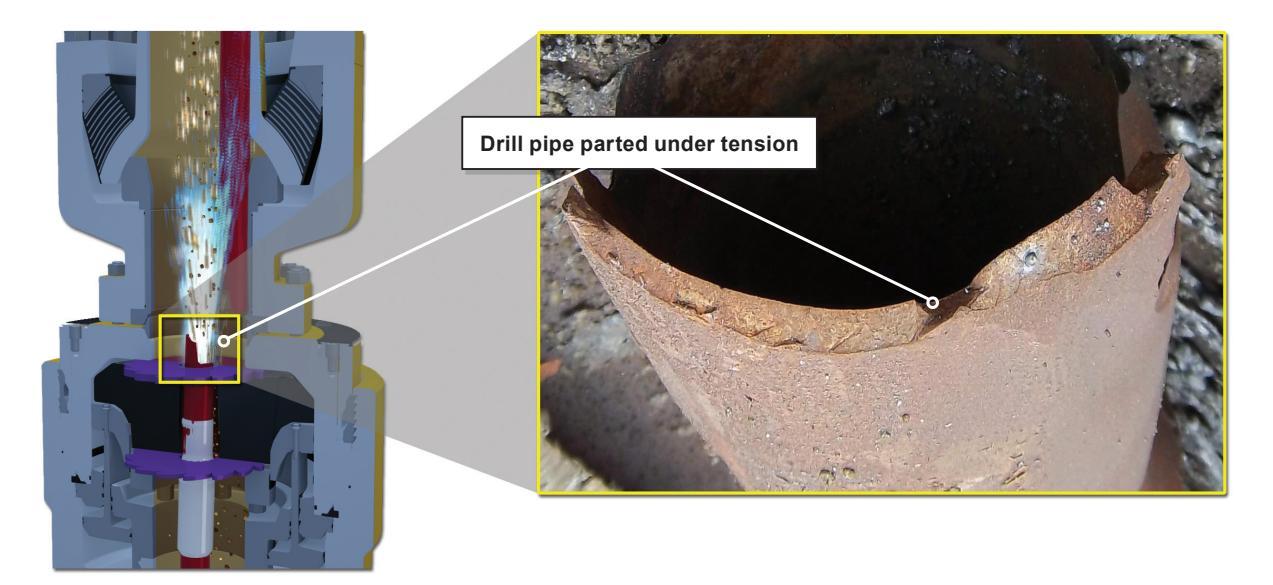
Figure 15 Tensile Separation of Drill Pipe at Upper Annular

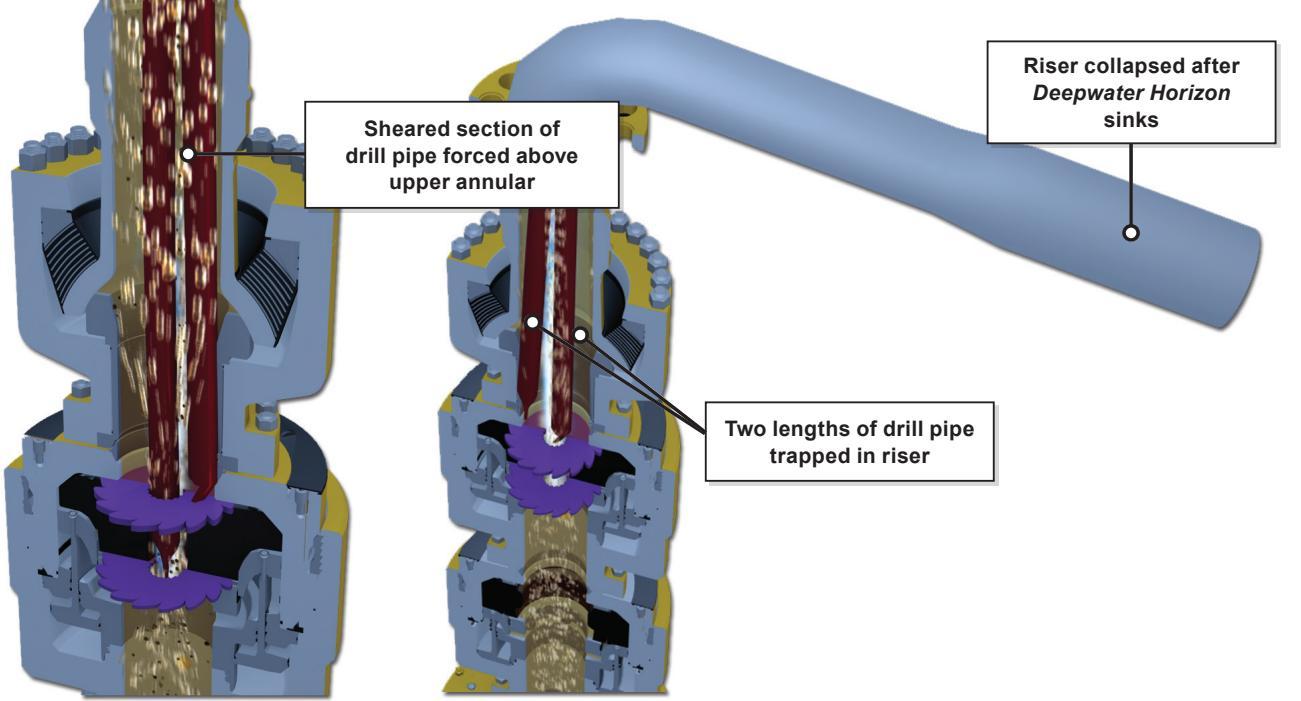
Figure 19 Sheared Drill Pipe Forced through Upper Annular

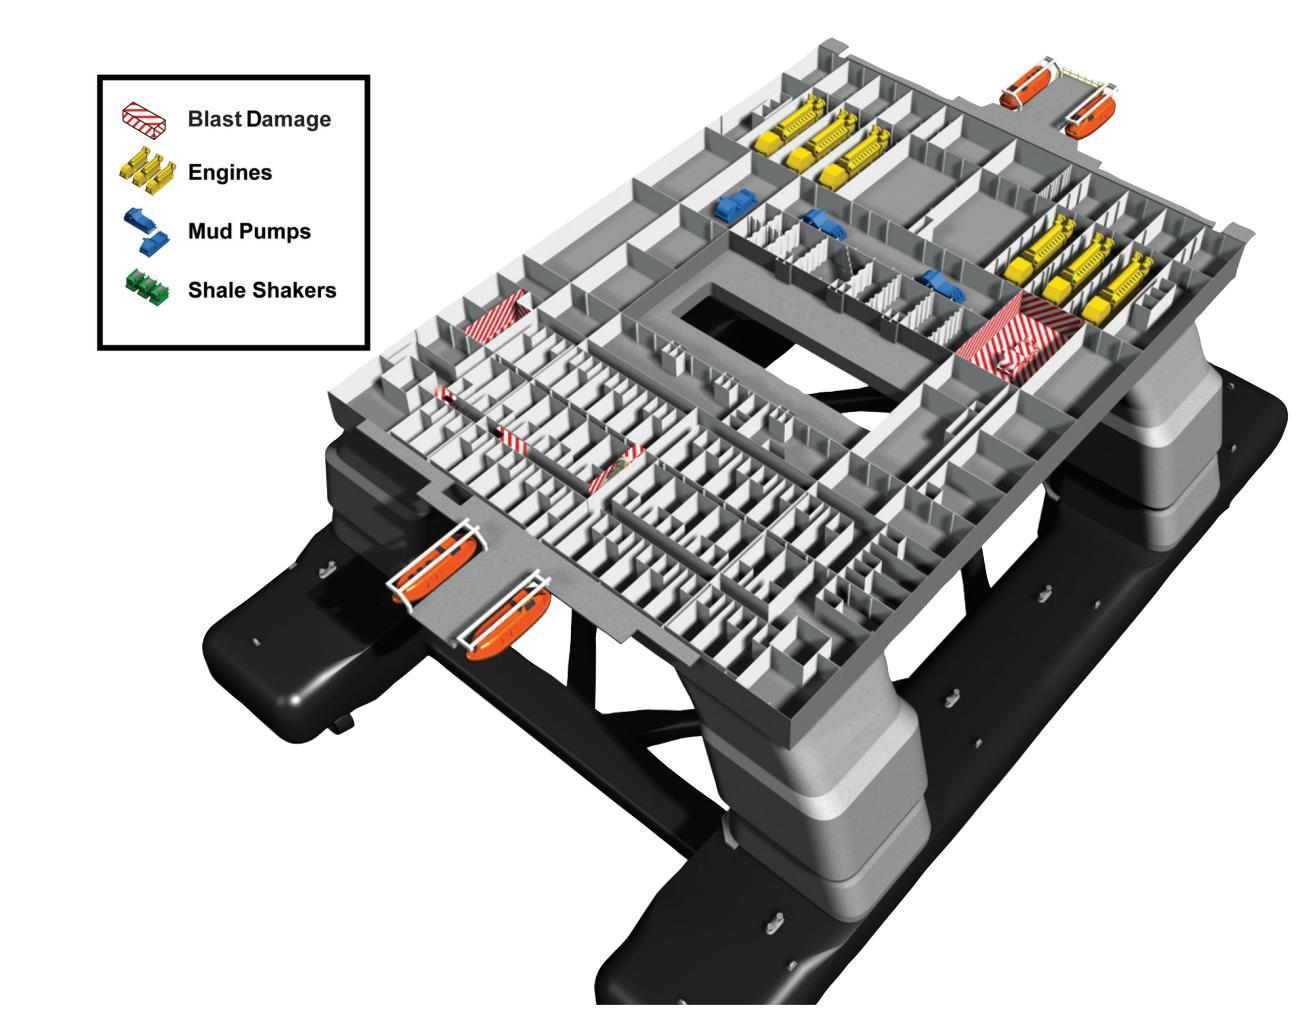
Figure 19 Blast Damage - Third Deck

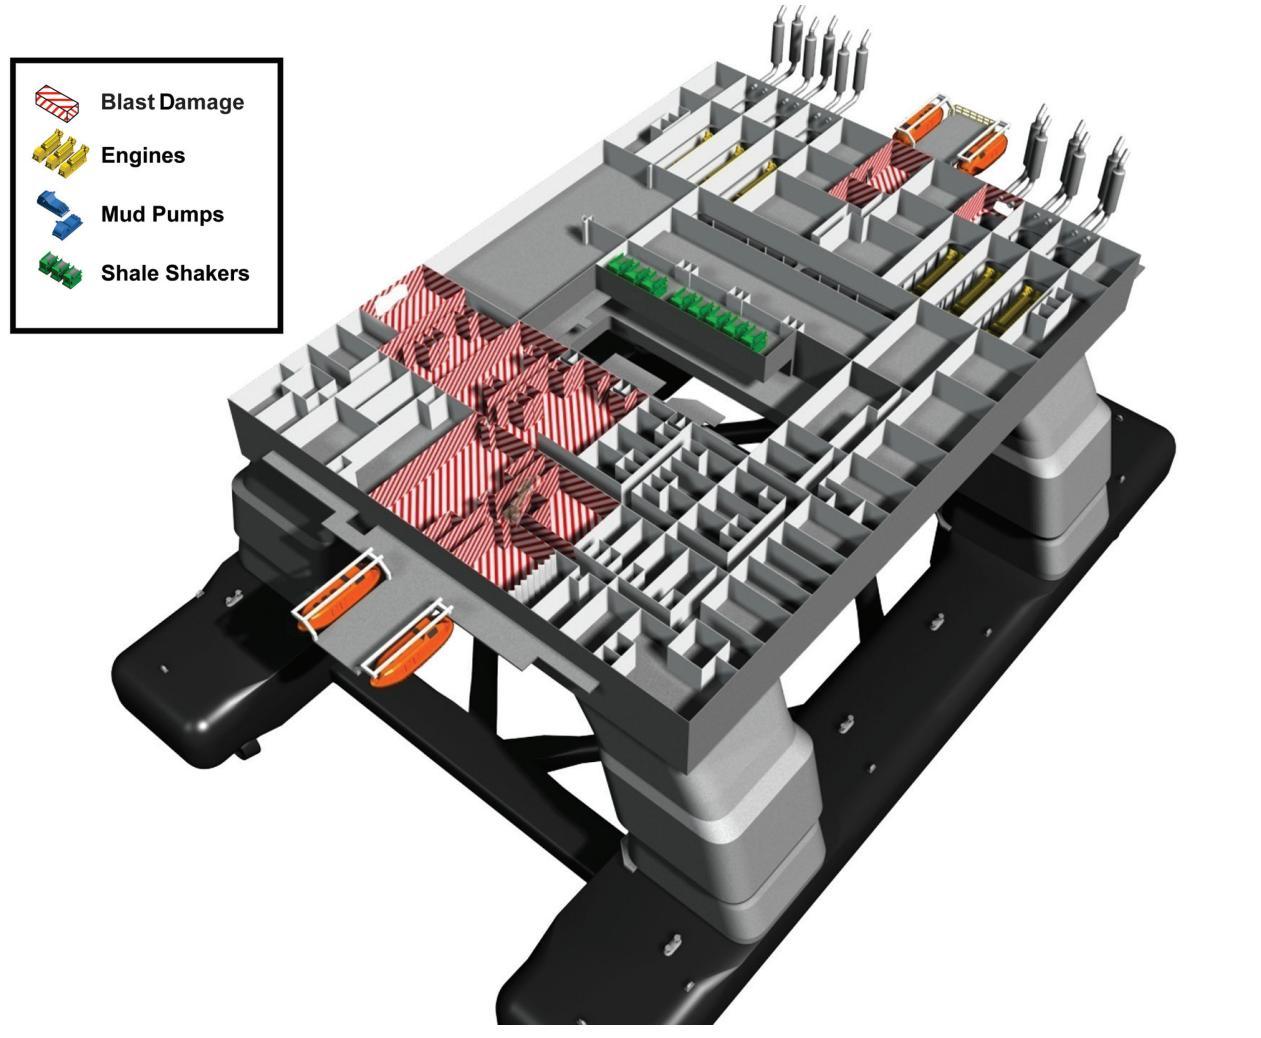
Figure 18 Blast Damage - Second Deck
