Proceedings

of the Marine Safety Council

July 1986

The "A Boats"

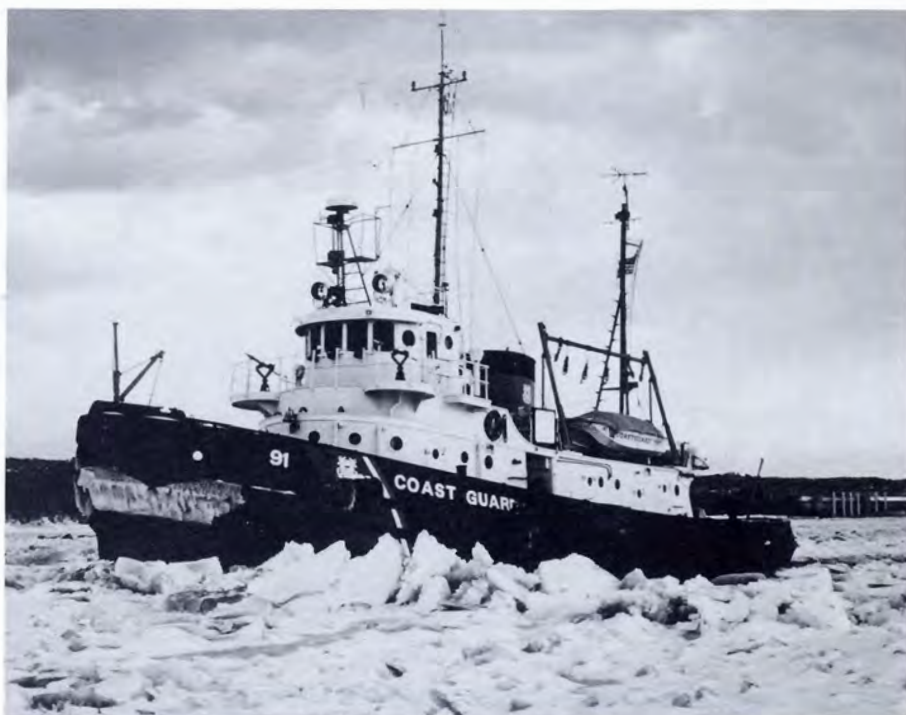
This 110-foot tug is used for breaking ice and for coastal search and rescue missions.

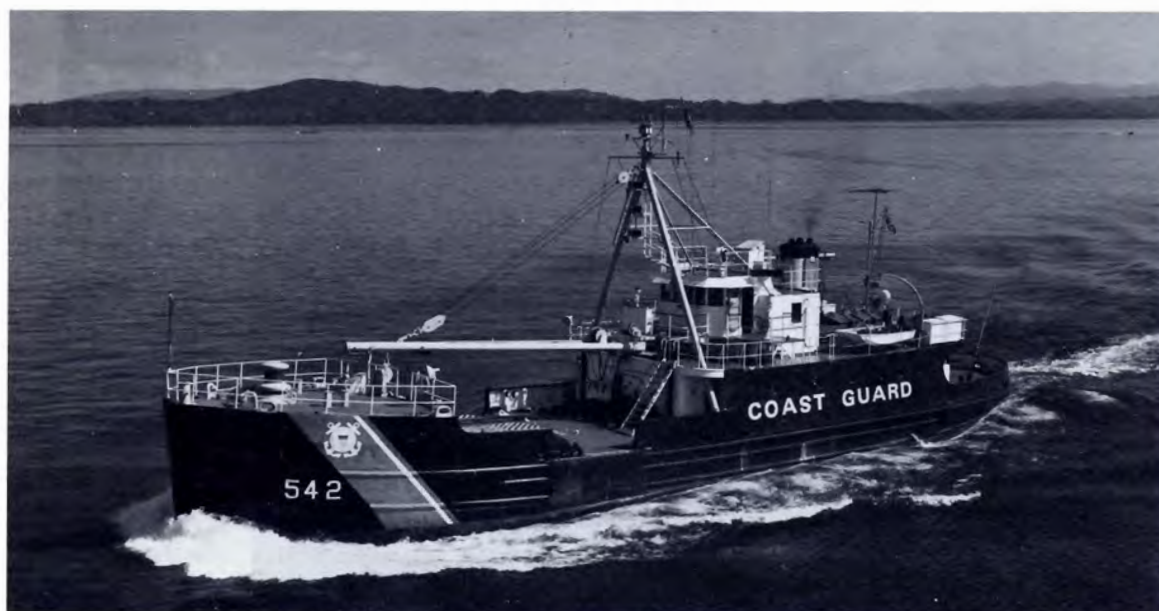
This coastal buoy tender maintains aids to navigation in coastal waters, performs SAR and law enforcement missions, and participates in special assignments.

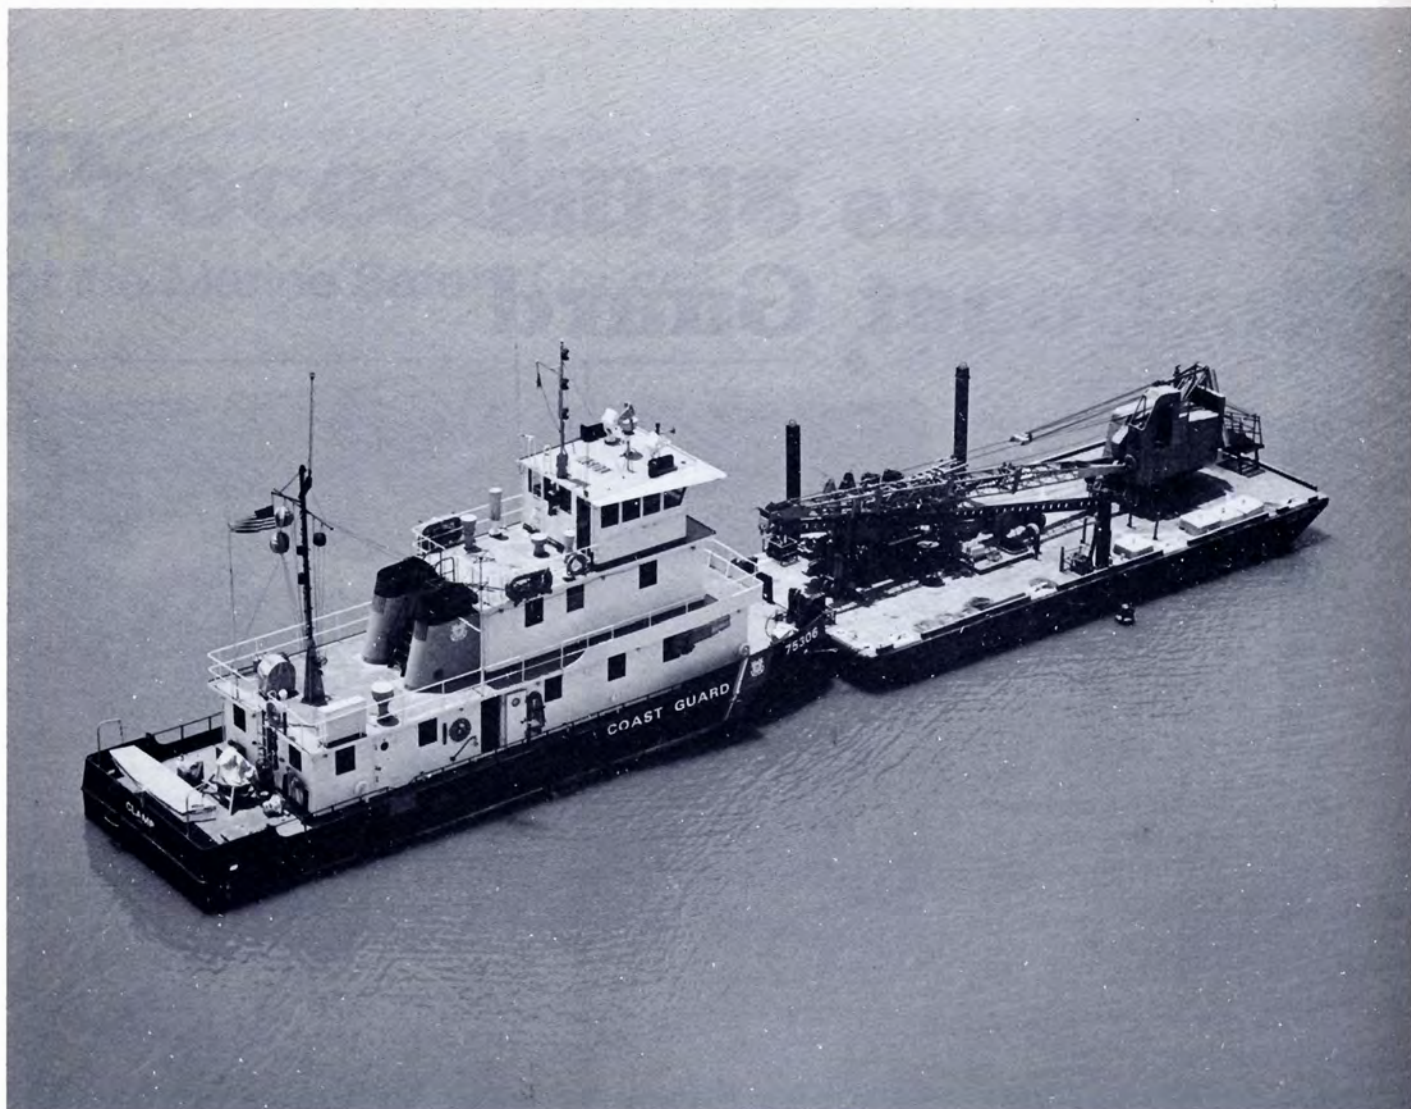
The Coast Guard's river tenders maintain aids to navigation on the Mississippi River and its navigational tributaries.

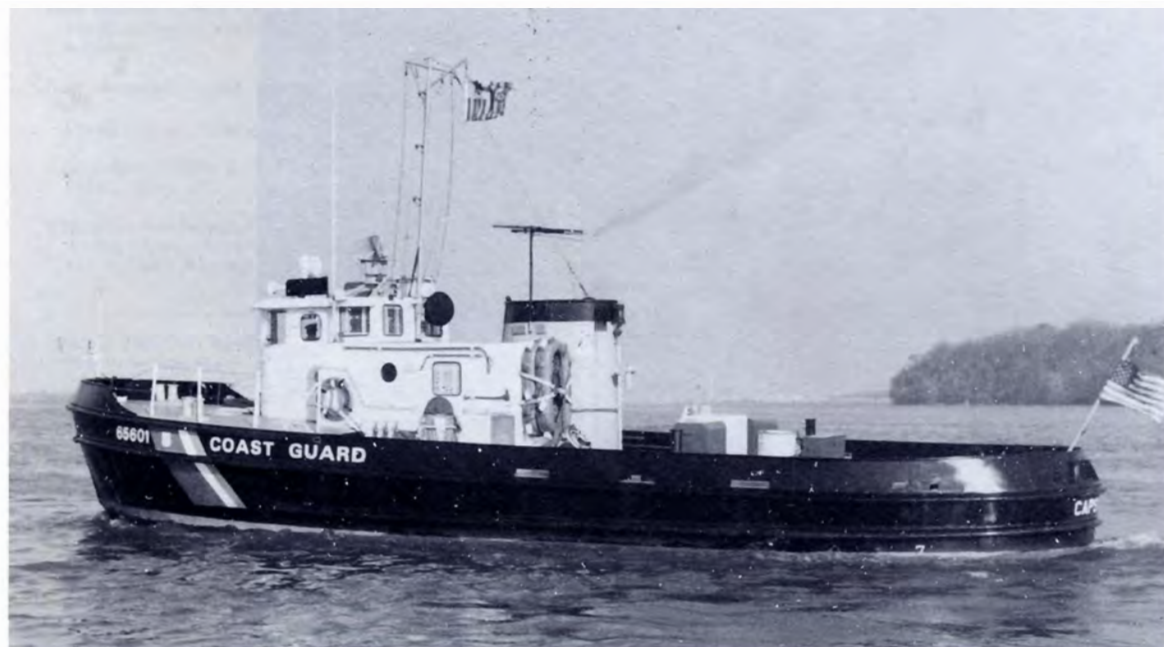
The Coast Guard's harbor tugs are employed in towing, assisting vessels in trouble, boarding, law enforcement, fire-fighting, and light icebreaking.

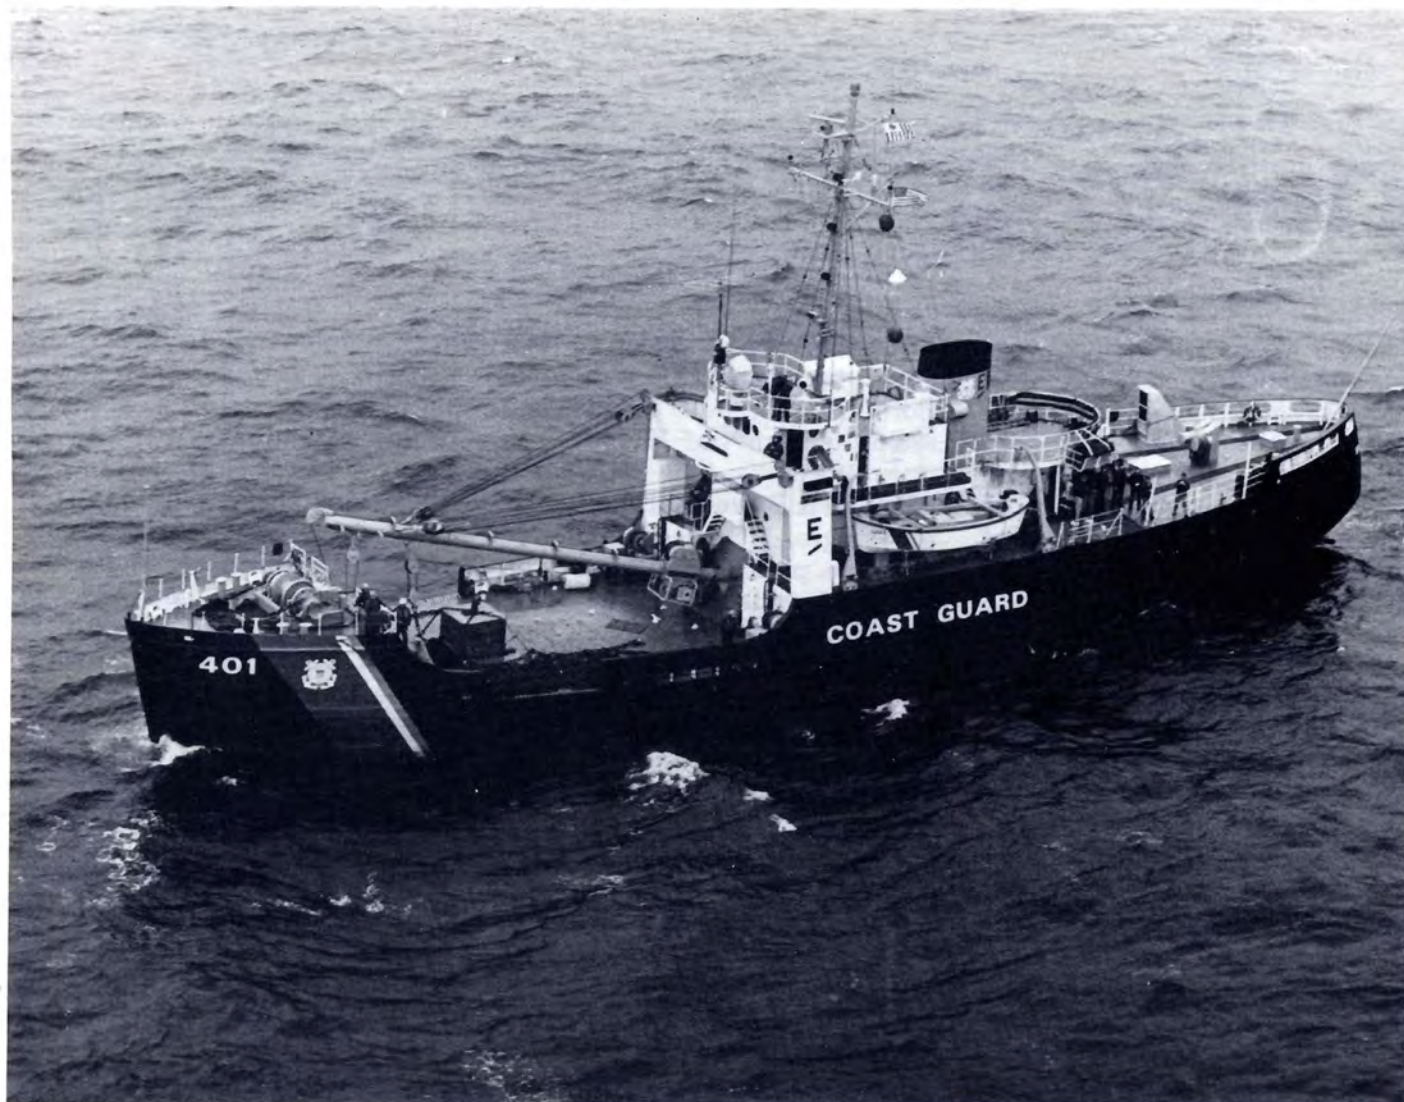
The "400 series" (note number 401 on this vessel's bow) of seagoing buoy tenders is considered the backbone of the Coast Guard's buoy tender fleet. These vessels have icebreaking bows for work in northern points. They also perform aids to navigation duties.

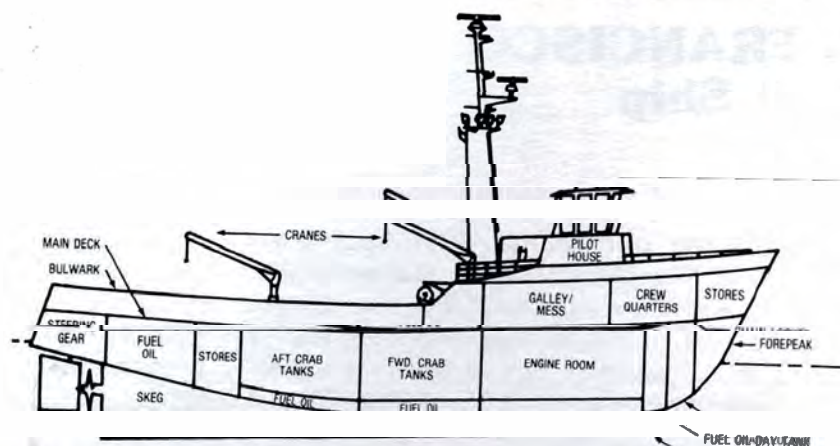
Figure 1. Profile view of AMERICUS before installation of trawling gear.

accommodations for eight persons, a toilet/shower room, a large frozen stores area, a galley and mess area, and an accessway to the pilothouse above and the engineroom below. Aft of the forecastle, the open main deck where the crab pots were carried was protected by wood planks fitted on supports a few inches above the steel deck. One 8-ton-capacity crane was located on the port side of the main deck slightly aft of amidships, and another was on the forecastle deck on the starboard side. (See figure 1.)

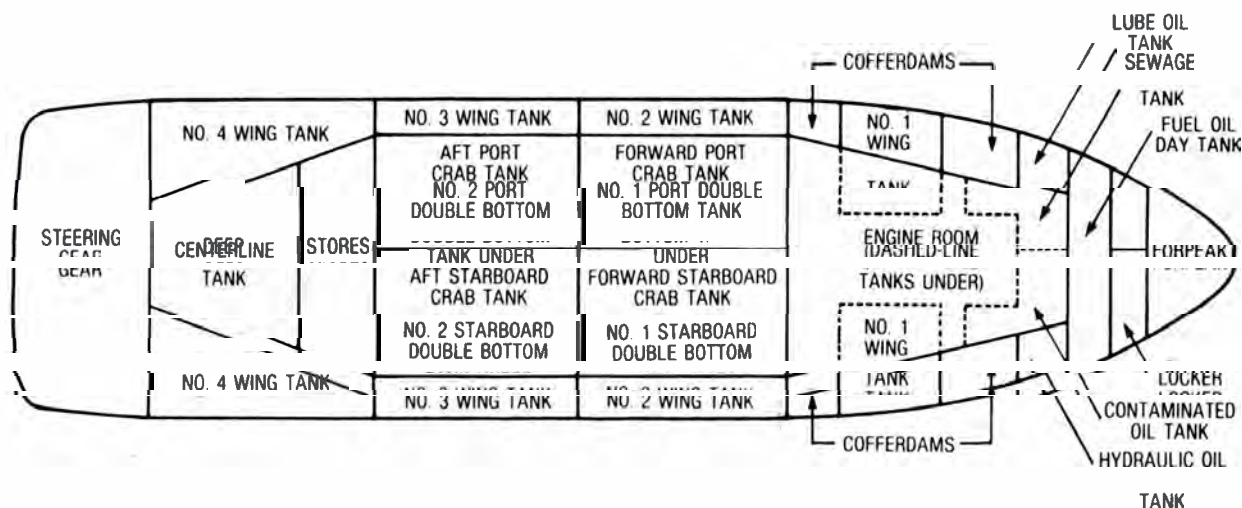
Figure 2. Tank arrangements and capacities for AMERICUS.

the four crab tanks, a dry storage area, and a centerline fuel oil tank. The steering gear compartment was at the stern. Fuel oil wing tanks extended aft from the aft cofferdam bulkhead to the forward bulkhead of the steering gear compartment. Fuel oil double bottom tanks were located below the crab tanks. (See figure 2.)

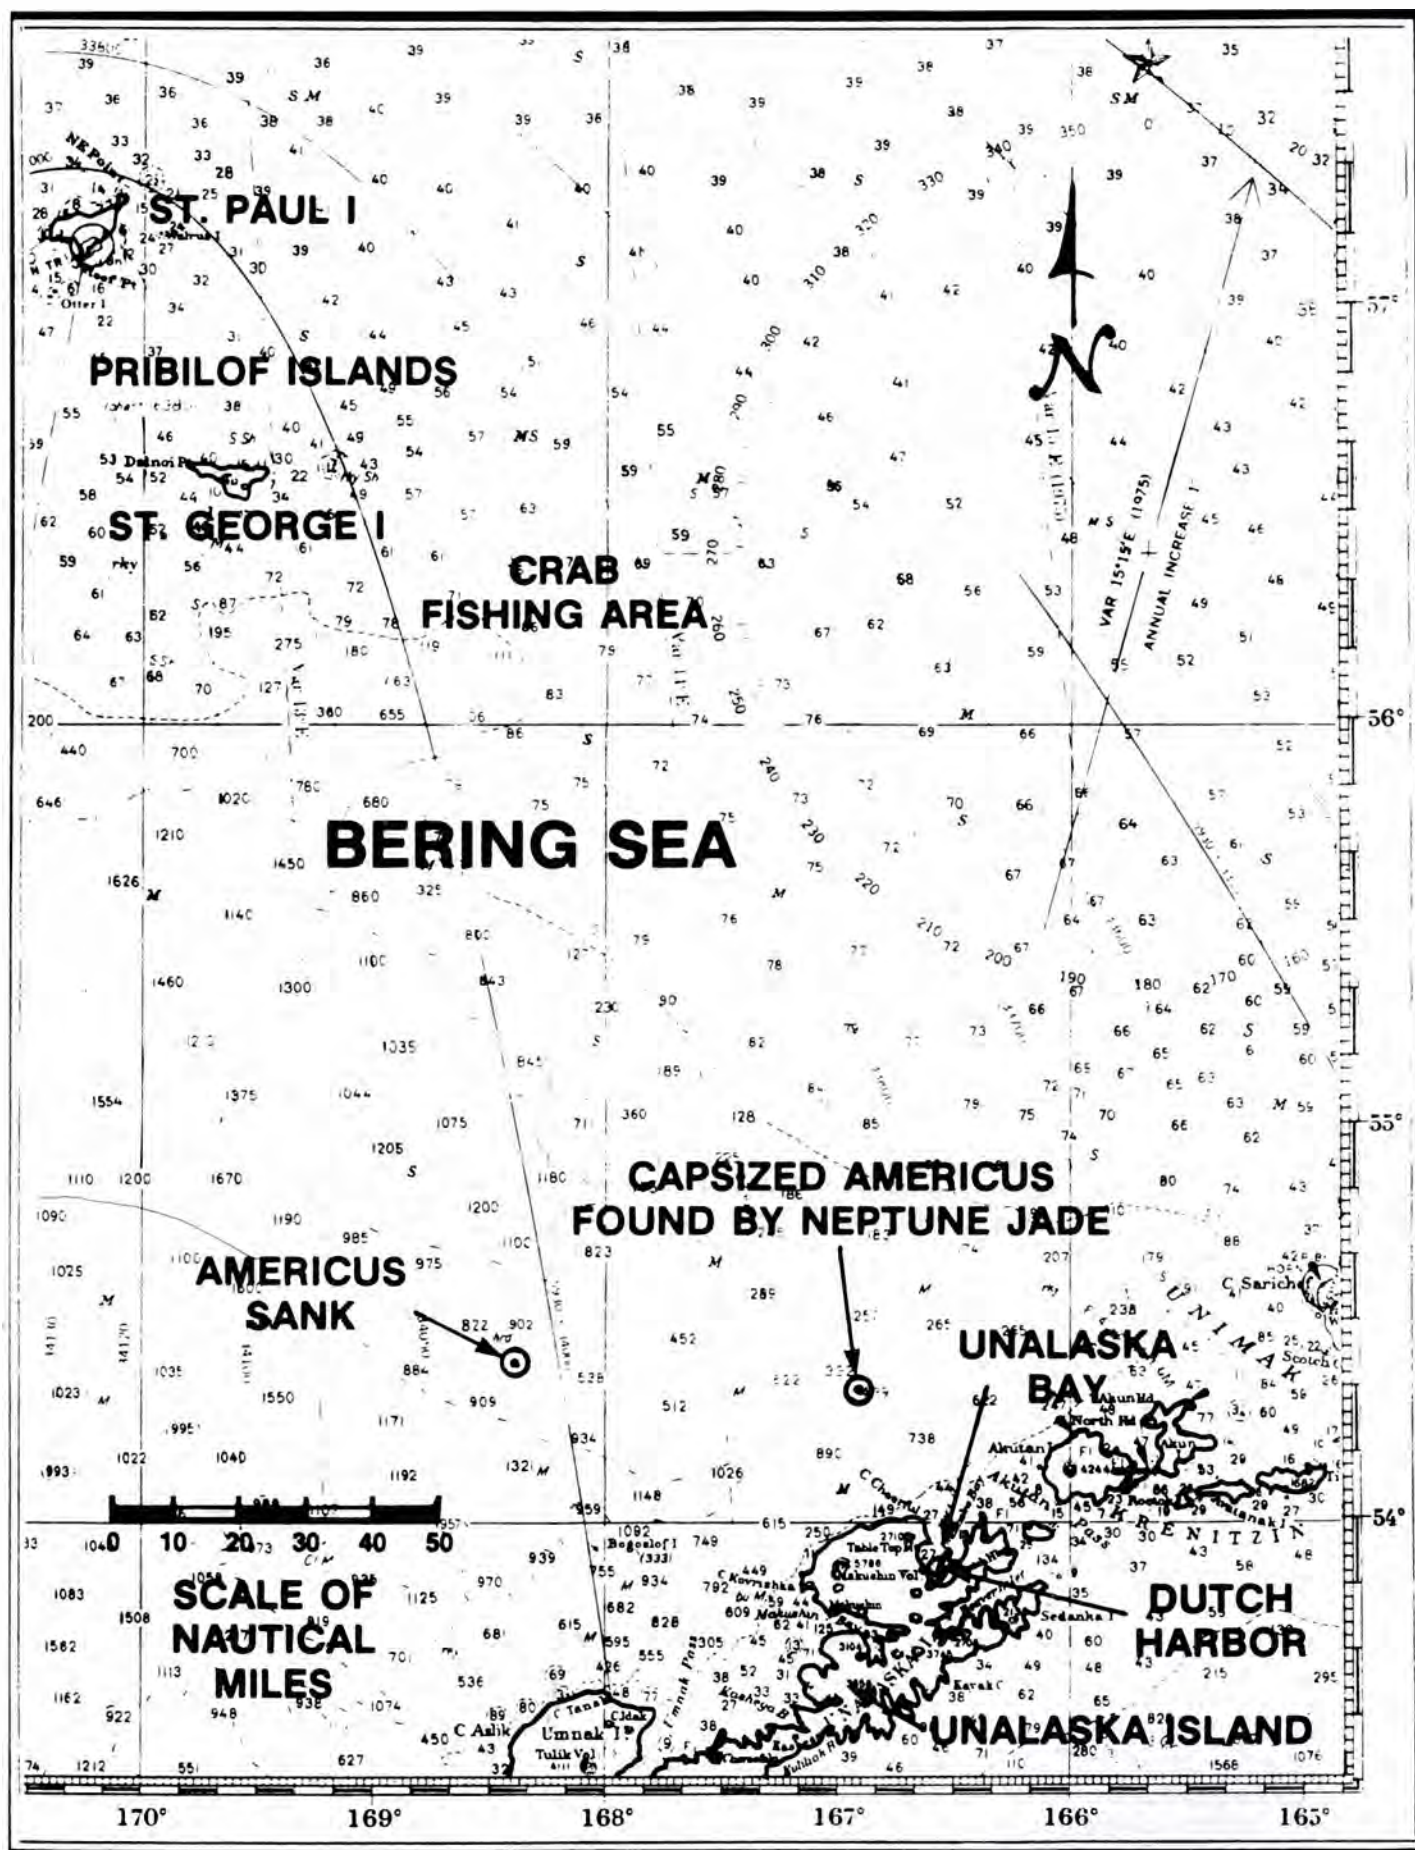
◀ Figure 3 (previous page).
Bering Sea crab fishing grounds
and location of AMERICUS.

On February 3, 1983, the U.S. fishing vessels AMERICUS and ALTAIR departed Anacortes, Washington, on a voyage to Dutch Harbor, Alaska. The vessels were fully loaded with fuel and galley stores in preparation for crab fishing in the Bering Sea. This was the vessels' first voyage (other than sea trials) since a shipyard period during which the installation of trawling equipment on each vessel was completed. In Dutch Harbor, the vessels were to be loaded with crab pots and were then to proceed to the crab fishing grounds selected by their respective captains. (See figure 3.)

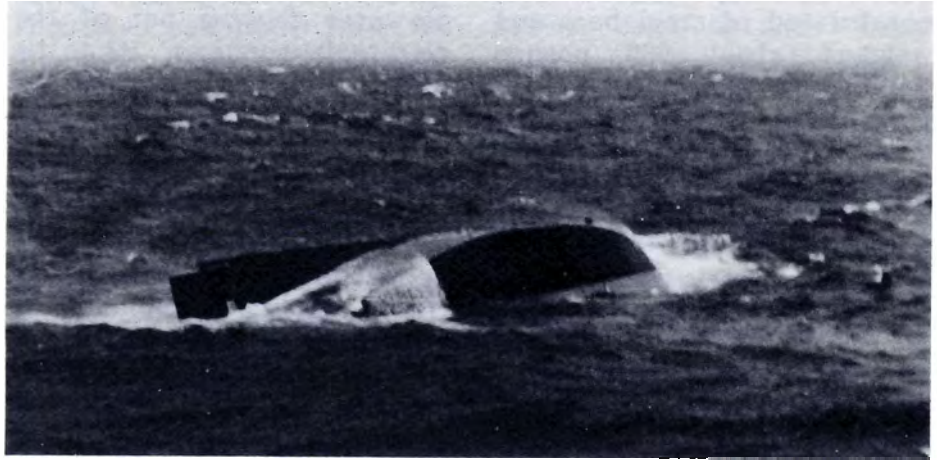
The capsized AMERICUS.
