Proceedings

of the
Marine Safety Council
March-April 1993 Vol. 50, No. 2

- 1) **World famous liner touches bottom**
PA3 Amy J. Gaskill
- 3) **QE2 is patched up**
LCDR Kevin Tone
- 4) **Thirteen fishing vessels
mugged in Typhoon Alley**
LT Vance Bennett
LT Don Noviello
BM1 Dan Derwey
- 8) **Rhode Island capsizes in Pennsylvania**
LT James H. McDowell
- 11) **Questions raised by engineroom fire**
LCDR Roger K. Butturini
- 14) **Casualty statistics 1989**
- 22) **National Pollution Funds Center
manages five missions**
LCDR Ernest Del Bueno
- 24) **New inspection circulars save time**
ENS Pamela Zearfoss
- 25) **Chinese flanges may be hazardous**
ENS Pamela Zearfoss
- 26) **Dramatic videos drive safety home**
LCDR Paul Comolli

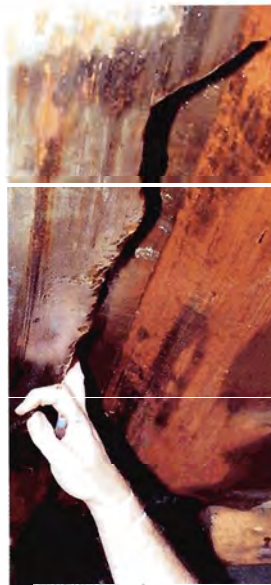
Extensive damage was found on the ship's bottom plating, centering along the keel. The damaged area extended about 500 feet from the stem to past amidship.

Many of the bottom shell plates were set in, some as much as two feet with fractures through some of the more severe insets. Many internal structural members including fuel and ballast tanks were severely damaged. One fuel tank was leaking.

(Left) Hand indicates width of gash in the hull.

Three-quarter inch doubler plates were welded over the one and one-half inch bottom plate where damaged. All fractures and cracks were stop drilled and welded tight. Internally, tripping brackets were installed to shore up damaged floors, and foam was inserted at watertight

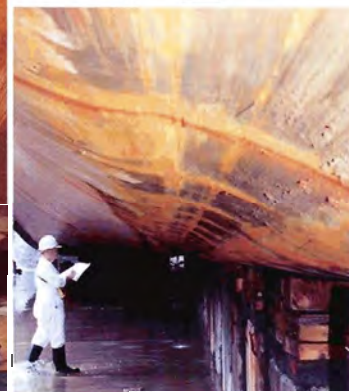
(Below) Inspector checks hull damage on QE2.

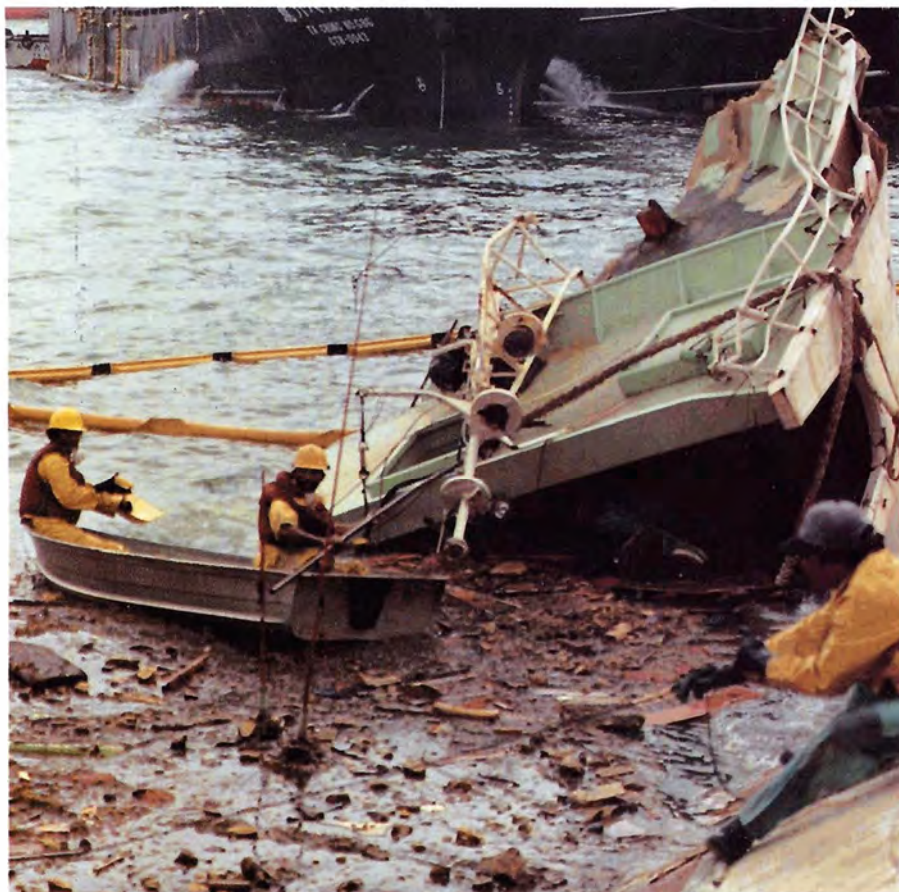
many moored vessels. Two 16,000-ton Navy supply ships were run hard aground and a large sailboat was pushed up on a breakwater. Several fishing boats were sunk, capsized and/or broken completely in half -- one down the centerline.

Salvage workers tackle remains of a fishing vessel that was sliced in half.

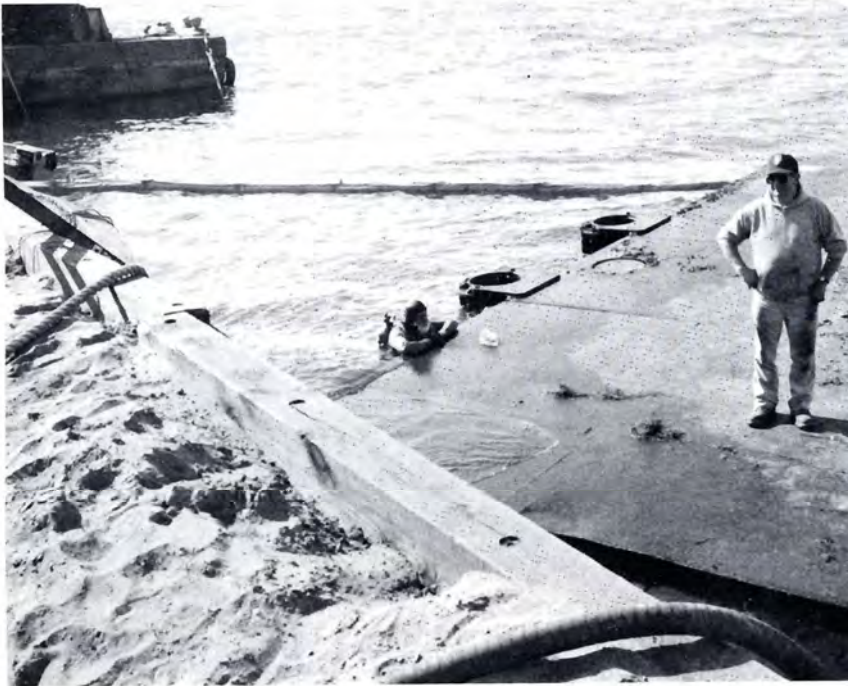
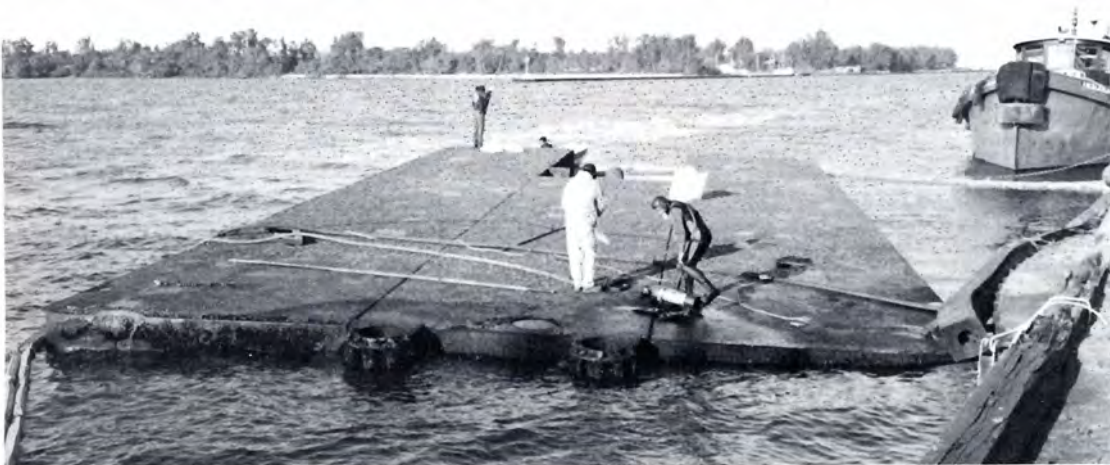
(Left) A diver (center) attached suction and vent hoses to remove fuel from the capsized dredge barge, Rhode Island.

(Below) The diver prepares to reenter the water to unhitch the hoses from the barge after defueling.
