MARINE SAFETY ALERT

Safety Alert 07-20

AIR CONTAMINANTS AND PAINT COATINGS CAN LEAD TO DANGEROUS STATIC DISCHARGES!

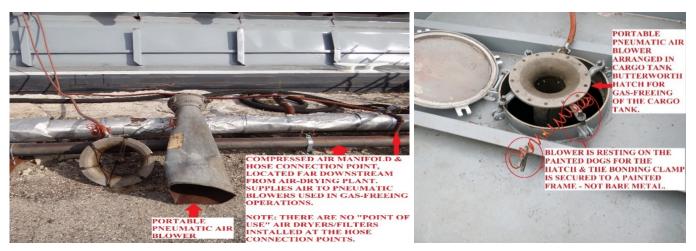
During the investigation, it was discovered that at the time of the tank barge explosion, workers had arranged portable pneumatic blowers to gas free the cargo tanks. These pneumatic blowers were made of conductive materials – each with an aluminum base and a sheet metal cone. An air compressor supplied the blowers with compressed air, which passed through an air-drying plant and into a carbon steel compressed air manifold, which ran north and south along the length of the dock. Air hoses were connected to connection points along this manifold to supply air to the pneumatic air blowers used in gas-freeing operations. Post casualty inspection of the compressed air manifold revealed that the interior of the manifold was contaminated with a thin film of water liquid and rust particles. Compressed air contaminated with water and rust particulates, directed against a conductive object, such as the aluminum pneumatic blowers and sheet metal cones, will cause static electricity to accumulate unless the conductive object is properly grounded/bonded. If the accumulated static charge is sufficient, and occurs in the presence of a flammable atmosphere, a static arc and ignition may result.

As previously highlighted in Marine Safety Alert 01-20, it is essential to electrically bond air moving equipment to the steel structure of a vessel in order to allow any accumulated static to safely dissipate. However, the steel structure on a barge where a pneumatic blower would be arranged is typically covered with paint coatings. Post casualty tests conducted by an independently hired fire investigator tested electrical continuity through the paint coatings on the barge involved in this casualty. The tests produced results that would have prevented the safe dissipation of accumulated static to the vessel's steel structure. To safely bond air moving equipment to a vessel's steel structure, the bonding mechanism must adequately penetrate any coatings so that a direct metal-to-metal connection to the vessel's steel structure can be made. To accomplish this, most portable pneumatic blowers used in gas freeing operations have a bonding wire connected to the blower's frame, with a spring-loaded alligator clamp affixed to the end of the bonding wire. These clamps typically have teeth or a pin that are meant to help the user penetrate paint coatings in order to make a bonding connection to the bare steel structure of the vessel. While this is a good idea in concept, due to the thickness of paint coatings, condition of

the bonding clamp, or both, these clamps may not be able to provide an adequate/reliable bond to the vessel's steel structure. Furthermore, portable pneumatic blowers and their bonding clamps typically do not have a means or an indicator which a worker can utilize to verify that they actually have a proper bonding connection through the vessel's paint coatings. This means that after the clamp is affixed to a coated surface, a visual inspection will not be able to determine whether the clamp is adequately bonded to the vessel's steel structure.

Not installing "point of use" air dryers/filters at hose connection points for pneumatic air blowers (left photo) & attaching air blower bonding clamps to painted surfaces instead of bare metal (right photo) can lead to dangerous static build up.

- o Implement engineering and administrative controls for compressed air systems, to ensure that compressed air supplied to pneumatic blowers is free of liquid and metallic oxide contaminants, which can greatly increase dangerous static generation. Examples of such controls are the installation of "point of use" air dryers/filters at hose connection points where pneumatic air blowers are connected to the facility's compressed air system; and the daily inspection/removal of contaminants from compressed air receivers, piping, and dryers/filters prior to use.

- Ensure that workers are trained and aware that connecting the bonding clamp for portable air moving equipment to a painted surface may not provide an adequate

- bonding connection, which could lead to static ignition of flammable vapors and an explosion.
- Implement procedures for workers to bond portable air moving equipment to the bare metal of a vessel's steel structure. ***Bonding to hatch dogs and associated hardware may not provide an adequate bond, even if the components are not coated.***
