**REPORT OF THE INVESTIGATION
INTO THE
MISSING OPERATOR OF THE RECREATIONAL
VESSEL BIG STICK (O.N. 1337362) ON APRIL 6,
2024**

**MAN OVERBOARD RESULTING IN THE PRESUMED LOSS OF ONE LIFE FROM
THE RECREATIONAL VESSEL BIG STICK (O.N. 1337362) NEAR OAK ISLAND,
NORTH CAROLINA ON APRIL 6, 2024**

INVESTIGATING OFFICER'S REPORT

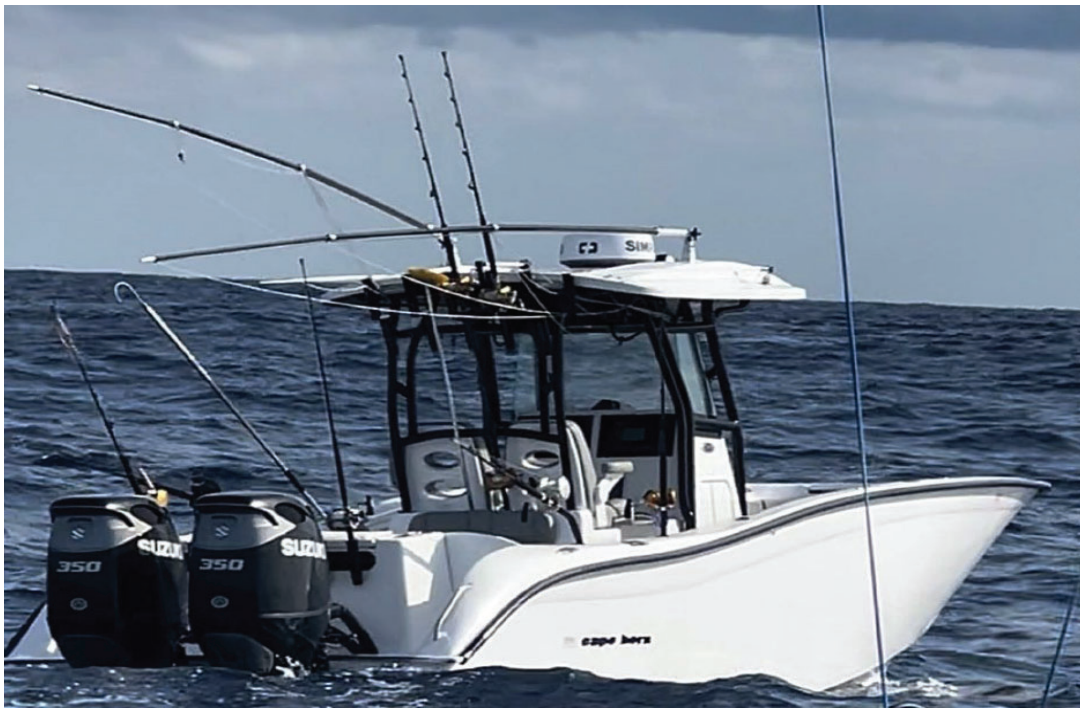
Figure 1: Photograph of the BIG STICK taken by the master of the Fishing Vessel HORSE on April 9, 2024.

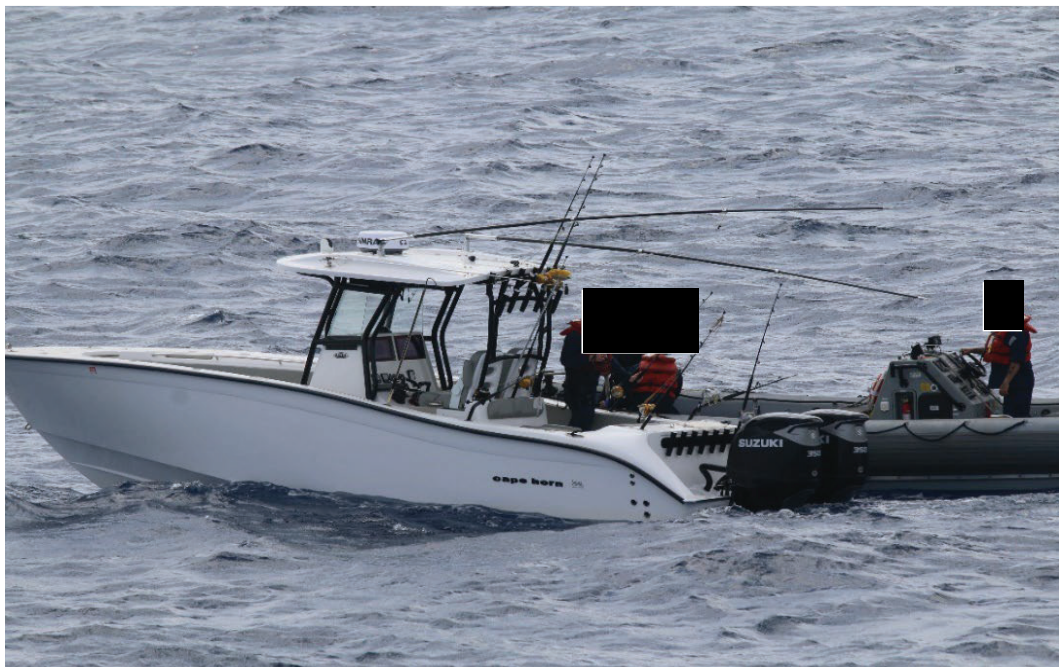
Figure 3: Boarding team from USS SHERMAN conducting investigation aboard BIG STICK.

4.1.37. BIG STICK was found with its engines in gear before the boarding team shifted them to neutral and powered them down.

4.1.38. BIG STICK had the boat keys in the ignition. The operator's cell phone was mounted on the console and connected to a charger. No wallet or additional keys were located.

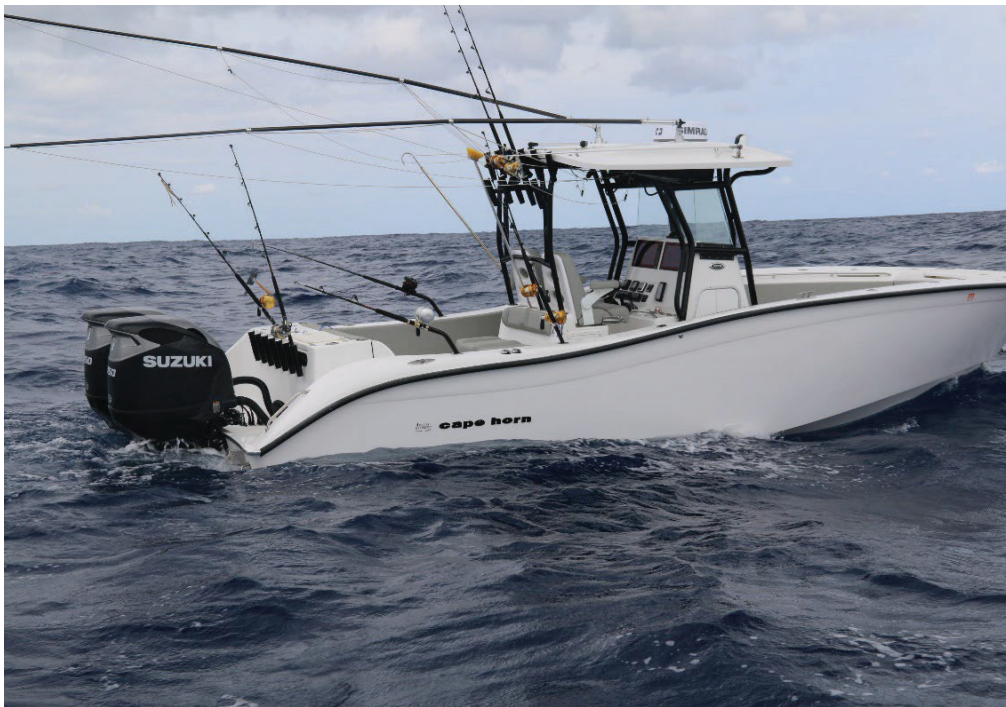
4.1.31. BIG STICK's port outrigger was deployed, while the starboard outrigger was stowed. A bent-butt Electro-Mate rod equipped with a planer (a device used to keep bait or lures running deeper in the water) was set on the port side. Three additional fishing rods were positioned in the stern rod holders, though no lines were in the water at the time. A fishing leader with bait remnants was also found near the transom, further indicating the vessel was set up for trolling.

Figure 4: Photograph of the BIG STICK's port side outrigger partially deployed, taken by the boarding team from the USS SHERMAN on April 9, 2024.

5.4. Vessel Condition and Fishing Activity: When the BIG STICK was recovered, the port outrigger was deployed, the starboard outrigger remained stowed, a port-side planer rod was in place, and three additional rods were secured in holders, with no lines in the water. The aft fish box contained fish, indicating the operator had been actively engaged in fishing prior to the incident. While the vessel's outriggers can be deployed from the deck using a spinning handle, reducing the need to climb onto the gunwale, it remains possible the operator accessed the gunwale for other reasons, such as adjusting the outrigger, handling fishing gear, or addressing an issue. Frequent movement around the deck during fishing activities, combined with vessel motion and potentially wet surfaces, could have increased the risk of losing balance and falling overboard.

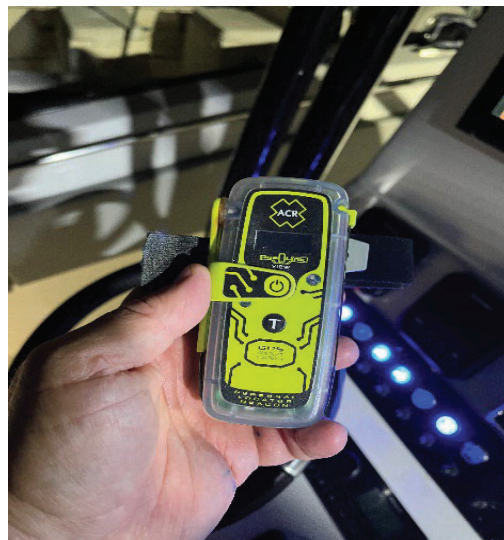
5.5. Operator Did Not Carry the ACR ResQLink PLB: BIG STICK was equipped with an ACR ResQLink PLB, which was found stowed in a compartment above the console. The ACR ResQLink is designed to transmit a distress signal using GPS positioning, a 406 MHz satellite signal, and a 121.5 MHz homing capability. These signals relay the distress information to satellites, which then transmit it to ground stations and appropriate search and rescue authorities. While the PLB is waterproof and capable of providing an accurate location to aid rescue efforts, it requires manual activation and must be accessible during emergencies. Had the operator been carrying the PLB on his person, such as in a pocket or attached to a life jacket, it could have remained accessible during an unexpected entry into the water, potentially enabling faster and more accurate location for search and rescue teams.

Figure 6: Photograph of the ACR ResQLink personal locator beacon found on the BIG STICK. Taken by U.S. Coast Guard Sector North Carolina Investigators on April 9, 2024.

6.1.2.2. The operator did not carry the ACR ResQLink PLB on his person while underway.

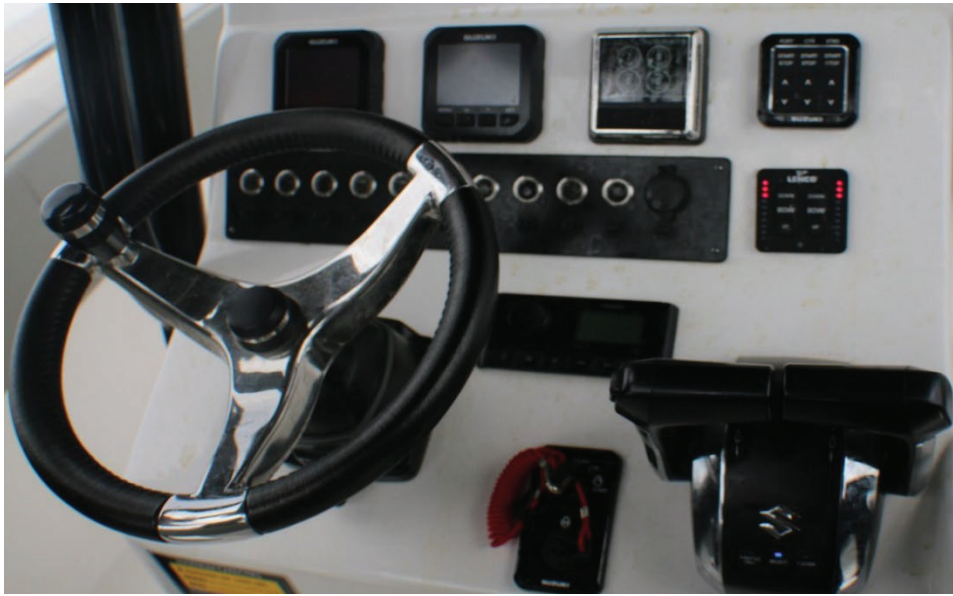
4.2.4. In videos posted to Facebook on April 6, 2024, the operator is clearly seen not wearing a PFD and without the engine kill switch lanyard attached. Upon recovery of the vessel on April 9, 2024, there was no indication that a PFD had been in use. The ACR ResQLink (PLB) was found stowed on the vessel, and the engine kill switch lanyard was attached to the engine kill switch.

5.6. Impact of Engine Kill Switch Non-Engagement on Operator Safety: The vessel was equipped with a lanyard-style engine kill switch, a safety feature designed to immediately shut off the engine if the operator is separated from the helm. When activated, the kill switch stops the vessel's forward motion by disconnecting the lanyard from the switch. Upon recovery of the vessel, the kill switch lanyard was found attached to the engine kill switch, indicating the system had not been engaged. Had the operator been wearing the lanyard at the time of an overboard incident, the system would have activated, shutting off the engine and reducing the vessel's forward momentum. In ideal circumstances, this could have prevented the vessel from moving away from the operator, thereby increasing the likelihood of self-rescue or timely recovery.

Figure 7: Photograph of the console of the BIG STICK, showing the lanyard-style engine kill switch to the right of the steering wheel. Captured by the USS SHERMAN boarding team on April 9, 2024.

6.1.2.4. The engine kill switch was not used properly, as the lanyard was attached to the switch and not worn by the operator.
