**REPORT OF THE INVESTIGATION
INTO THE
LOSS OF LIFE ON BOARD THE COMMERCIAL FISHING
VESSEL LA6893ER ON LAKE CHIEN, LA, ON
OCTOBER 16, 2024**

**FALL OVERBOARD RESULTING IN THE LOSS OF ONE LIFE FROM THE
COMMERCIAL FISHING VESSEL LA6893ER WHILE OPERATING ON
LAKE CHIEN, LOUISIANA ON OCTOBER 16, 2024**

Official Name/State Number:	LA6893ER
Hull Identification Number	EKHB1097I596
Flag:	United States
Vessel Class/Type/Sub-Type	Commercial Fishing Vessel (CFV), Pot/Trap
Build Year:	1996
Length:	21.0 feet
Main/Primary Propulsion:	Diesel Outboard, 200 HP
Owner:	[REDACTED]

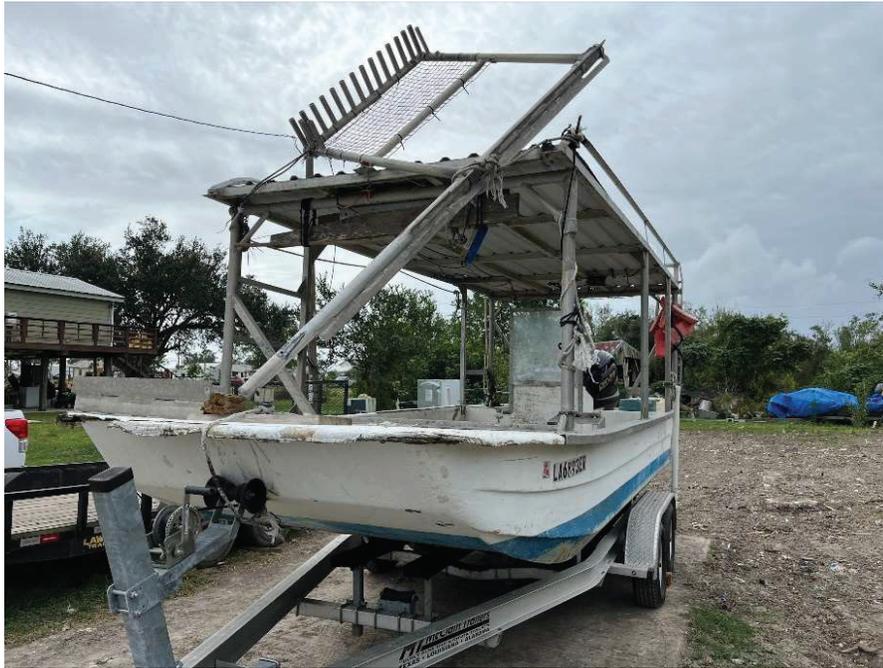
Figure 1. Bow of LA6893ER taken by USCG on 10/31/24.

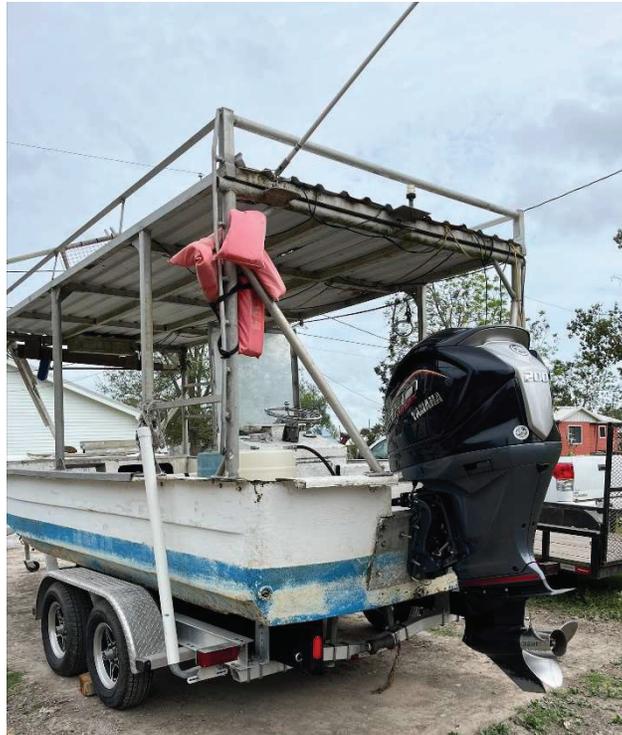
Figure 2. Stern of LA6893ER w/ location of PFDs.
Taken by USCG on 10/31/24.

4.2.7. The master did not typically wear a personal flotation device (PFD) during fishing operations. The vessel carried at least two PFDs on board at the time of the incident. Title 46 CFR Part 28 does not mandate PFD wear for commercial fishermen, only that serviceable PFDs be readily accessible near work and berthing areas.

5.2. Failure to wear a Personal Flotation Device (PFD). At the time of the incident, the master was not wearing a personal flotation device, despite the presence of two serviceable PFDs on board. This reflects a longstanding and widespread practice among commercial fishermen to forego wearing PFDs during active deck work due to concerns about comfort, mobility, and entanglement with gear. While not required under federal regulations for commercial fishing vessels of this size and category, the absence of PFD usage introduces a significant risk in man-overboard situations, especially in solo operation if the Master falls overboard there is no one to throw them the PFD. In this case, no witnesses observed the master falling overboard, and no immediate distress signal was received. A properly worn PFD could have kept the master afloat for a longer period, increased visibility to SAR units, and substantially improved the chances of recovery. In water temperatures around 80°F with generally favorable visibility, survival time could have been extended significantly with flotation support. Had a PFD been worn, the probability of a successful recovery during the multi-day search operation could have increased.
