**REPORT OF THE INVESTIGATION
INTO THE CREWMEMBER LOSS OF LIFE ONBOARD THE
COMMERCIAL FISHING VESSEL MASTER WAYNE IN
THE VICINITY OF WEST BAY NEAR VENICE LOUISIANA
ON SEPTEMBER 23, 2021**

**FALL OVERBOARD AND SUBSEQUENT LOSS OF ONE LIFE FROM
THE COMMERCIAL FISHING VESSEL MASTER WAYNE (O.N. 621112)
IN THE VICINITY OF WEST BAY NEAR VENICE, LOUISIANA
ON SEPTEMBER 23, 2021**

INVESTIGATING OFFICER’S REPORT

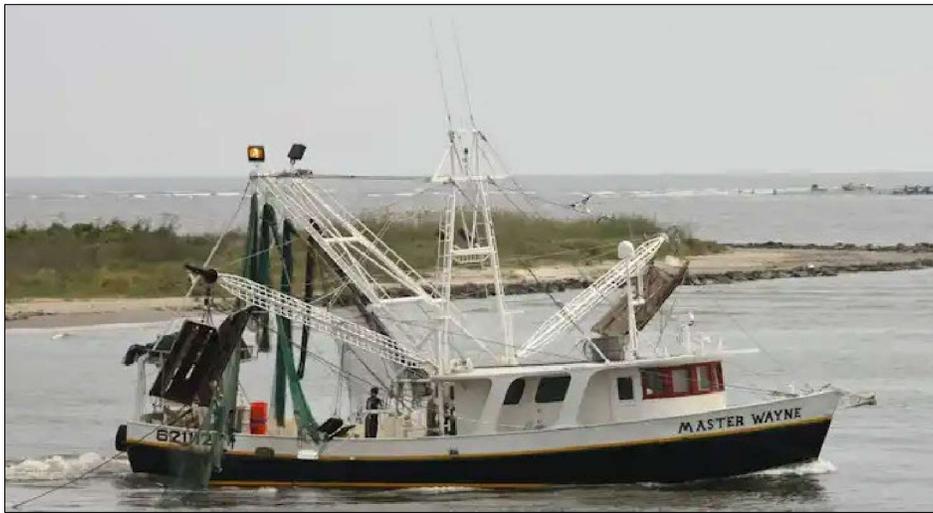
Figure 1. Photograph of *Master Wayne* (Google)

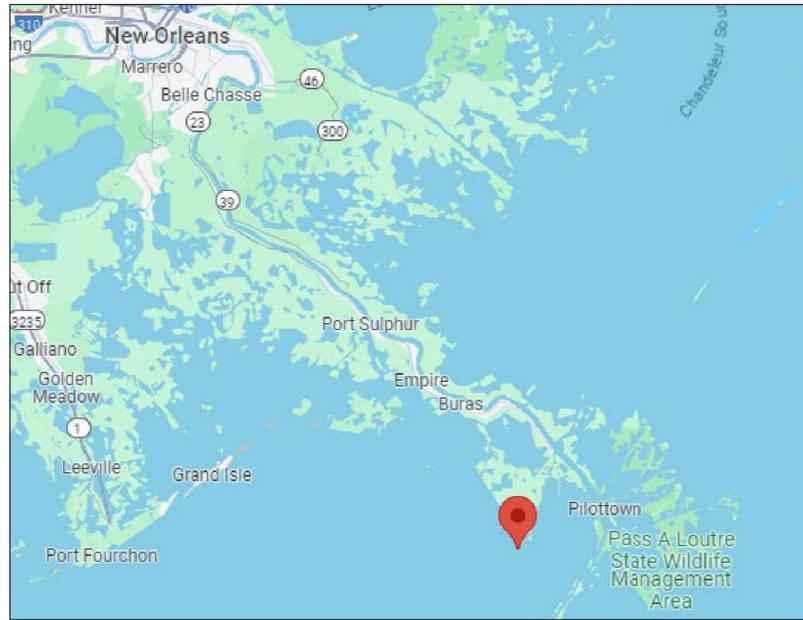
i.
Figure 3. Approximate location of incident in vicinity of West Bay (June 12, 2024 / Google Maps)

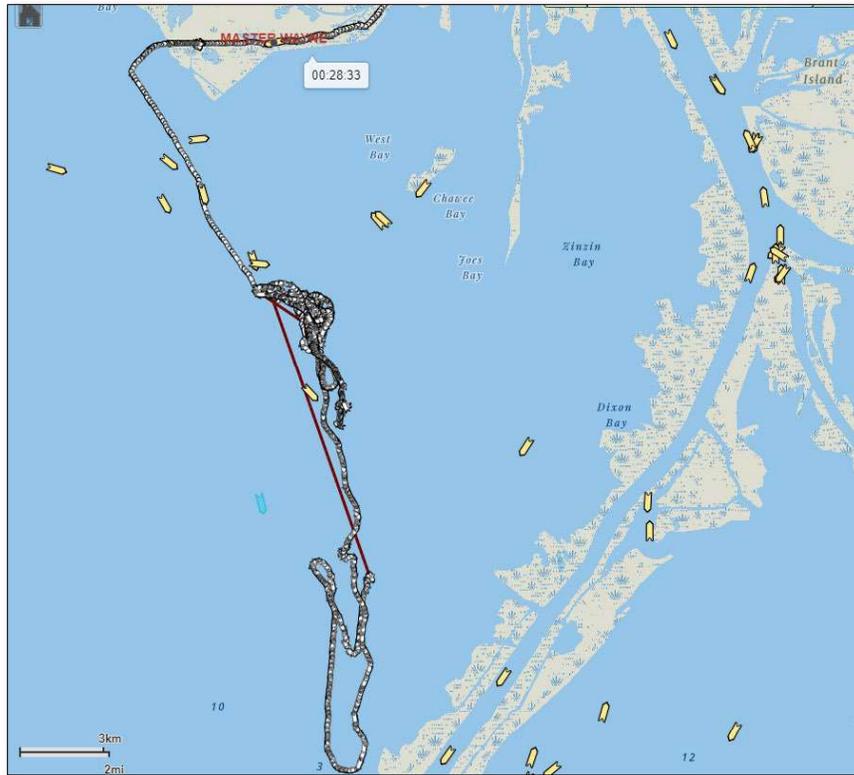
Figure 4. *Master Wayne* trackline around time of incident (September 23, 2021/USCG)
