**REPORT OF THE INVESTIGATION
INTO THE
LOSS OF LIFE ON BOARD THE COMMERCIAL FISHING
VESSEL MISS WINNIE (O.N. 1047703) IN THE
GULF OF MEXICO ON DECEMBER 02, 2023**

MISLE ACTIVITY NUMBER: 7833847

FALL OVERBOARD AND SUBSEQUENT LOSS OF ONE LIFE FROM THE COMMERCIAL FISHING VESSEL MISS WINNIE (O.N. 1047703) WHILE ENGAGED IN FISHING IN THE GULF OF AMERICA APPROXIMATELY 120 NAUTICAL MILES SOUTHWEST OF PORT FOURCHON, LOUISIANA ON DECEMBER 2, 2023

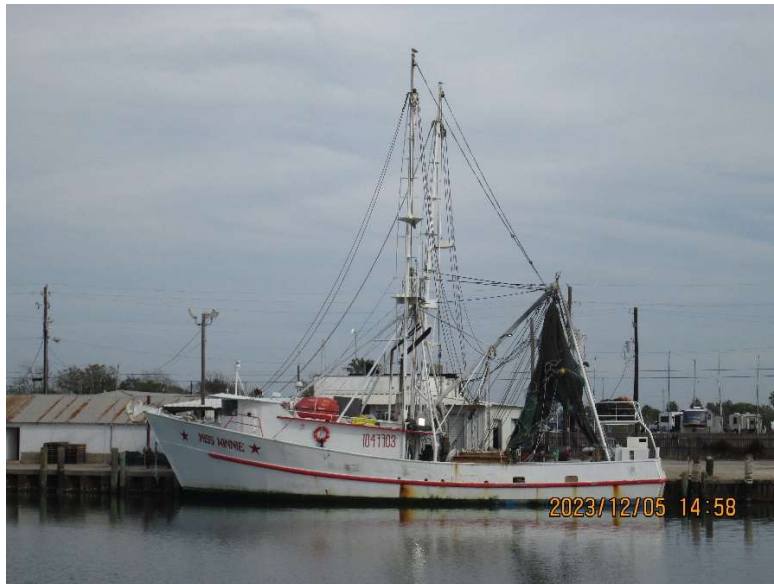
Figure 1. MISS WINNIE, taken in Palacios, TX on 12/05/23 by USCG.
