Damage Control Trainer Repairs

Coast Guard Commercial Fishing Vessel Safety Program

Safety Note & Preventive Maintenance

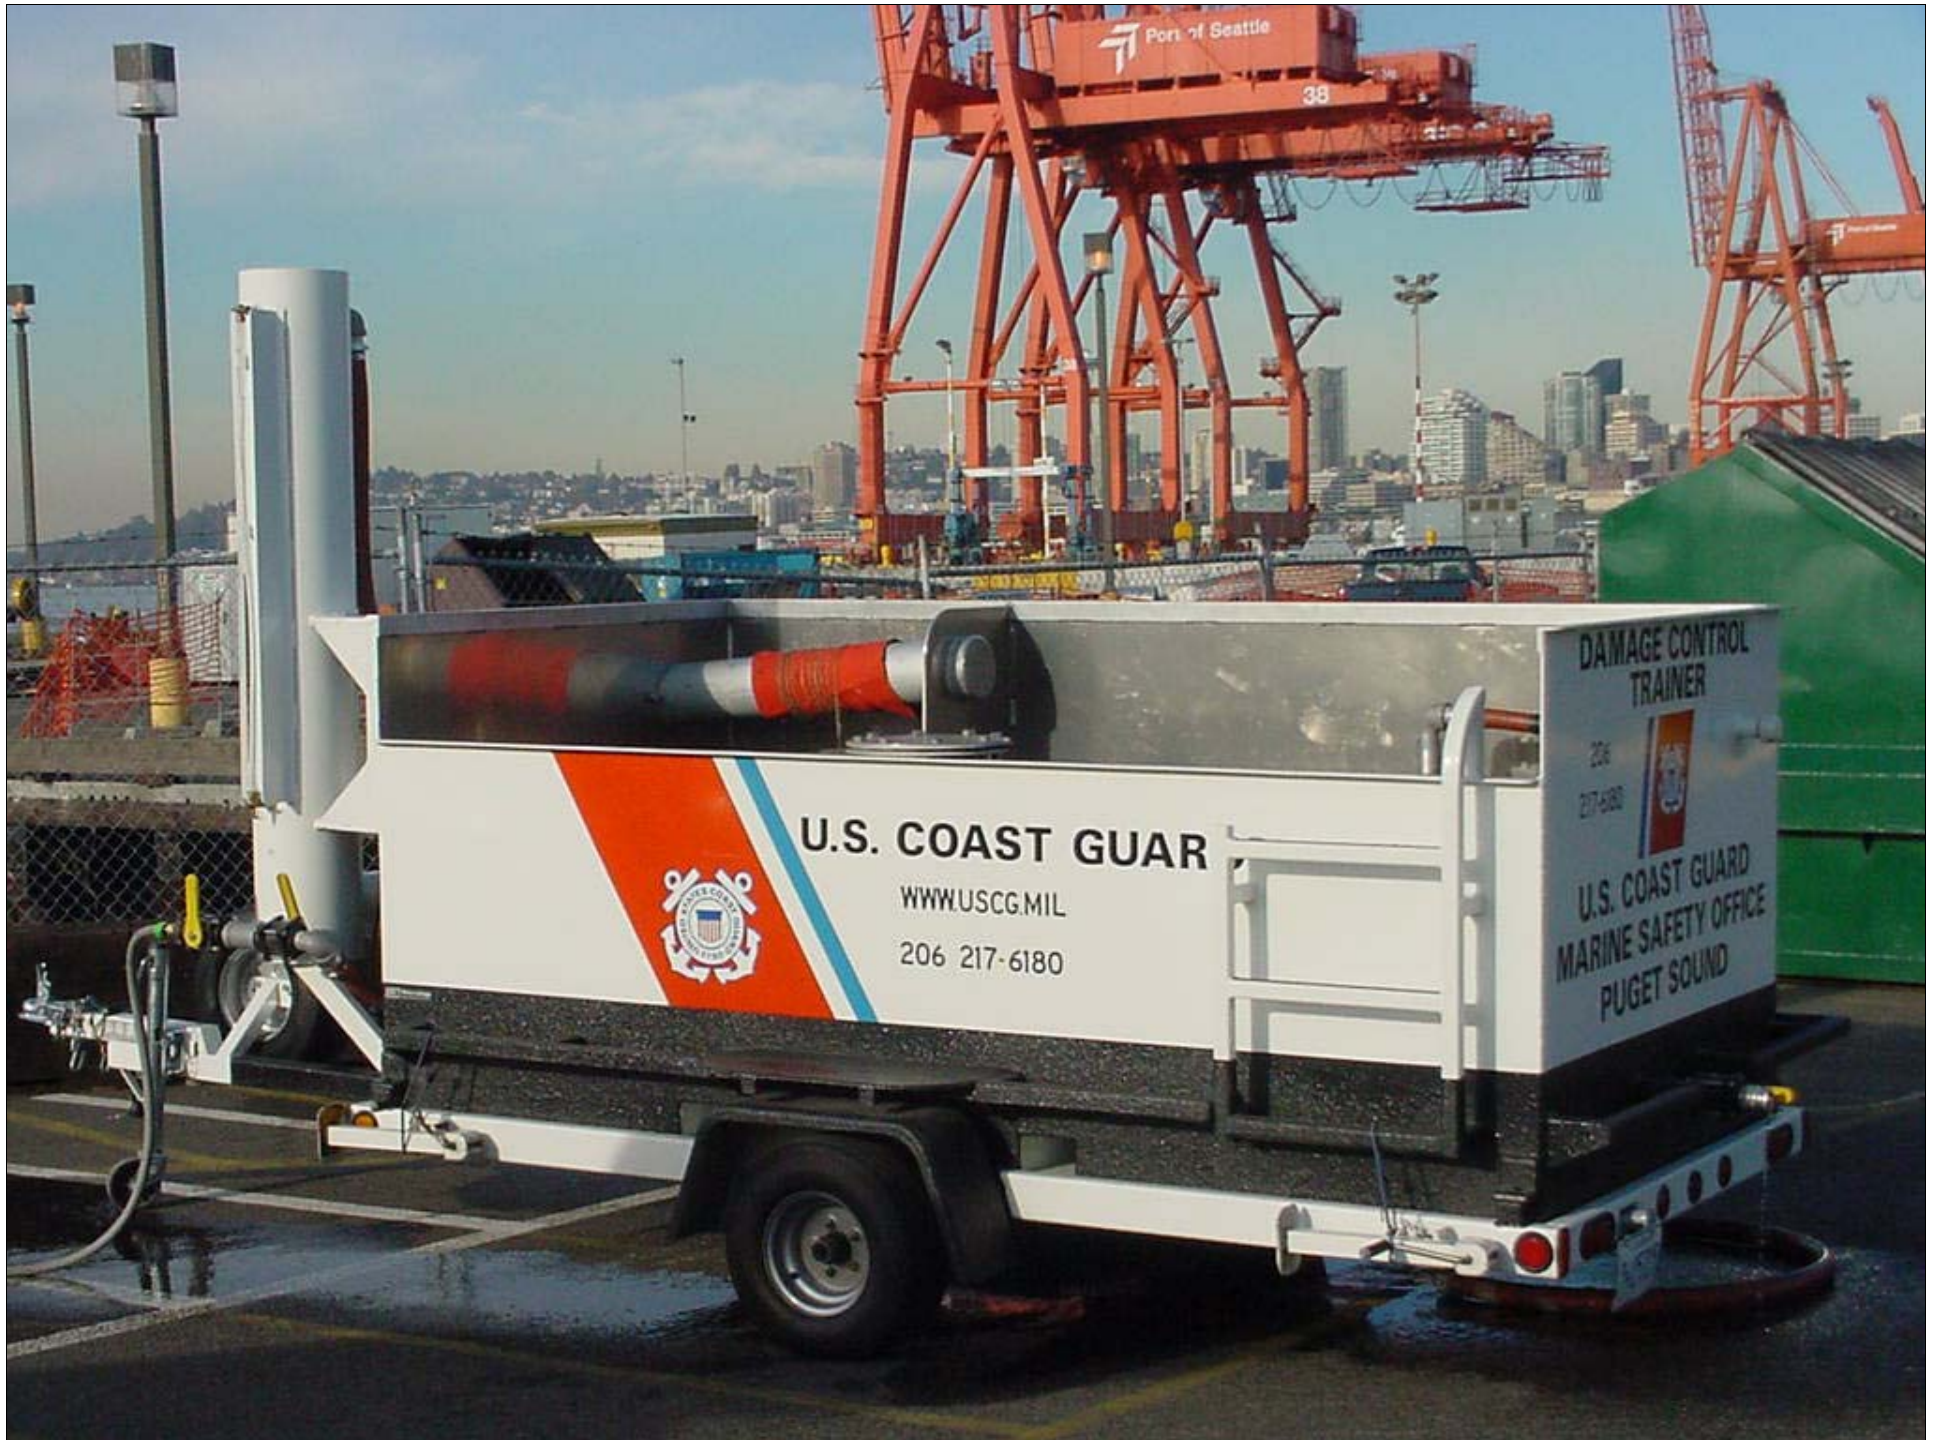
- “The repair shop has already begun repairs on the trailer so I will not be able to show the actual damage. I will however send a photo of the repairs. The crack was in the tongue right at the front of the trailer and it was nearly invisible. I did not see it until I lifted up the front of the trailer and the crack opened up. I suspect it was caused by stress at that point and the roads are very rough with frost heaves. It had been cracked for a while because there was rust inside the crack. The repair shop will be adding additional metal to that part of the tongue to strengthen it.
- Here are pictures of the repair and improvements to the DC trainer trailer tongue. It will give you a better idea of where to look on the other trainers (trailer tongues) for similar problems.

- The triangular braces and the strips along the sides were added for extra strength. The break was across the top and down both sides of the bar. There was a small strip of metal on the bottom side holding it together.”
