MARINE SAFETY ALERT

Alert 07-14

SLIPS, TRIPS and FALLS

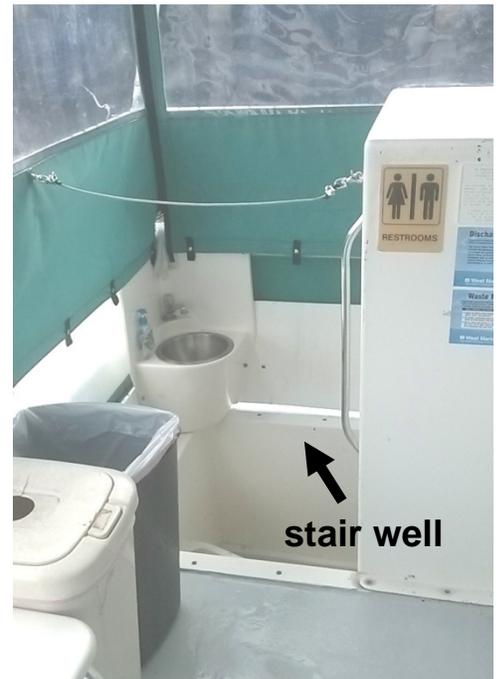
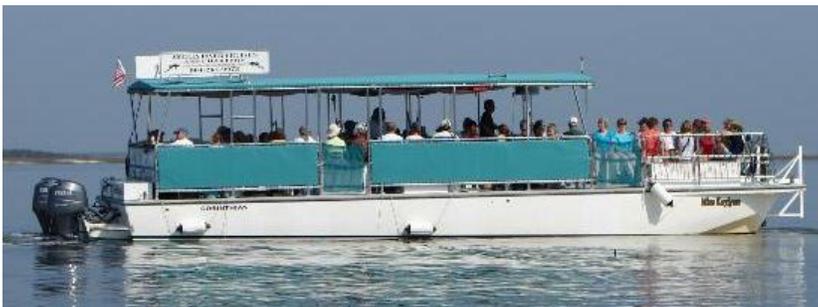
Coast Guard casualty investigators recently responded to an incident whereby a tour boat customer fell into an unprotected two step stair well and received significant injuries. Although the customer was taking photographs at the time and may have lost situational awareness there were no defenses to prevent the fall. The hazard was not previously identified and, as is often said, was an accident waiting to happen. Only afterwards did the owner operator install a small lifeline cable across the opening.

This type of vessel design, with a stair well leading to the head, is very common. These specific catamaran vessels were constructed by Cooper Marine, Inc. and Corinthian Catamarans, Inc. (formerly Corinthian Yachts, Inc.) in various sizes over many years. There may be hundreds of these vessels in operation as tour boats, water taxis, dive boats, etc., world over.

As a result of this incident and many others like it the Coast Guard **strongly recommends** that owner operators;

- identify similar stair well hazards and secure them in a manner that will prevent slips, trips and falls;
- when a hazard cannot be completely eliminated (as with the image above), bring the hazard to the attention of passengers during the initial safety brief; and
- make risk awareness part of your operational culture by having vessel personnel frequently evaluate the vessel's condition with the express purpose of identifying and mitigating hazards.
