## **MARINE SAFETY ALERT**

Safety Alert 03-21

### **BLOCKED FREEING PORTS CAN TRAP SEAWATER ON DECK REDUCING YOUR VESSEL'S STABILITY**

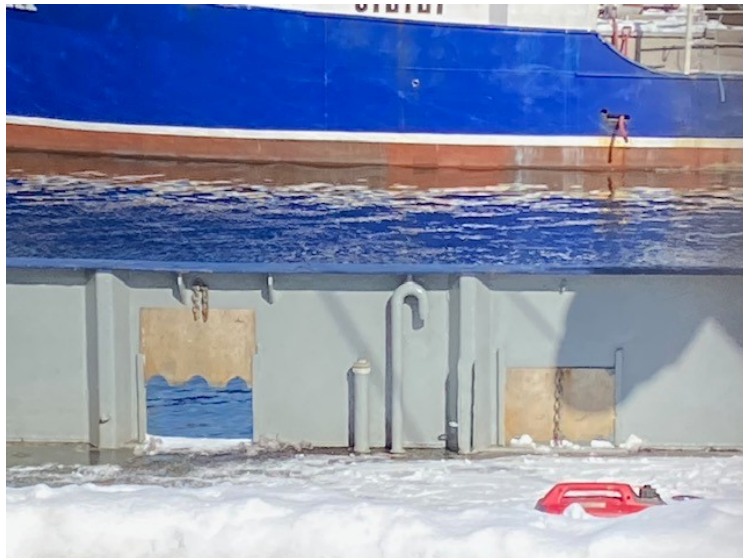
It has come to the attention of Commercial Fishing Vessel Examiners and Marine Casualty Investigators that some commercial fishing vessel operators, at times, close or block their freeing ports to prevent their catch from washing off deck after hauling gear. Freeing ports occasionally remain closed following haul back, and sometimes throughout the entirety of the vessel's voyage.

While the practice of blocking freeing ports may appear harmless, it can have disastrous consequences if seawater accumulates on deck. To put things in perspective, a vessel's deck that measures 37-feet by 14-feet having only one inch of water covering it, equates to 2,763 pounds of surplus liquid weight. The addition of weight on deck, above the vessel's center of gravity (COG), will have a negative impact on the vessel's stability. When an external force (such as waves and wind) rolls the vessel from side-to-side, the trapped water on deck will also slosh from side-to-side, causing a free surface effect. In the above example, that means 2,763 pounds of seawater would be moving back and forth on the main deck. As the water moves, the COG of the vessel also shifts. Seawater added on deck above a vessel's COG and offset from the centerline by sloshing, creates a significantly greater negative impact on the vessel's stability. Open freeing ports allow water on deck to freely escape overboard, preventing the weight shift of seawater from having a dangerous impact on the vessel's stability. A video depiction explaining this in detail can be viewed at <http://www.fishsafewest.info/Training.asp>.

- Ensure freeing ports remain open at all times to allow seawater to drain freely off the deck.
- Ensure owners/operators discuss with their crews the hazards trapping seawater on deck can pose to vessel stability.
- Come up with an alternate means to prevent loss of catch while maintaining adequate drainage.
