MARINE SAFETY ALERT

Safety Alert 04 -21

VERIFY YOUR WIRE ROPE TERMINATIONS: **INCORRECT TERMINATIONS CAN LEAD TO CATASTROPHIC FAILURE**

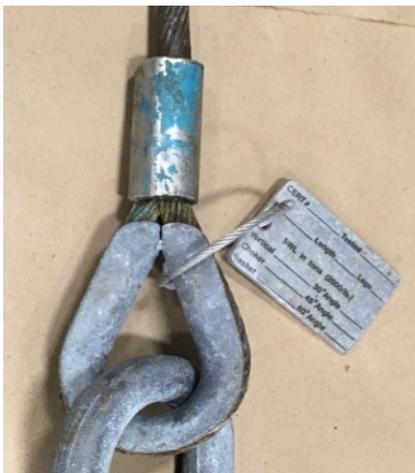
Figure 1: Fitting has a uniform appearance.

- Visually examine wire rope terminations for abnormalities that may indicate improper installation (Figure 1 shows a crimp with a uniform appearance, Figure 2 shows out-of-roundness, and Figure 3 shows ridges created by over-crimping);
- Compare fitting dimensions against the manufacturer's specifications/tolerances for the completed fitting (i.e., does the length and diameter fall within fitting manufacturer specifications); and

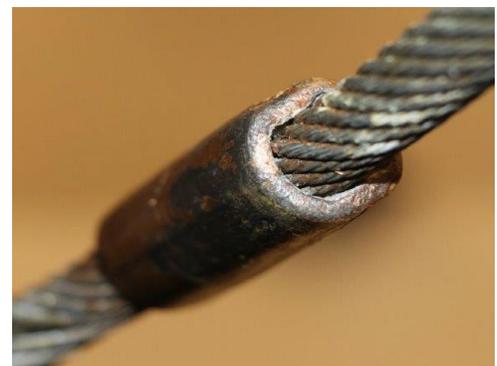
The Coast Guard observed that improperly applied swaged fittings could result in unintentional damage to the wire rope, resulting in failure of the termination. Improper swaging procedure includes failures within a quality management system in which materials are improperly selected and do not match the specifications of the original equipment manufacturer.

Figure 2: Completed fitting is not "round" nor within manufacturer specifications.

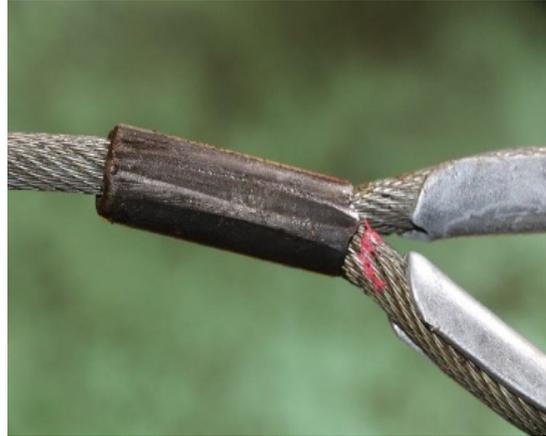
Figure 3: Fitting is deformed with “ridges” of extra material present from over-crimping.
