MARINE SAFETY ALERT
Inspections and Compliance Directorate

Safety Alert 09-24

CHAFING ON FUEL HOSES CAN CAUSE CATASTROPHIC FIRES

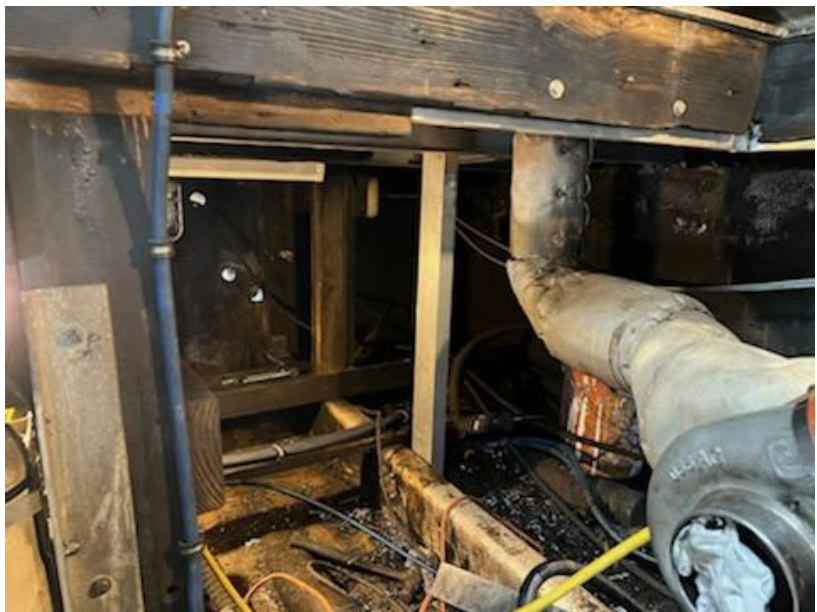
Figure 1 – Main Engine Dry Exhaust

A recent fire onboard an inspected towing vessel has highlighted a critical safety concern involving fuel hoses on main engines. While it is standard marine practice to install protective chafing gear on areas prone to wear, there are currently no statutory requirements for inspected towing vessels to install such protections on fuel lines. Failure to prevent chafing on these hoses can lead to fuel leaks, which may spray onto the engine and ignite, causing a fire.

Although these measures may seem minor, compromised fuel hoses can pose significant risks to the vessel's crew, the environment, and the vessel's seaworthiness. In the incident cited, the vessel was underway when the port main engine's fuel hose sprayed fuel onto the exhaust, resulting in a fire that caused over \$100,000 in damages and injured a crew member due to smoke inhalation.

- **Install fire-retardant hose coverings and chafing protection:** Consider standardizing installed equipment across fleets to ensure consistent protection and crew member familiarity.

- **Conduct thorough inspections:** Inspect fuel hoses regularly as part of a standard maintenance routine. This should include visual inspections for signs of wear, such as cracks, abrasions, or any other indicators of deterioration.

- **Install flange spray shields:** Where pressurized fuel piping is flanged or threaded, spray shields or anti-spray tape should be installed to prevent leaks from contacting hot surfaces or other ignition sources. The document [*IMO MSC.1/Circ. 1321*](#), published by the International Maritime Organization (IMO), provides detailed guidelines on installation of spray shields, proper hose installation, and other measures to prevent engine room fires.
