UNITED STATES COAST GUARD

INVESTIGATION INTO THE CIRCUMSTANCES
SURROUNDING THE BARGE

MARIA T

O.N. 649301, DRAGGING ANCHOR WHILE UNDERTOW OF
THE TOWING VESSEL SCOTT TURECAMO O.N. 1067705,

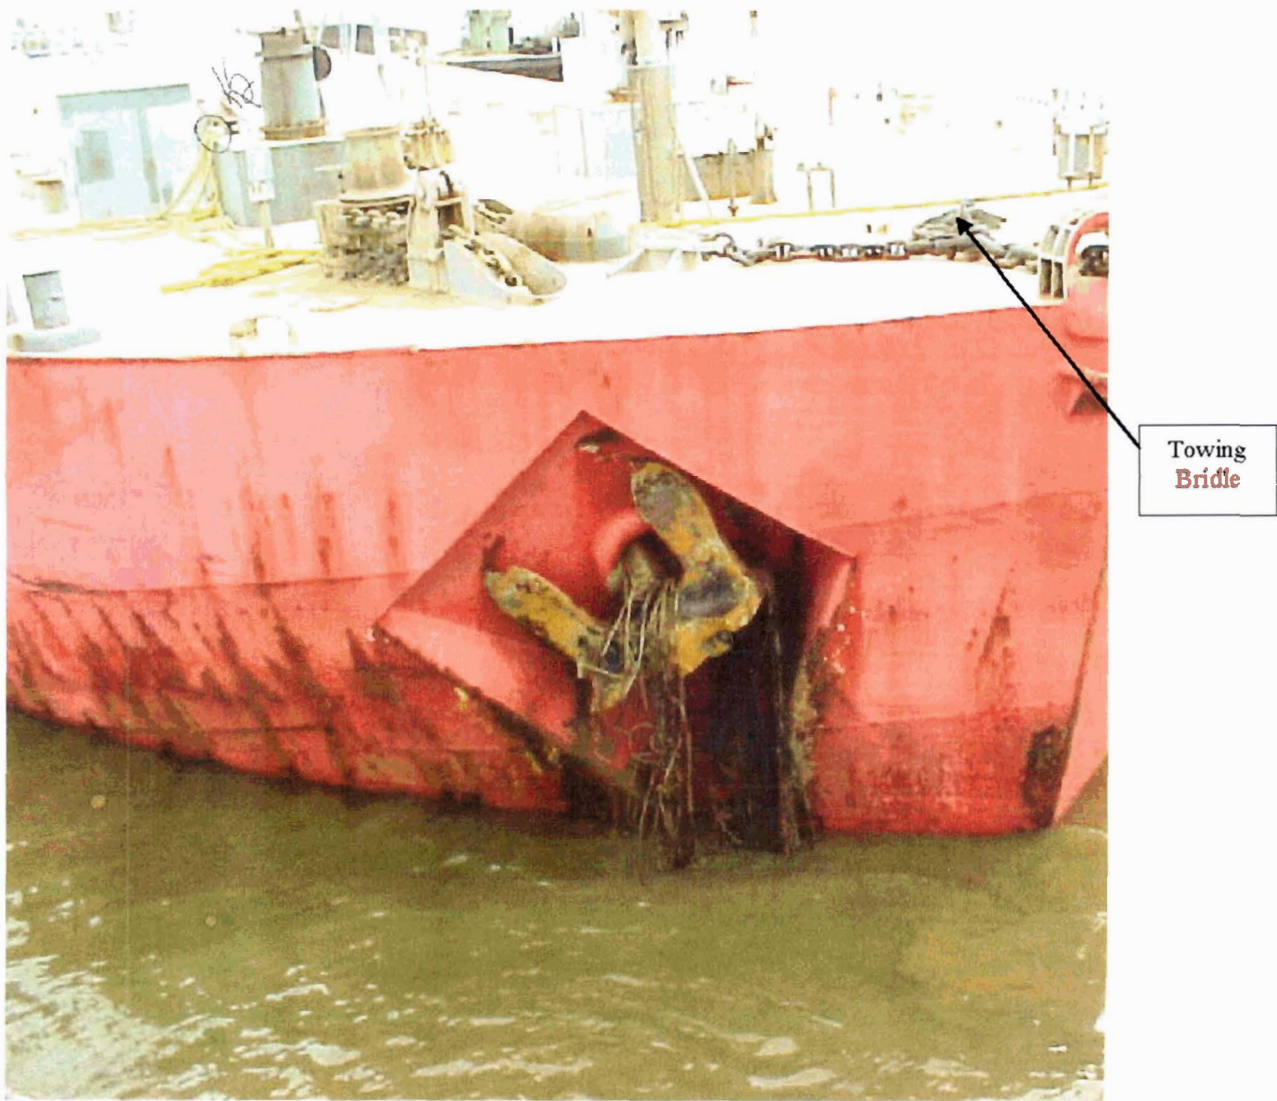
Cement barge MARIA T moored on August 8, 1999. Anchor shows debris picked up as the anchor dragged along the bottom of the Hudson River. Photograph taken August 8, 1999 in Roseton, New York. (Exhibit 54)

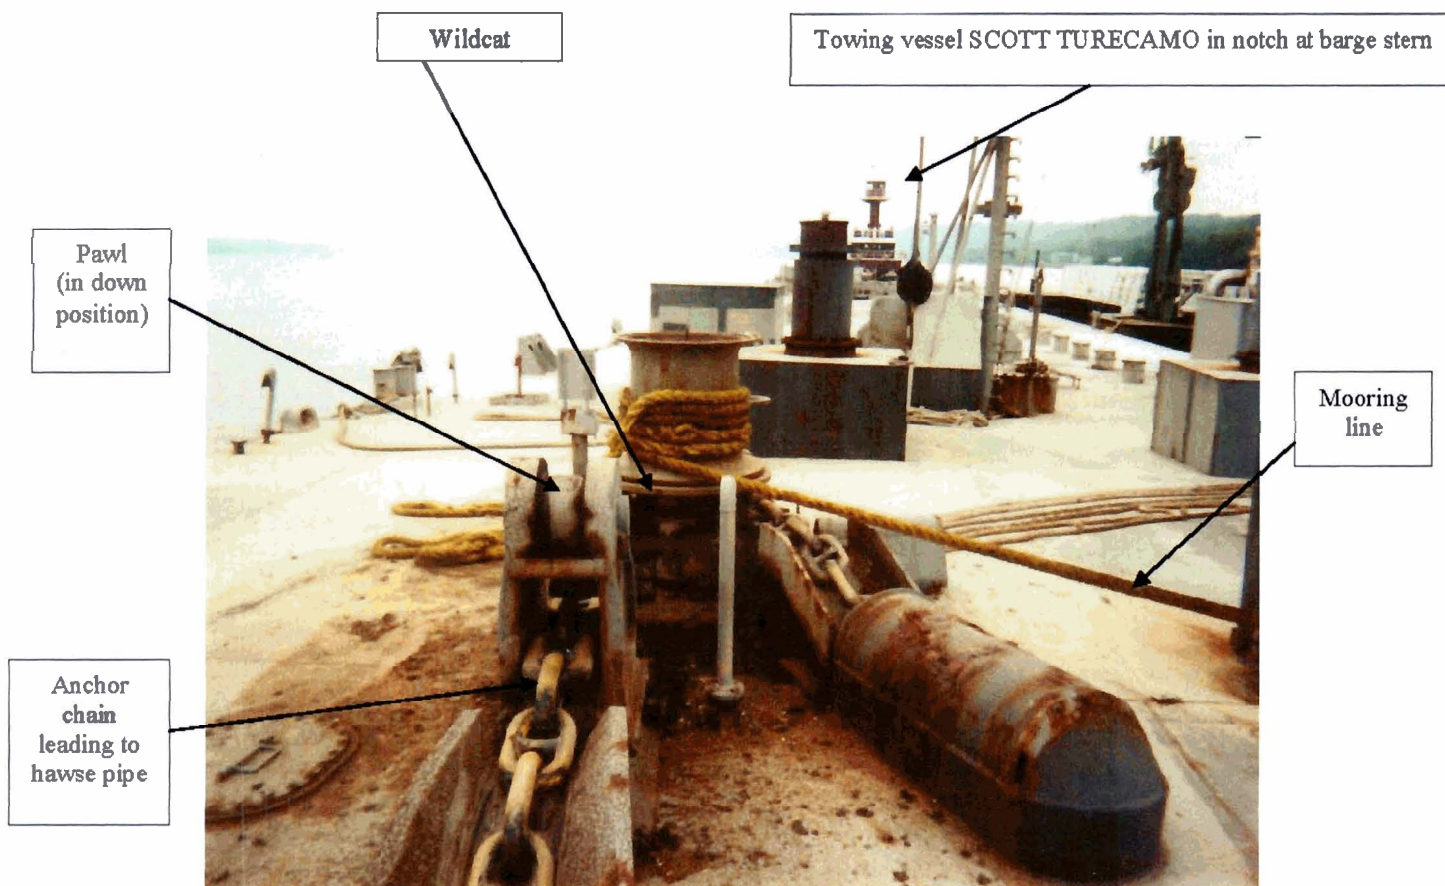
Barge MARIA T – Photograph taken from bow looking aft. Towing vessel SCOTT TURECAMO at barge stern, in the notch. Photograph taken August 15, 1999 (Exhibit 30)
