# OPERATIONAL SAFETY INFORMATION FOR COMMERCIAL CRABBING VESSELS **2024**

U.S. COAST GUARD OFFICE OF INVESTIGATIONS AND ANALYSIS  
& OFFICE OF COMMERCIAL VESSEL COMPLIANCE

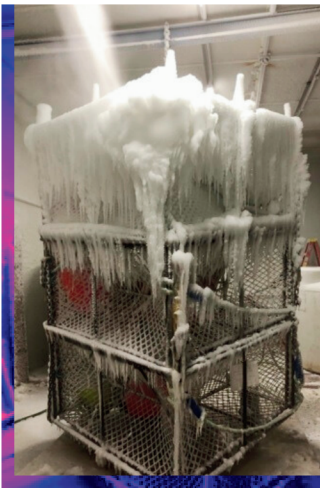
A triple stack of typical crab pots iced over in a test chamber.

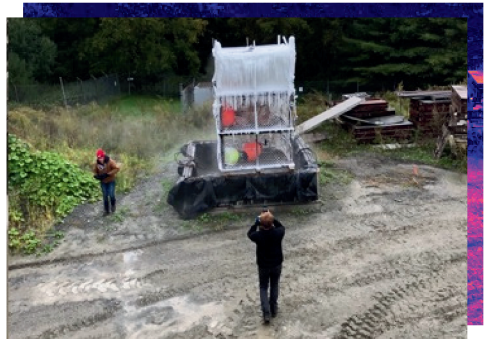
The same stack of pots removed from the test chamber and placed at a distance equal to the distance from the forward wheelhouse to the front of the pot stack on SCANDIES ROSE. Can you estimate the ice thickness accurately?

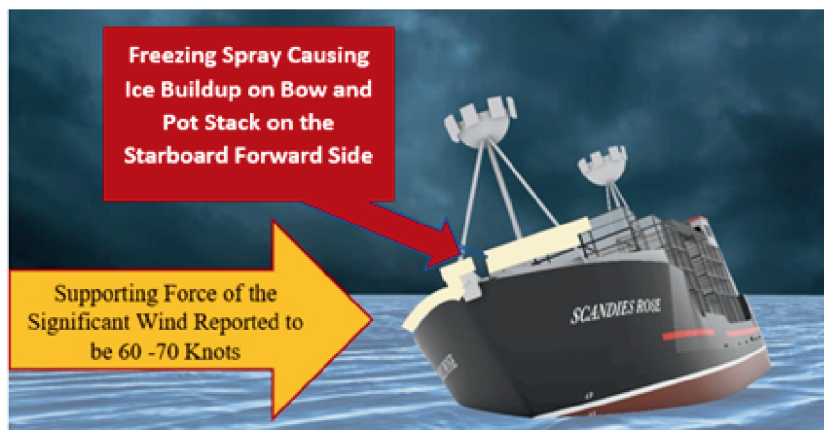
A model showing the final hour of the SCANDIES ROSE with significant icing on the starboard bow and pot stack, leading to the vessel listing into a significant wind on the starboard bow.

Current regulations for determining stability constraints for crabbing vessels do not consider the formation and effects of asymmetrical icing of vessels and pot stacks. As such, captains and owners should take this into account when determining the number of pots to carry when freezing spray is anticipated and err on the side of caution.

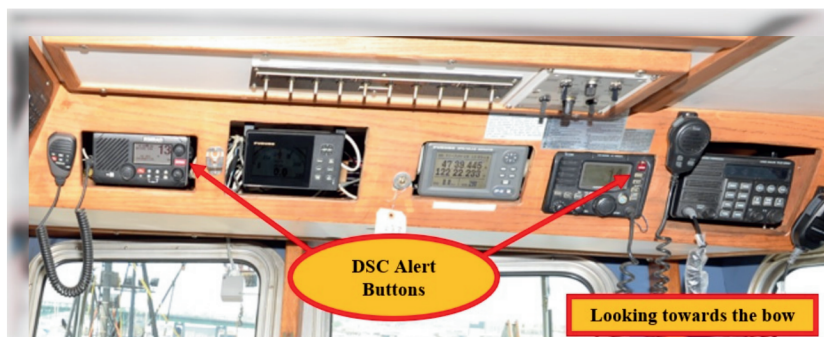
The visor panel on the SCANDIES ROSE wheelhouse with two VHF radios that could have had the DSC feature configured. When every second counts, the DSC function might have provided the master valuable time to don a survival suit, attend to his crew, egress the vessel, and potentially help him save his own life and the lives of his crew.

The SCANDIES ROSE had several VHF marine radios. None of these were configured to use the Digital Selective Calling (DSC) distress alert feature. On the SCANDIES ROSE, the captain stayed at his post in the wheelhouse, broadcasted the “mayday” message, and repeated the vessel’s position twice. With the DSC distress alert feature, the radio would automatically transmit the distress and the GPS-enabled latitude and longitude until it was received at a shore station, saving the master and crew valuable time in an emergency. Information on configuring the DSC function can be found in Coast Guard Marine Safety Alert 03-23 (QR code provided on the last page).

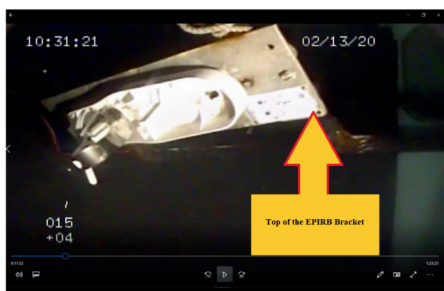
The empty EPIRB bracket of the SCANDIES ROSE. There was no evidence of the EPIRB being trapped in the exterior wreckage of the vessel when the underwater wreckage was later surveyed by a remote underwater vehicle (ROV).

The SCANDIES ROSE was equipped with an Emergency Position Indicating Radio Beacon (EPIRB), but it was never located and did not transmit the distress signal to satellites overhead. It is possible that the EPIRB was taken into the wheelhouse of the vessel in preparation to abandon the ship. That would have trapped this critical device in the wheelhouse when the vessel suddenly capsized. While it is good practice to bring the EPIRB with you when abandoning a vessel in an emergency, the device should not be brought into the skin of a sinking vessel. Make sure that the EPIRB and mounting bracket with a valid hydrostatic release mechanism are installed and tested as specified by the manufacturer. It is also imperative to install this in a location where it will float free in an emergency to transmit critical search and rescue information including the name of the vessel and geographic position.

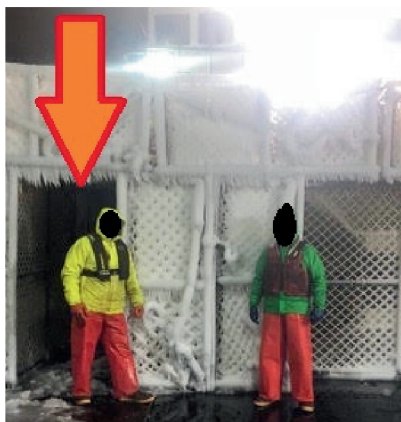
An alleyway through the pot stack on an unidentified commercial crabbing vessel. The orange arrow shows the path to move safely forward through the interior of the pot stack.

On the accident voyage, the Captain and deckhand on the SCANDIES ROSE talked about going forward “over the top” of the pot stack, but with 60–70 knot winds and high seas, this was too risky. As a result, the crew was unable to accurately determine the amount of icing forward or make any attempts to break the ice off the pots or vessel equipment. Creating a pot stowage plan that considers safe access throughout the deck which includes alleys or walkways in the pot stack enables the crew to access icing and take necessary actions to protect the vessel and crew in all weather conditions.

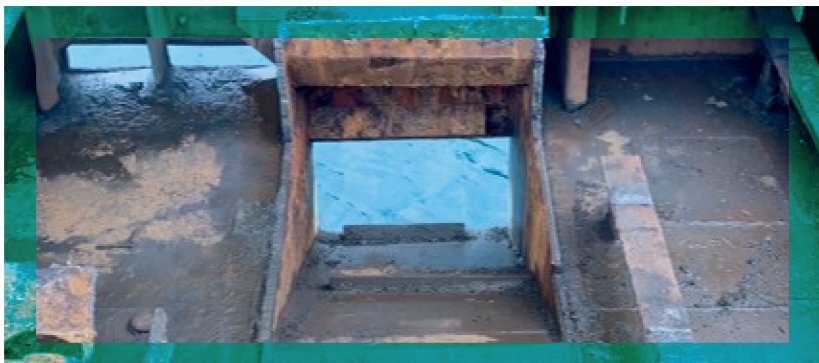
## ***THE CHUTE BEFORE REPAIR:-***

The overboard chute, prior to cropping and renewing which leaked and penetrated the side shell plating on the SCANDIES ROSE and after the repair non-destructive testing conducted by an ABS certified welder.

Keeping the water outside the vessel where it belongs is a complex issue and requires proactive maintenance of the watertight integrity of the vessel. The sea will look for any opening to get into the vessel such as wasted hull plating, poorly welded seams, and hatches or other fittings left open, either inadvertently or for ease of passage onboard. Closing the appropriate hatches, scuttles, and other valves and fittings when underway is key to ensuring vessel stability and safety. If repairs are needed, seek certified welders who test their work. The captain of the SCANDIES ROSE had requested repairs of previous sub-standard weld work. In response, the owner approved the use of a certified welder to crop, renew, and perform non-destructive testing to ensure the quality of the final welds. The difference in quality of work was evident in the provided photos.
