Best Practice: Continuing Fence Line Into Water

Category: Perimeter Control

Location First Observed: Port of Kandla, India

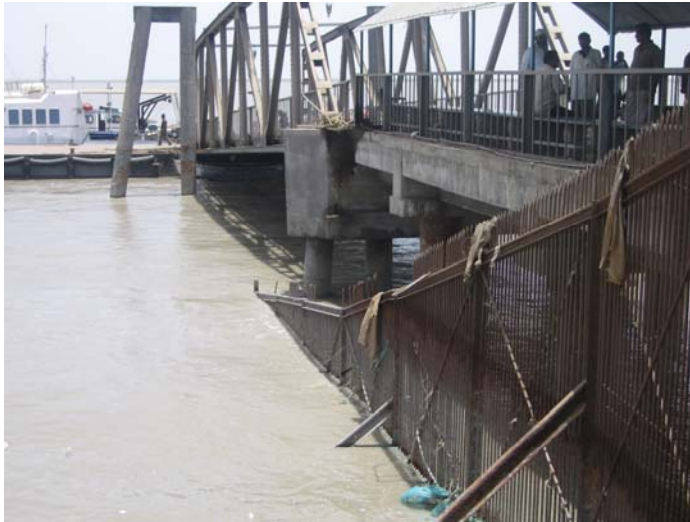
Description: The fence line is continued down the bank of the channel into the water to prevent trespassers from circumventing the fence to access the facility.

Discussion: At a waterfront facility, a common challenge to the effectiveness of walls and fences is the land/water interface, and how to prevent intruders from walking around walls and fences at the waterline. This is especially problematic with tidal water, which floods and recedes; often leaving a gap at the end of the fence during low tide. At the Kandla Facility, this issue was addressed by continuing the construction of security fence from land down into the channel. At high and low tide, the fence creates an effective barrier against intruders. Lateral supports protect fence against tidal movement or current.

Potential Down-side: A fence of this type is susceptible to flood damage and/or collecting trash from flooding and receding tides. The fence can still be circumvented by an intruder willing to go farther into the water to go over or around the fence. Constructing a fence in a waterway can be an expensive and time consuming endeavor, especially if concrete footings are required.
