PROCEEDINGS

OF THE MERCHANT MARINE COUNCIL

Vol. 19, No. 9 • September 1962

MARINE CORROSION IN SHIPS

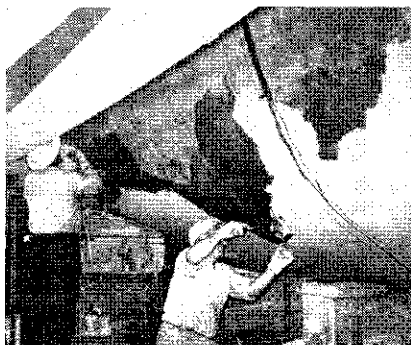
Figure 1. Failure of vinyl underwater body paint due to poor surface preparation and application.

Figure 1 shows a vinyl film which looked good when the vessel was docked, but which had very poor adhesion with accelerated corrosion beneath. As shown, the film had just been penetrated by a knife and pulled loose by hand. Corrosive products underneath were so extensive as to require some hull inserts, although the boat was only 6 months old when this docking occurred. Other sources of corrosion on these lightweight underwater bodies are rough welds, badly fitting plates and, above all, electrolytic corrosion due to dissimilar metals.

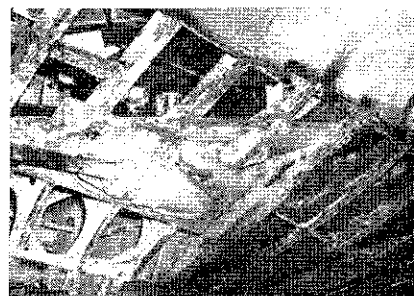
Figure 4. Deteriorated shell, bounding bars, sight edges and frames

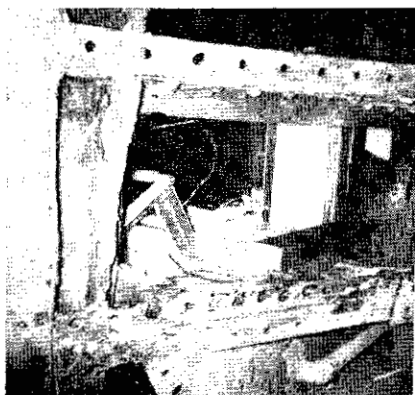
Figure 5. Deteriorated frames, sight edges and structure.
