MEMORANDUM

To: [REDACTED]
CG INCOE
Lead Investigator, FPS AUGER 30 June 2019 Lifeboat Casualty Investigation

Subj: USCG TESTING OF SCHAT-HARDING LHR 3.5M2 RELEASE MECHANISM

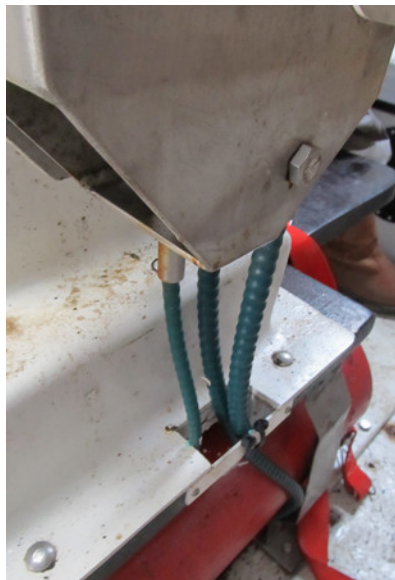
Figure 8: AUGER Lifeboat 6 cable routing at release unit (circa 2014). Credit: Shell.

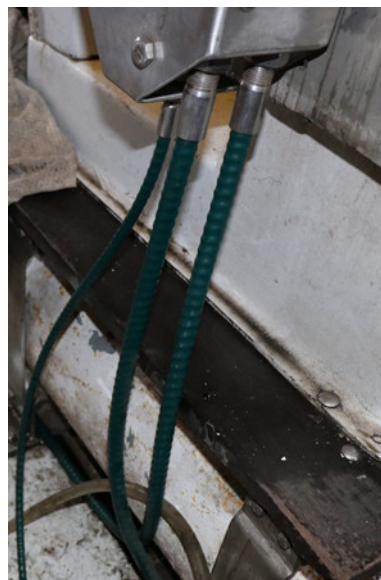
Figure 9: MSTC Lifeboat 1 cable routing at release unit. Credit: CG.

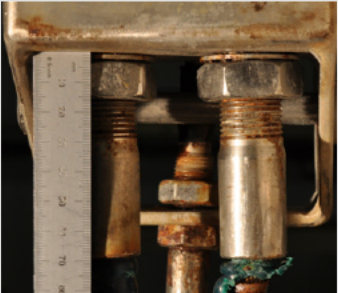
<p>7 threads exposed (inside of clevis)² <i>Left is the forward hook cable/Right is the aft hook cable</i></p>	Removed lock nuts; adjusted to 7 threads exposed (inside of clevis)
Release Unit Aft Cable Clevis	8 threads exposed (inside of clevis) ²	Removed lock nuts; adjusted to 8 threads exposed (inside of clevis)/bottomed against shoulder
Release Unit Forward Cable Bulkhead Connection

<p>7 threads exposed (between bottom nut & thread shoulder) <i>Left is the forward hook cable/Right is the aft hook cable</i></p>	Adjusted to 7 threads exposed (between bottom nut & thread shoulder)
Release Unit Aft Cable Bulkhead Connection	7 threads exposed (between bottom nut & thread shoulder)	Adjusted to 7 threads exposed (between bottom nut & thread shoulder)

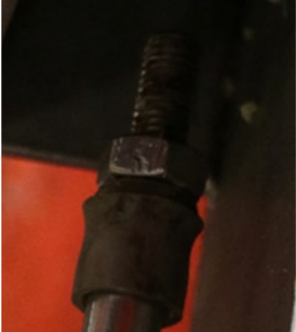
Hooks		
Forward Hook Cable Clevis

<p>Disconnected³</p>	Connected ⁴

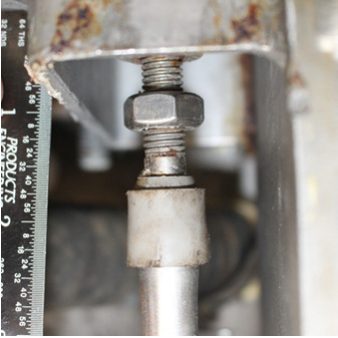
<p>Aft Hook Cable Clevis</p>

<p>Lock nut loose with 4 threads between the thread shoulder & the nut and 6 threads between the nut & the clevis)</p>	<p>Loosened lock nut; adjusted to 4 threads between the thread shoulder & the nut and 6 threads between the nut & the clevis)</p>
<p>Forward Hook Cable Bulkhead Connection</p>

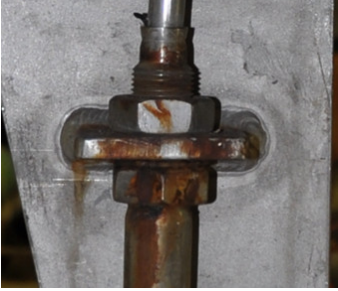
<p>5 threads exposed (between the top nut & start of threads)</p>	<p>Adjusted to 5 threads exposed (between the top nut & start of threads)</p>
<p>Aft Hook Cable Bulkhead Connection</p>

<p>5 threads exposed (between the top nut & start of threads)</p>	<p>Adjusted to 5 threads exposed (between the top nut & start of threads)</p>
<p>¹ The as-found conditions were documented by the DNV-GL Lab in Columbus, OH (DNV-GL USA, Inc. (Oil and Gas), Pipeline Services Dept, Incident Investigation). Table Photo Credits: DNV-GL. ² No lock nuts (jam nuts) were found installed for cable clevises at the release unit. Both clevises were threaded to the shoulder at the bottom of the threads. ³ The forward hook cable clevis was found disconnected after recovery, with evidence indicating this occurred post-incident and was not a causal factor. ⁴ Forward hook clevis was adjusted after all other adjustments were completed and, in a manner, to allow the release unit to function in the as-found condition (i.e., release handle locks in the closed position, but not in the open position) and allow the hooks to open simultaneously.</p>

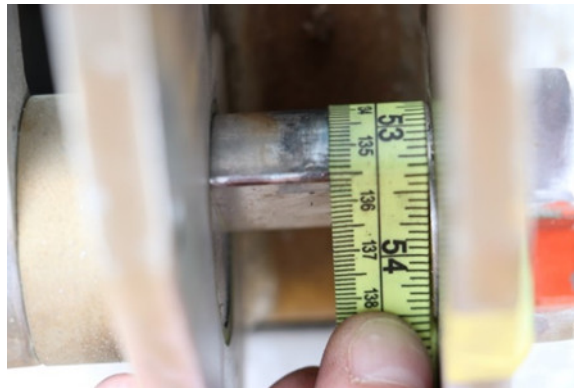
Figure 14: Measuring from locking shaft opening (notch) fillet/radius (looking down from the front side of the hook). Credit: CG.

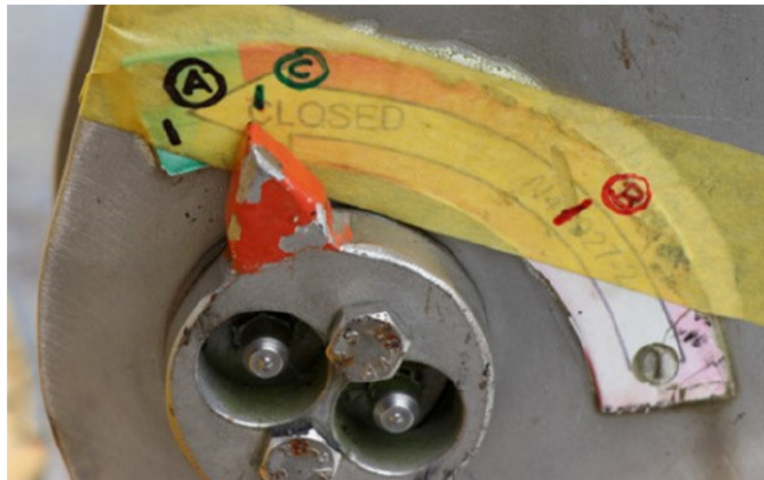
12. The distance from the flat of the locking shaft to the hook roller was measured at **12 mm**.
13. The hook was marked with a **green** marker (labeled as “C”) to show the closed position of the aft hook in the as found condition (Figure 16).

Figure 16: Locking Shaft Positions: A = maximum closed position (against the stop), B = Open (no load applied), and C = as found closed position for Auger Lifeboat 6.
Credit: CG.

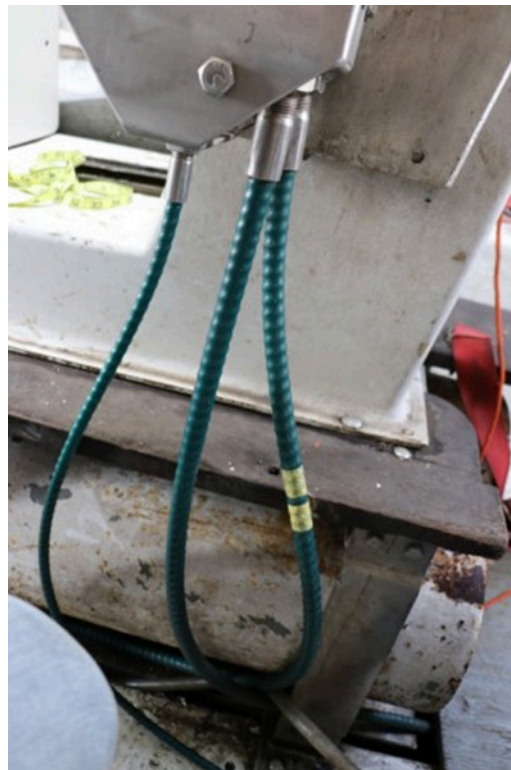
Figure 17: Aft hook control cable marked for simulated damage. Credit: CG.

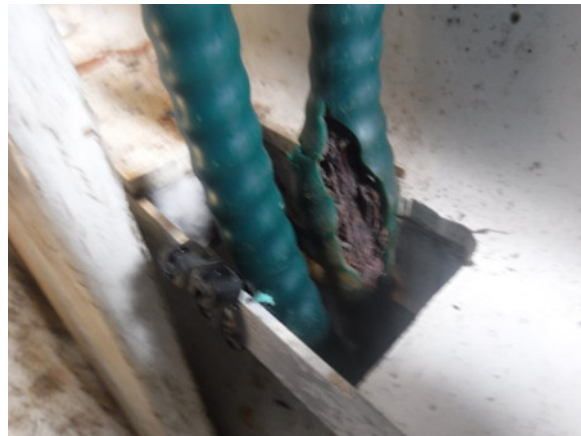
Figure 19: Condition of the aft hook control cable & location in relation to the bottom of the coxswain's console as documented Jun2019, prior to the incident. Credit: Palfinger.

It is also unknown if the deterioration documented during the June 2019 servicing (Figure 19) was allowing movement of the polyethylene liner inside of the compromised steel layers of the cable conduit.

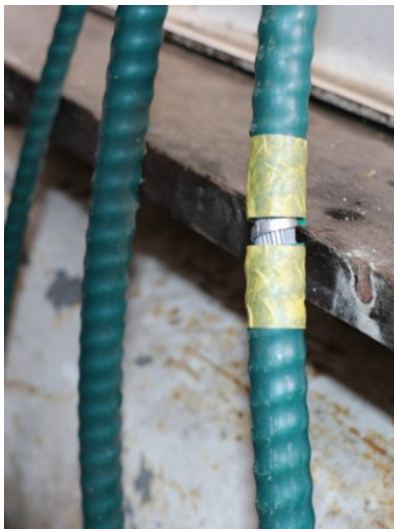
4. A section of the green outer layer (cover), steel binding and steel strands were removed to expose the white polyethylene liner. A 9 mm section was removed to simulate the deteriorated section shown in Figure 19. The outer jacket was cut with a razor and the steel binding and strands were removed with a DREMEL® tool with cutting wheel. Extreme caution and slow, deliberate cuts were made in an effort to prevent any nicks to the polyethylene liner or heat transfer to the galvanized steel strands as they were being cut (Figures 20, 21 and 22).

Figure 20: Section of conduit cover removed. Credit: CG.

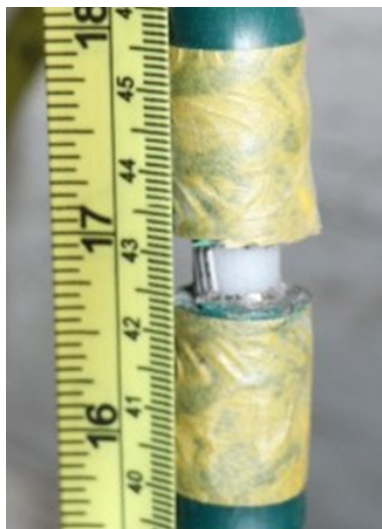
Figure 21: Measurement prior to removing the last few steel strands (9 mm). Credit: CG.

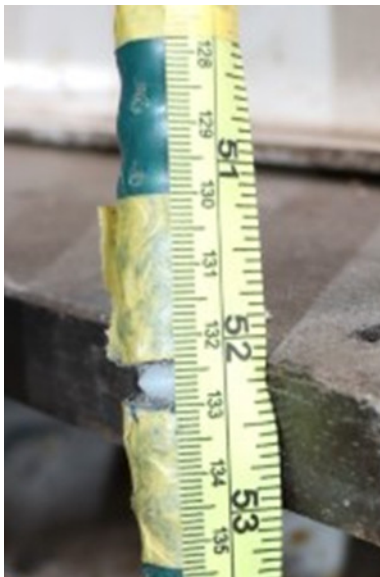
Figure 23: Compression of PTFE liner during the first open cycle of the release handle (outer conduit separation reduced to 6 mm). Credit: CG.

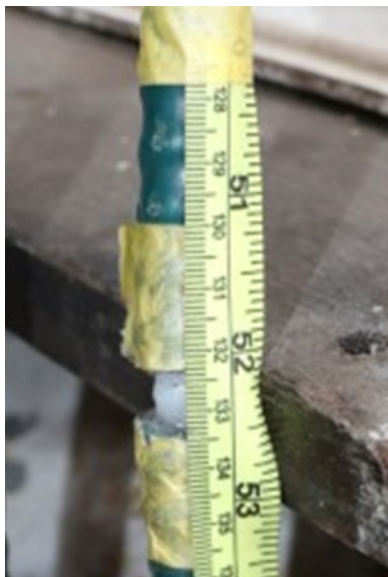
Figure 24: Distortion of PTFE liner after the first open/close cycle of the release handle (outer conduit separation increased to 12 mm). Credit: CG.

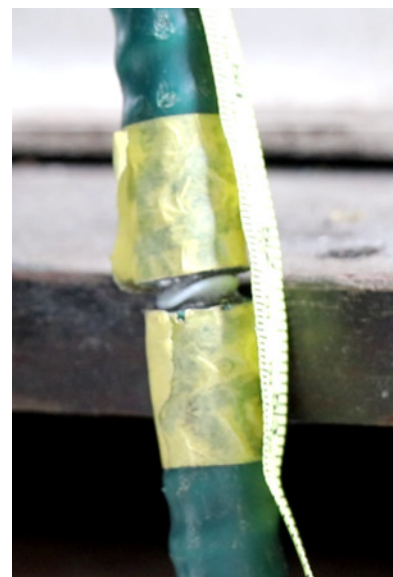
Figure 25: Compression of PTFE liner during the third open cycle of the release handle (outer conduit layers are now nearly touching). Credit: CG.

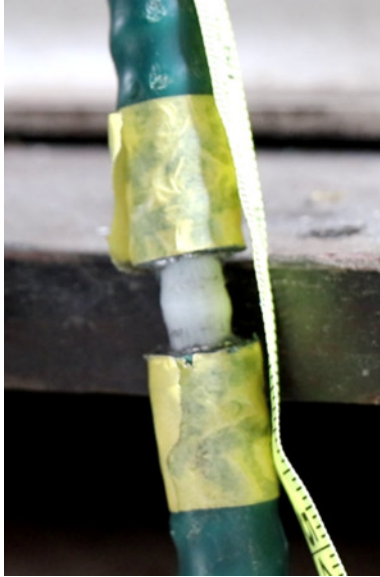
Figure 26: Maximum separation of the outer conduit layers and corresponding polyethylene stretch during the third close cycle of the release handle. Credit: CG.

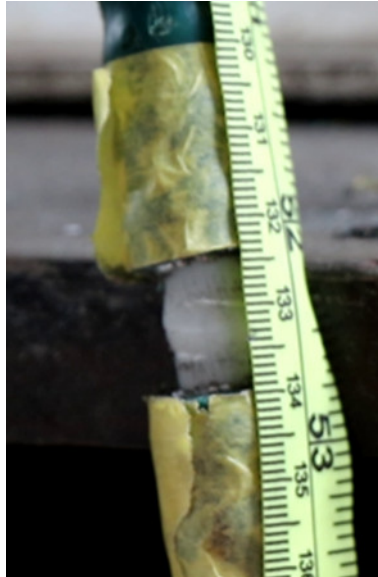
Figure 27: Translucent lines near the base of the compressed area of the polyethylene liner (after 12 cycles; started at 5 cycles). Credit: CG.

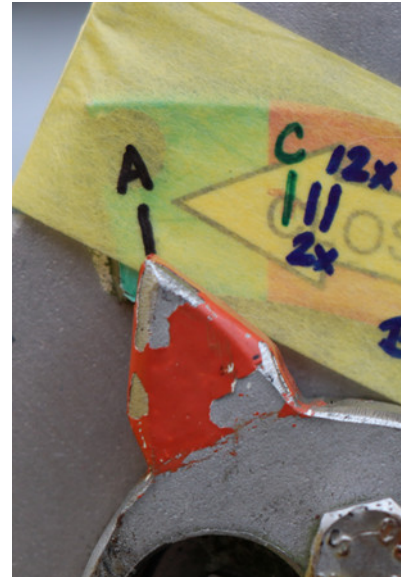
The locking shaft position was marked on the hook after completion of the 12 cycles, showing the creep of the locking shaft toward the open position (Figure 28).

Figure 28: Locking shaft positions observed: A = maximum closed position
C = as found closed position for Auger LB6
2x = movement toward open after 2 cycles,
12x = movement toward open after 12 cycles;
locking shaft is shown in the closed position (picture taken after testing). Credit: CG.

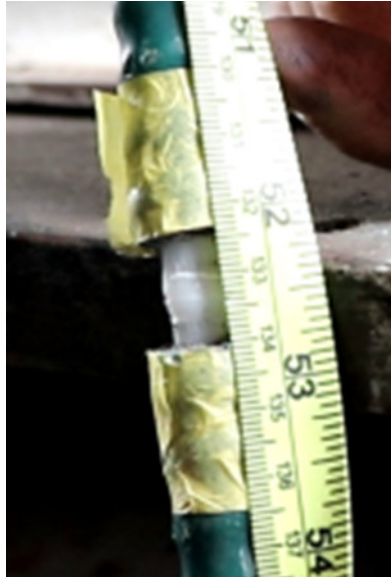
Figure 29: Separation after two activation cycles with the first cut in the polyethylene liner (increased by 1 mm).
Credit: CG.

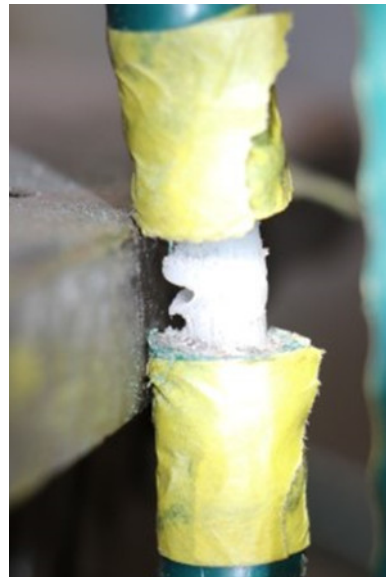
8. A small cut (approx. 1/8 of the circumference) was introduced to the polyethylene liner by pressing a razor blade through the polyethylene until it contacted the inner member.
9. The release handle was actuated through two (2) open/close cycles with the following observations:
 - a. The separation in the outer layers of the conduit was measured at **17 mm** (Figure 29).
 - b. The cut in the polyethylene liner was distorted; the cut area began to open and conduit separation increased by approximately 1 mm (Figure 30).

Figure 30: Distortion of the cut area (first cut) after two activation cycles.
Credit: CG.

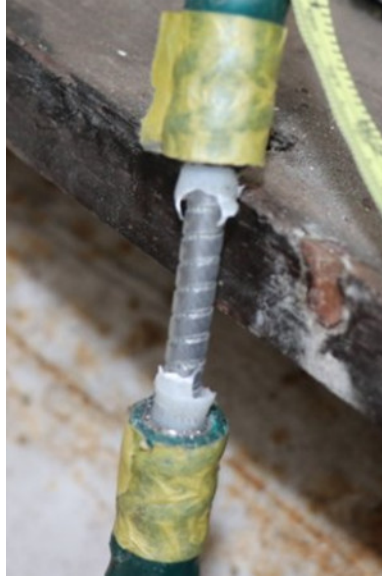
Figure 31: Broken polyethylene liner.
Credit: CG.

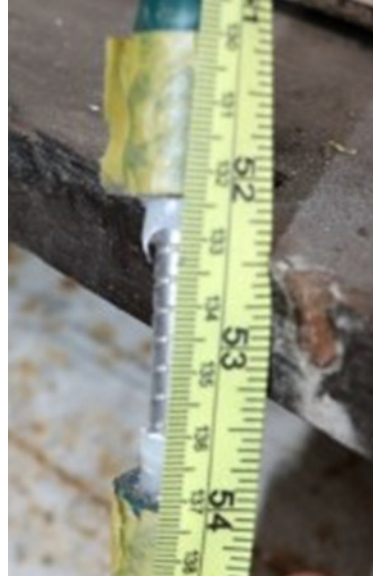
Figure 32: Conduit separation upon polyethylene liner breakage (closing action). Credit: CG.

Note that this corresponds to approximately 1.5" of inner member travel (just as if the inner member was moved with the release handle in an uncompromised control cable). 48mm separation - 9 mm of initial separation (before distortion of the polyethylene liner) = 39 mm of inner member movement in relation to the fixed ends of the control cable.

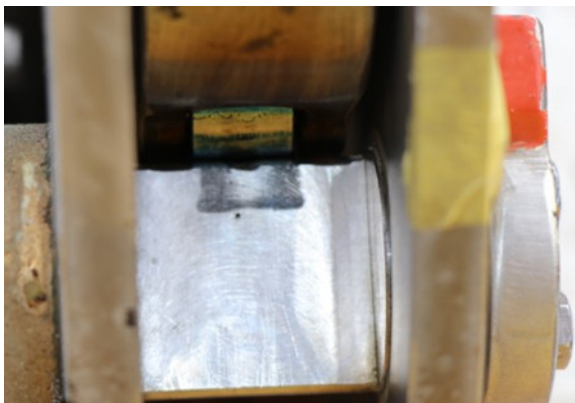
12. The locking shaft position was marked on the hook, showing movement toward the open position (Figures 33 and 34; "2nd Cut/Break" shows the position upon completion of Step 11). Note that the locking shaft is shown in the fully closed position in Figure 34 and the reference marks indicate the positions observed.

Figure 33: Locking shaft (cam) position upon breakage of the polyethylene liner and separation of the cable conduit.
Credit: CG.

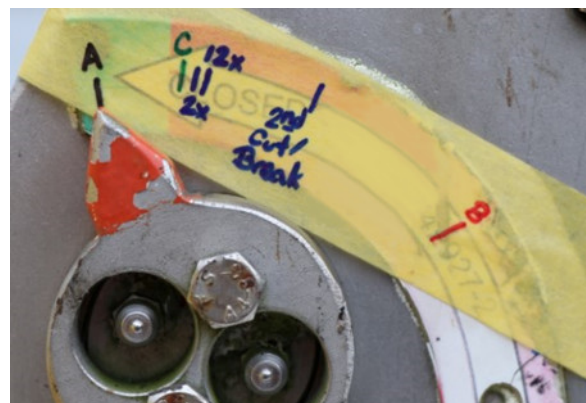
10. A 2nd small cut (an additional 1/8 of the circumference) was introduced to the polyethylene liner (extension of the first cut).
11. The release handle was actuated and the polyethylene liner **separated during the closing action of the release handle** (Figure 31). The separation of the outer conduit was measured at **48 mm** (Figure 32). The position of the locking shaft was observed approximately halfway between the “**C**” (closed, as adjusted) and “**B**” (open, no load) marks (Figure 34; marked as “2nd Cut/Break”).

Figure 34: Locking shaft positions observed – the "break" observed in Step 11 put the locking shaft approx. halfway between closed ("C") and open ("B"); locking shaft is shown in the closed position. Credit: CG.

- a. The results of these experiments show that damage to the conduit and polyethylene liner can result in failure of the cable. With damage present, a combination of the force required to open the locking shaft and the friction force in the cable itself produces a tensile force in the polyethylene liner that can cause it to fail completely. If the failure occurs while cycling the release lever, it can result in the hook locking shaft stopping between the open and closed positions (“B” and “C” positions, respectively, on Figure 34).

The results of these experiments show that damage to the conduit and polyethylene liner can result in failure of the cable. With damage present, a combination of the force required to open the locking shaft and the friction force in the cable itself produces a tensile force in the polyethylene liner that can cause it to fail completely. If the failure occurs while cycling the release lever, it can result in the hook locking shaft stopping between the open and closed positions (“**B**” and “**C**” positions, respectively, on Figure 34).

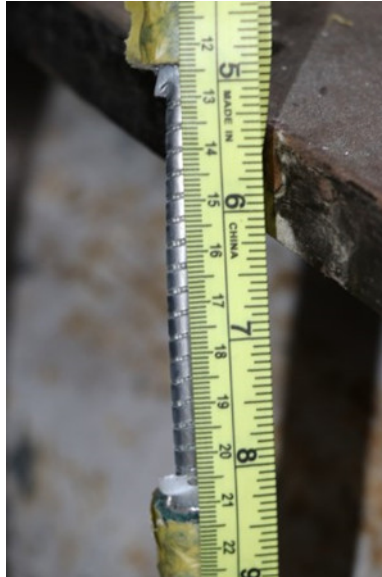
13. The release handle was actuated from closed to open. Conduit movement was observed in the area surrounding the conduit break only.
14. The release handle was moved back to the closed position and the cable conduit separated to a distance of **91.5 mm** (Figure 35). At this point, the locking shaft remained in the fully open position, preventing the hook from resetting.
15. The release handle was cycled several more times, however, every time the release handle returned to the closed position, the cable conduit separation remained constant at **91.5 mm**.

Figure 35: Conduit separation after cycling the release handle with a broken cable conduit/liner. Credit: CG.

This corresponds to approximately 3.25” of inner member travel (just as if the inner member was moved with the release handle in an uncompromised control cable). 91.5mm separation - 9 mm of initial separation (before distortion of the polyethylene liner) = 82.5 mm of inner member movement in relation to the fixed ends of the control cable. The control cable is designed/assembled with a 4” travel of the inner member.

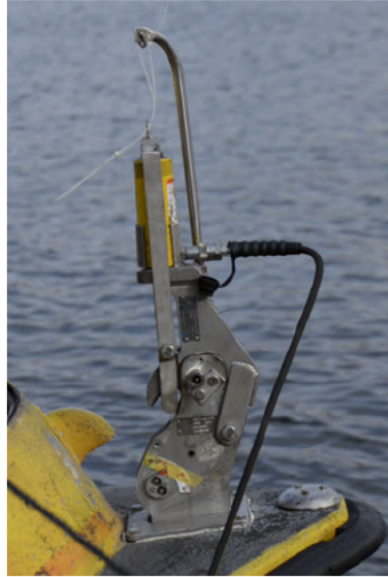
⁴ ENERPAC Model No. RC154 hydraulic cylinders; Capacity: 15.7T/142 kN; Owned by Palfinger Marine in New Iberia, LA; pressure gauge calibrated by The Gauge House in Lafayette, LA July 9, 2019.

Figure 37: Test apparatus on aft hook (forward hook set up the same during testing). Credit: CG.

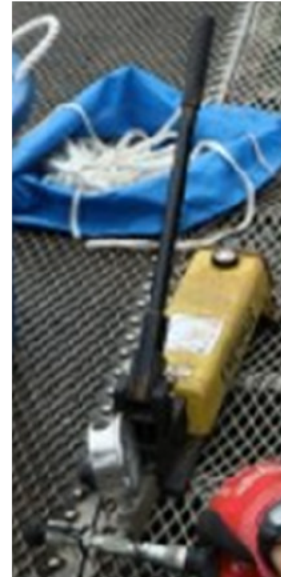
Figure 38: Hydraulic pump unit for hook test apparatus. Credit: CG.

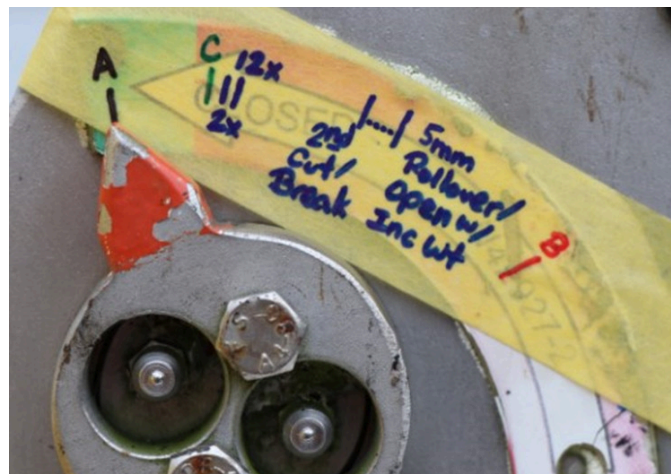
Figure 39 shows the locking shaft position in conjunction with the tests conducted in steps 2 through 9 of Experiment 3. The tests started at the mark for the 2nd Cut/Break and progressed at 1 mm increments (indicated by the dots marked on the tape), to the point at which the hook would open with no influence other than an increasing load. Figure 40 shows the approximate degrees of rotation corresponding to the positions observed during this experiment.

*Figure 39: Locking shaft positions observed:
 2nd Cut/Break - position upon break of the polyethylene & separation of cable conduit
 "B" - open position with no load
 Rollover - locking shaft forced to open with increasing weight
 Dots: positions that hook supported the test weights applied;
 locking shaft is shown in the closed position (picture taken after testing).
 Credit: CG.*
