# UNITED STATES COAST GUARD

## REPORT OF INVESTIGATION INTO THE CIRCUMSTANCES SURROUNDING THE INCIDENT INVOLVING

### THE COLLISION BETWEEN THE M/V SUMMER WIND AND THE T/B KIRBY 27706 PUSHED BY THE UTV MISS SUSAN ON MARCH 22, 2014

**THE COLLISION AND RESULTING MARINE FUEL OIL SPILL BETWEEN THE  
MOTOR VESSEL SUMMER WIND (O.N. 9114139) AND THE TANK BARGE KIRBY  
27706 (O.N. 1116758) BEING PUSHED BY THE UNINSPECTED TOWING VESSEL  
MISS SUSAN (O.N. 1026248) IN THE HOUSTON SHIP CHANNEL, TX  
ON AUGUST 13, 2014**

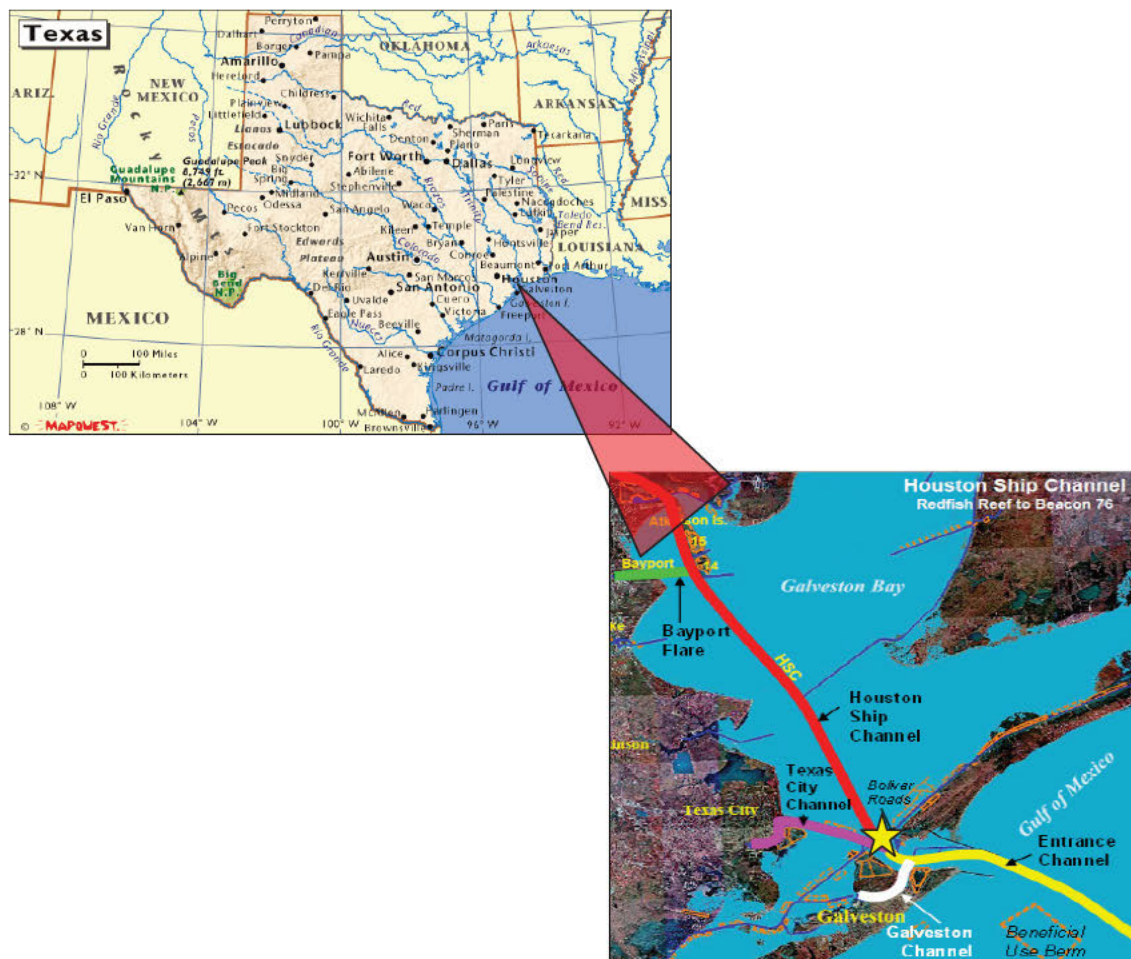
Figure 4: Location of incident

At approximately 1235 on Saturday March 22, 2014, the bulk freight ship M/V SUMMER WIND collided with the T/B KIRBY 27706, one of two barges being pushed ahead by the UTV MISS SUSAN. The collision occurred as the MISS SUSAN was crossing the Houston Ship Channel near Lighted Buoy 26, known locally as the “Texas City Y”. (See Figure 4 on page 15)

25. The incident occurred where the Texas City Channel and the Galveston Channel intersect with the Houston Ship Channel. This area is known locally as the “Texas City Y”.
