Report of Investigation into the  
circumstances surrounding the fire  
onboard the ROGER BLOUGH on  
February 1st, 2021

MISLE Activity Number: 7139261  
MISLE Case Number: 1249272

**THE FIRE ON THE U. S. CARGO VESSEL ROGER BLOUGH (O.N. 533062) WHILE  
MOORED AT THE FINCANTIERI BAY SHIPYARD IN STURGEON BAY, WI  
ON FEBRUARY 1, 2021**

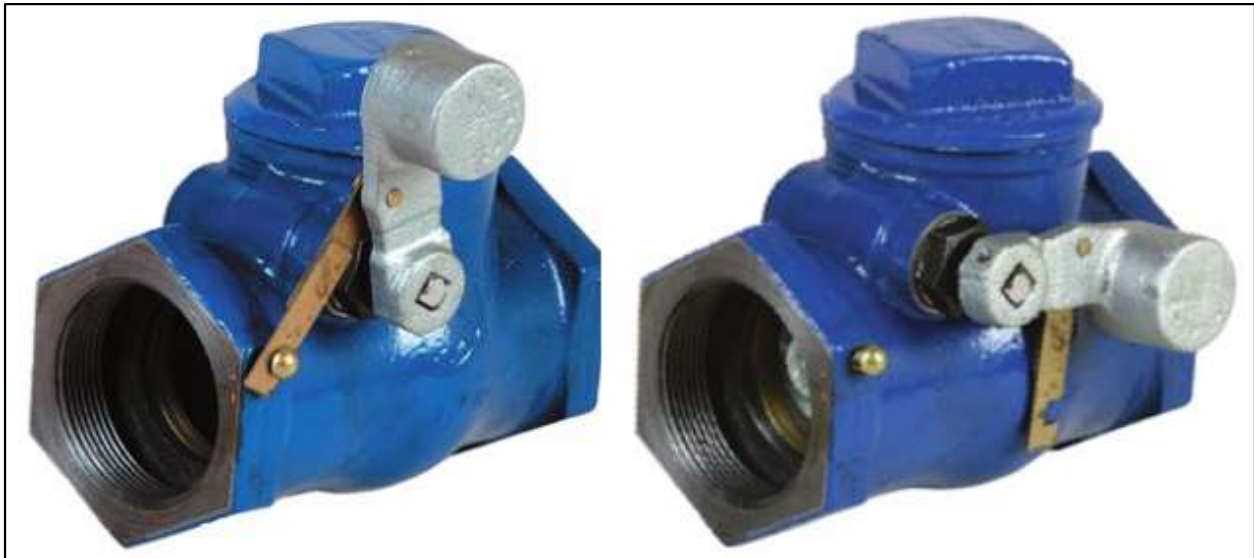
Figure 2: Example of a Fusible Link Safety Shutoff Valve shown in the open and closed positions.

4.2.7. The SUNTEC fuel unit attached to the Carlin 601CRD Burner Assembly was installed by Tweet Garot without a Fusible Link Safety Shutoff Valve required by NFPA 31. NFPA 31 8.10.6 states: “A readily accessible fusible link safety shutoff valve that closes against the supply pressure shall be installed at each of the following points, (1) As close as practical to the filter on the tank side of the filter, and (2) As close as practical to the inlet connection to the burner.”

4.2.8. The new furnace and its burner installation did not have a fusible link safety shutoff valve. A fusible link safety shutoff valve is a fuel system piping component. The valve is designed to shut off the fuel flow from the fuel storage tank in the event of a fire. As shown in Figure 2, below, a fusible link is attached to a spring-operated lever that holds the valve open to allow for fuel flow under normal operation. In the event of a fire, the fusible link melts at a preset temperature and the spring-actuated poppet shuts off the flow of fuel in the fuel supply line. The valve's close proximity to the burner assembly would ensure the fuel can be secured as quickly and closely to the burner as possible in the event of a fire.

4.2.9. Key Lakes' winter engineer for the ROGER BLOUGH installed new stainless fuel supply piping from the quarter turn shutoff ball valve in the fuel system just forward of the furnace to the fuel connection on the SUNTEC Fuel Unit model B2TA-8260 P/N 98042. The newly installed stainless steel piping from the fuel shutoff ball valve forward of the furnace to the mild steel connection on the SUNTEC fuel unit was rigid and did not provide flexibility in the fuel system's attachment to the fuel unit. The new piping did not include a fusible link safety shutoff valve.

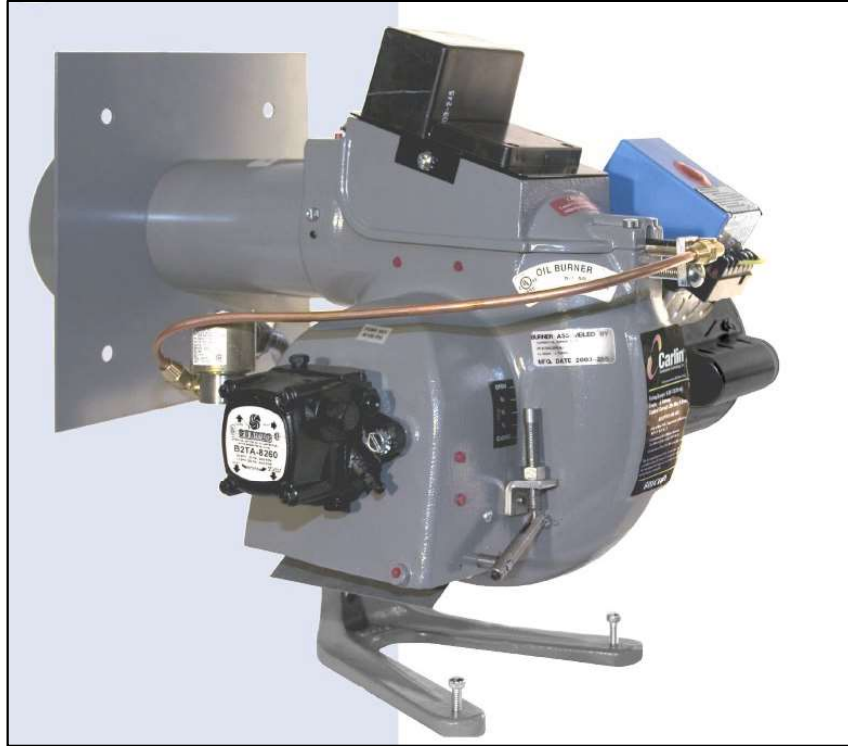
Figure 11: Example of a Carlin Burner Installed with the Pedestal Mount Option.

4.2.3. Tweet Garot’s technician mounted the burner assembly to the furnace without using a pedestal mount option. Instead the burner assembly was mounted directly to the flame tube. The mounting support method for the installation consisted of “hanging” the burner on the flame tube by sliding it on, and then used two small “set” screws to prevent the burner from slipping off of the flame tube. No other supporting hardware was installed above or below the burner to help support its weight. A pedestal support is another mounting option for the burner in accordance with Carlin Combustion’s documentation. An example of a pedestal mount is shown in Figure 11.

- 5.2. Mounting method may not have been appropriate: The 601CRD burner manufacturer provides a pedestal-mount installation option as shown in Figure 11. Tweet Garot did not use this option and instead "hung" the burner on the flame tube, another manufacturer specified option. The equipment's shipboard service may not have been fully evaluated prior to installation. The pedestal mount installation option would have provided additional support to the 65-lb burner which may have been more appropriate considering the dynamic forces and stresses which are typical in a marine application. The pedestal mount option may have prevented the burner from falling despite material failure of the retention ring, and may have prevented the casualty.
