# United States Coast Guard

## Marine Safety Alert

Alert 5-06

#### Structural Integrity of Propulsion Boiler Casings

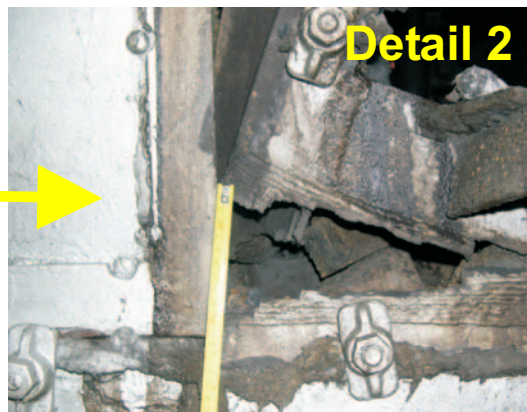
**Area of Detail 1.**

An investigation revealed that the structural integrity of the inboard boiler casing was compromised and the increase in internal casing pressure caused by the flashing of water into steam and its expansion caused a portion of the casing to separate, allowing the steam and a mixture of soot, refractory and other debris to be released in the vicinity of the operating station. (Attachment detail 1) Investigators discovered a number of areas where the strength of the inboard casing was compromised.

**Side View**  
(Inboard side of casing.)

To prevent a similar casualty, the U.S. Coast Guard strongly recommends that owner operators of steam propelled vessels have their engineering staffs assess the structural integrity of their boiler casings; paying particular attention to support structure interfaces at the steam drum, front to side casing attachments and upper to lower casing transitions. It is also recommended that a thorough review of previous casing repairs be conducted to identify signs of diminished structural integrity. For U.S. flag vessels, any repairs necessitated by this assessment should be coordinated with the cognizant Officer in Charge Marine Inspection and Classification Society representatives to ensure that the equipment is reconstructed as originally designed and in accordance with good marine practice.
