**MARINE SAFETY ALERT**  
**Inspections and Compliance Directorate**

Safety Alert 12-14

**DESIGNED FOR A REASON – FUEL SYSTEM MODIFICATIONS LEAD TO FIRE**

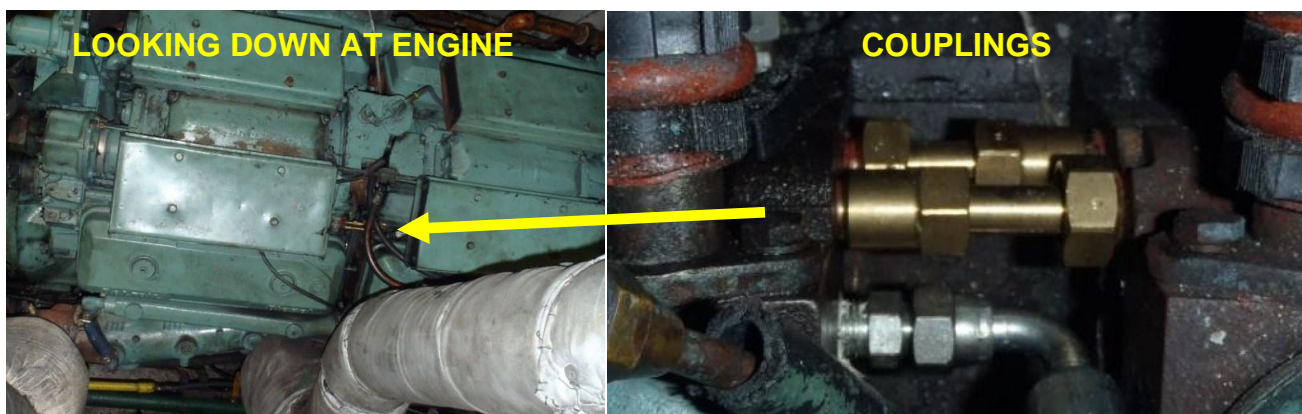
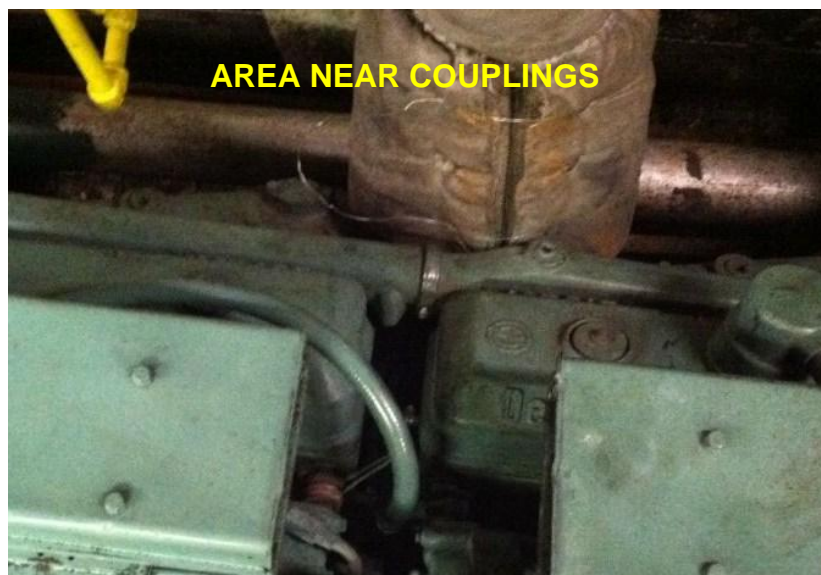
On the passenger vessel that experienced the engine room fire, couplings on three of the four engines were replaced with threaded hose barb fittings and rubber hose. One of those fuel hoses subsequently failed and sprayed fuel directly onto the main engine exhaust lagging and blankets. The seam in the insulation blanket was facing towards the engine rather than away and likely provided the ignition source.

- Always use proper replacement parts,
- Consider seam placement of exhaust insulation blankets and lagging during installation,
- Follow good marine practice by always maintaining the tightness and correct fit of the insulation blankets over the entire exhaust system, and
- For those who repair or own and operate vessels with these Detroit Diesel engines either as propulsion or electrical generation equipment of design configuration 16V92 ,12V92, 12V71 and 16V71, inspect and verify that the proper head to head couplings are used for the fuel supply and return passages. If incorrect, contact an authorized manufacturer technician for specific guidance.
