# U.S. COAST GUARD

**SAFETY ALERTS  
1996-2014**

**PREVENTION**

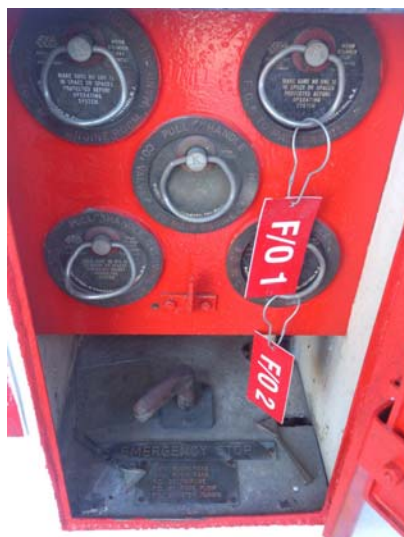
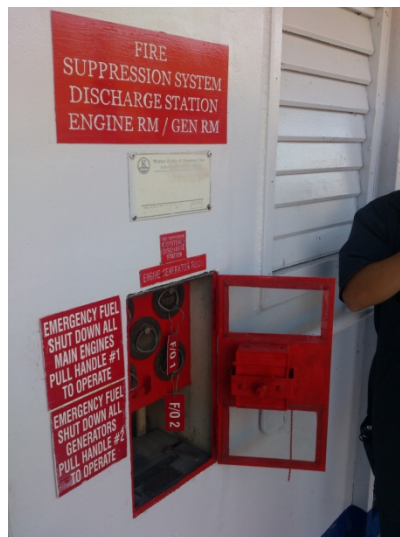
During a recent Uninspected Towing Vessel (UTV) exam, a vessel crewmember intending to test the fuel oil shut-off cables instead pulled the CO<sub>2</sub> system release cables. As seen in photos directly below and at the end of this safety alert, the emergency control panel used during the incident contained pull cables for both the CO<sub>2</sub> system and fuel oil shut-offs.

Similar activation pulls were collocated for fuel and CO<sub>2</sub> systems. Fuel oil shut down signage was located on the left, but fuel oil pulls were located on the far right with three CO<sub>2</sub> pulls in between.

In a separate recent UTV examination, an inspector found two sets of remote emergency shutdowns with only one set operational. The original station (see image on the right) appears to be fully operational, but was not connected. The operational shutdowns were at a separate location.

The Coast Guard **recommends** conducting a comprehensive pre-test meeting and simulated step-by-step “walk-through” between involved parties prior to actual testing of complex or potentially confusing systems. Operational controls should be implemented to maximize safety and reduce risk.

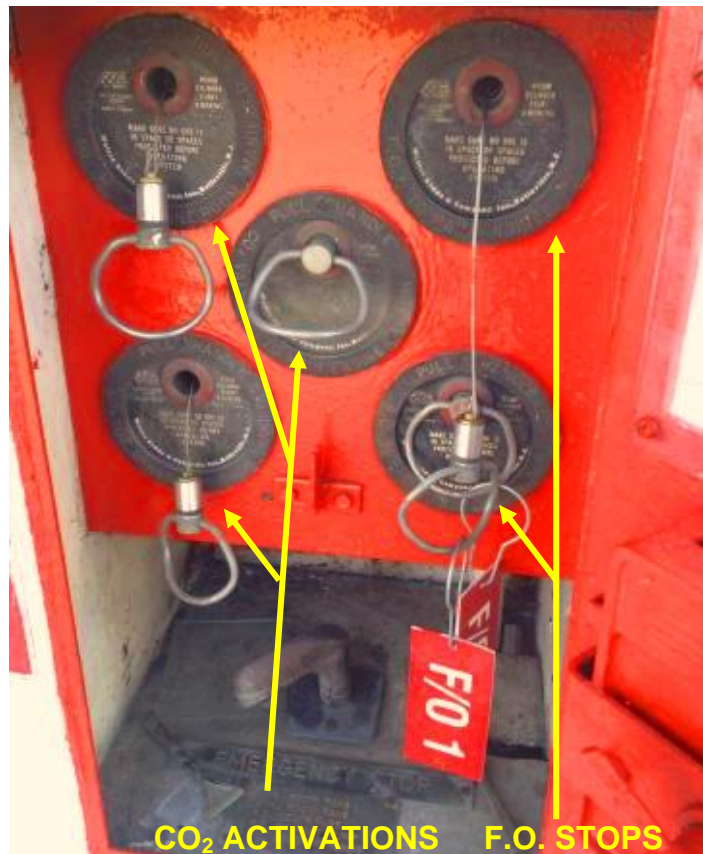
**Fuel Oil valve stops:**

- To main engines - Top Right
- To generators - Bottom Right

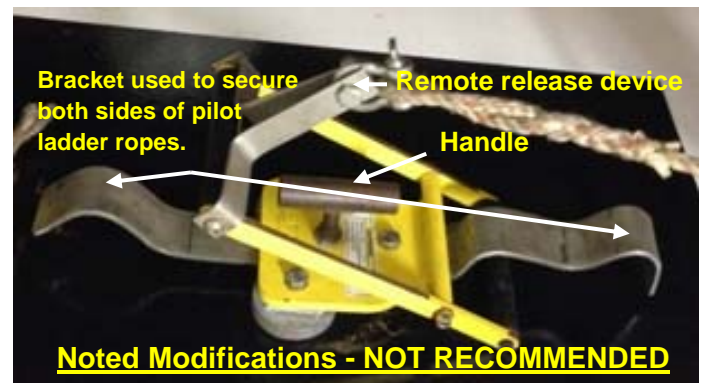
This alert raises awareness as to the importance of not modifying equipment or components from their intended design or operation. Recently, a State Pilot suffered a concussion as he was boarding a vessel via its pilot ladder. The primary cause of the accident was an improperly modified embarkation ladder hull magnet that disconnected from the ship's hull and struck the Pilot on the head.

Hull magnets are easy to operate devices and when positioned correctly, provide substantial holding force. The handle of the magnet is also a lever and enables easy release from the hull of the vessel. The intended proper use of the magnets is shown in the above image. In the incidents where the magnets unexpectedly detached from the hull, only one securing magnet was used between the rails of the ladder along with equipment alterations that deviated from the manufacturer's design (see image below).

The Coast Guard **strongly recommends** that vessel owners/operators refrain from modifying embarkation equipment. In addition, operators should regularly inspect existing vessel boarding equipment and return improper modifications back to the manufacturer's original design. Pilots are encouraged to consult with their appropriate associations to determine if any additional precautions should be taken as part of their normal boarding practices and this identified risk.

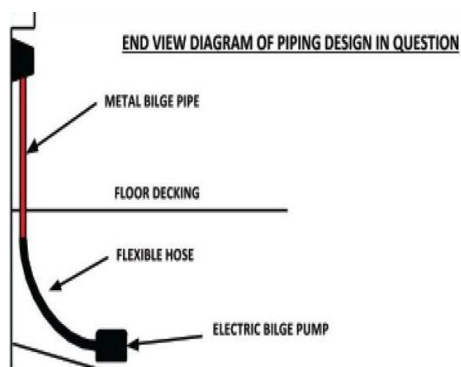
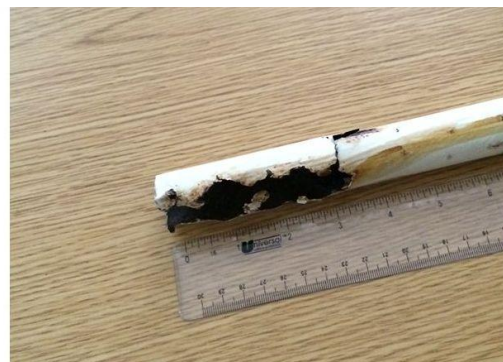
**WHAT YOU CAN'T SEE - CAN HURT YOU!**  
**Corrosion of "Duck" Boat Bilge Pump Discharge Piping**

During a recent Coast Guard inspection of an amphibious passenger vessel / DUKW ("duck") boat, a marine inspector discovered water back-flowing into the vessel's bilge while testing the vessel's bilge pump system. An expanded inspection of the system revealed a severely wasted and holed section of the steel bilge piping leading vertically to the overboard bilge discharge port. After inspecting the remaining fleet of six vessels, the same problem was discovered, in various degrees of severity, on four other vessels.

The failure of this piping creates an extremely unsafe condition by rendering the vessel's bilge pumping system ineffective. Because the wasted section of piping is hidden behind inner sidewalls within the passenger seating section, the problem can persist and evade detection by the vessel owner or operator.

The U.S. Coast Guard **strongly encourages** owners, operators, and other persons involved with the inspection of these types of vessels to:

- Immediately trace out and inspect the entire bilge piping system for wastage or deterioration of metal bilge piping, check the condition of all hoses, hose clamps, supports and make repairs as needed.
- Make the inspections of these concealed components part of the vessel's overall routine inspection process.
- Consider installing an access plate on the inner panel at the area of the discharge piping so that the piping is easily accessible for inspection and maintenance. (See image at right)
- Inform the appropriate Coast Guard personnel if the system piping has changed significantly or in any way that may require regulatory notification, oversight or guidance for permanent repair solutions.

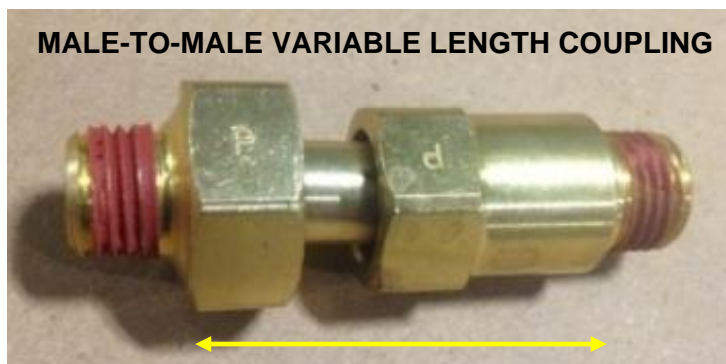
The vessel was equipped with four Detroit Diesel sixteen cylinder high speed engines - model 16V92. The engines were constructed by coupling two V-8 cylinder engines together. There are also other similarly coupled engine models and in widespread use including the Detroit Diesel 12V92, 12V71, and 16V71. Fuel and coolant flow from head-to-head and within passages on each side of the engine. The fuel supply passage delivers fuel to the injection equipment of each cylinder. A return passage handles excess fuel. To connect the heads on each side of the engine, a male-to-male threaded variable length coupling is used by design. There are four couplings per engine that handle fuel supply and returns from the injection components. These couplings are unique in that they facilitate installation by their capability to lengthen when their ends are threaded into the heads.

On the passenger vessel that experienced the engine room fire, couplings on three of the four engines were replaced with threaded hose barb fittings and rubber hose. One of those fuel hoses subsequently failed and sprayed fuel directly onto the main engine exhaust lagging and blankets. The seam in the insulation blanket was facing towards the engine rather than away and likely provided the ignition source.

- Always use proper replacement parts,
- Consider seam placement of exhaust insulation blankets and lagging during installation,
- Follow good marine practice by always maintaining the tightness and correct fit of the insulation blankets over the entire exhaust system, and
- For those who repair or own and operate vessels with these Detroit Diesel engines either as propulsion or electrical generation equipment of design configuration 16V92 ,12V92, 12V71 and 16V71, inspect and verify that the proper head to head couplings are used for the fuel supply and return passages. If incorrect, contact an authorized manufacturer technician for specific guidance.

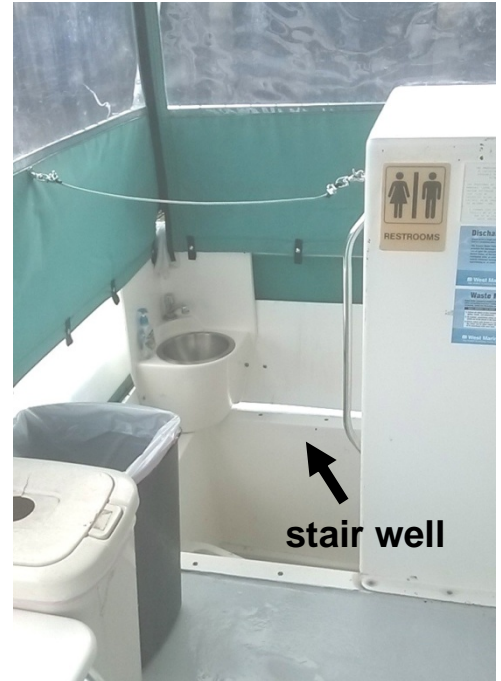
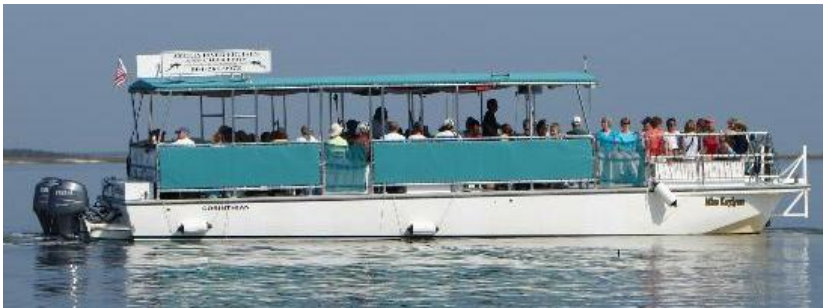
Coast Guard casualty investigators recently responded to an incident whereby a tour boat customer fell into an unprotected two step stair well and received significant injuries. Although the customer was taking photographs at the time and may have lost situational awareness there were no defenses to prevent the fall. The hazard was not previously identified and, as is often said, was an accident waiting to happen. Only afterwards did the owner operator install a small lifeline cable across the opening.

This type of vessel design, with a stair well leading to the head, is very common. These specific catamaran vessels were constructed by Cooper Marine, Inc. and Corinthian Catamarans, Inc. (formerly Corinthian Yachts, Inc.) in various sizes over many years. There may be hundreds of these vessels in operation as tour boats, water taxis, dive boats, etc., world over.

As a result of this incident and many others like it the Coast Guard **strongly recommends** that owner operators;

- identify similar stair well hazards and secure them in a manner that will prevent slips, trips and falls;
- when a hazard cannot be completely eliminated (as with the image above), bring the hazard to the attention of passengers during the initial safety brief; and
- make risk awareness part of your operational culture by having vessel personnel frequently evaluate the vessel's condition with the express purpose of identifying and mitigating hazards.

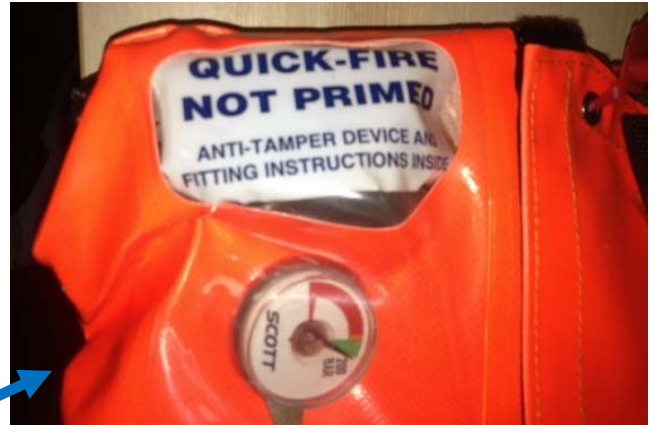
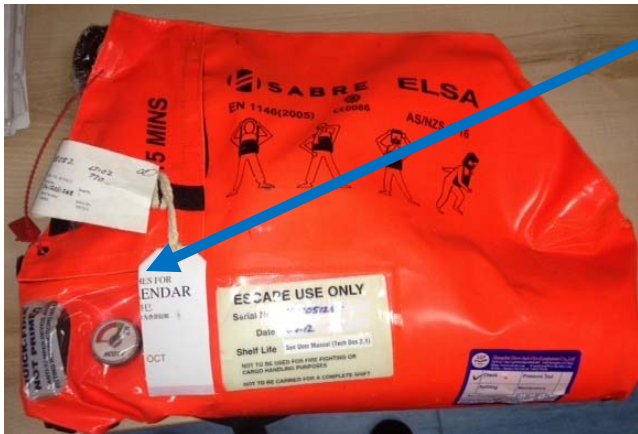
Recently while performing several Port State Control examinations Coast Guard Sector Hampton Roads inspectors discovered numerous SABRE Emergency Escape Breath Devices (EEBD) / Emergency Life Support Apparatus (ELSA) in an unprepared status. The "Quick Fire" functionality that puts the EEBD into operation when the bag is opened up and hood is worn was not in its "Primed" state. Such a circumstance can have fatal consequences when time is of the essence to escape a hazardous atmosphere.

When purchased or returned from servicing this equipment will have a small removable label viewable through a window on the bag that states "QUICK-FIRE NOT PRIMED ANTI-TAMPER DEVICE AND FITTING INSTRUCTIONS INSIDE." The unit is not ready. Once delivered to a vessel a technician or competent ship's employee should have opened the bottom left corner flap, attached the "Quick Fire" cord and removed the label. The device will operate correctly and begin to supply air to the hood when the flap is properly connected and later opened.

With the concern that insufficient preparation of critical life saving equipment could contribute to unintended fatalities, the Coast Guard **strongly recommends** that owners and operators of vessels using this or similar devices **carefully inspect their own EEBDs/ELSAs ensuring they are ready for use.**

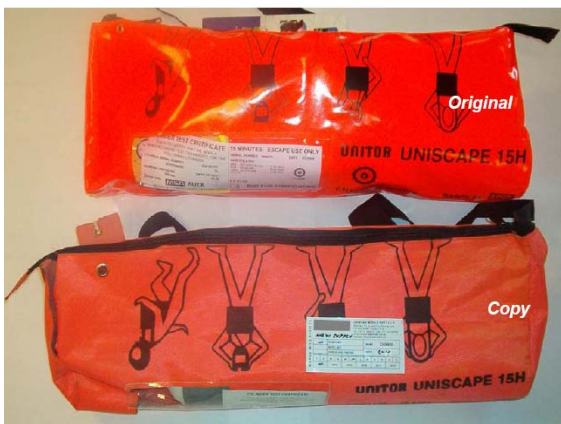
An authentic Unitor UNISCAPE 15H is contained in a shiny PVC bag. When viewed from the front with the instruction icons upside down, the zipper opens from left to right, and at the most left section of the zipper is a two centimeter gap covered by a clear tab that has a button closure.

The **fake reproduction** is contained within a **dull canvas-like** material bag. When viewed from the front with the instruction icons upside down, the **zipper opens from right to left**, and at the most left section of the zipper there is no opening, although a tab made of what appears to be the same material of the bag is present with a button closure. This unit will not automatically activate.

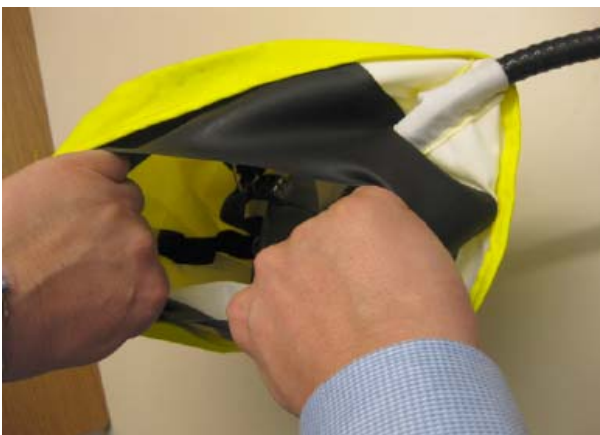
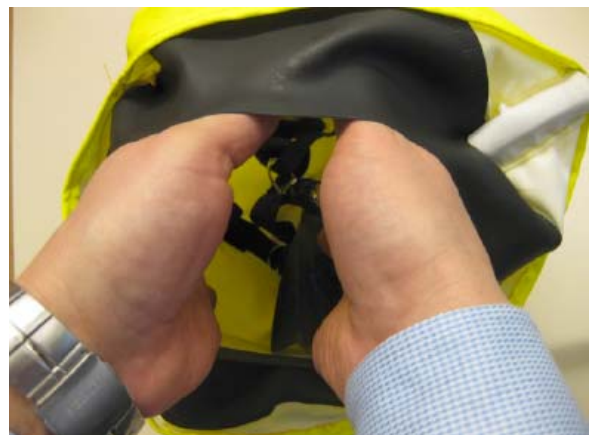
- **The mask hood is impossible to get over your head.** This is the most serious identification; The neck tightening rubber membrane is not flexible enough to be able to pass a normal head size, and it is sewed to the hood with one single seam – not welded as an original Unitor hood.
- The bag has similar print as the WSS original: “UNITOR UNISCAPE 15H” and “Safety by MSA” is printed on the frontside (together with 4 sketches of how to use).
- The bag material is different; Unitor: shiny PVC. Fake: Dull canvas-like material.
- The zipper is opened from right to left, which means that we evaluate the **functionality of the automatic release mechanism to be doubtful**. When the zipper is opened, it moves towards the cylinder valve – not away from it/pulling also the air release line.
- All sets that are discovered per now has a company label/service tag, with the following information:

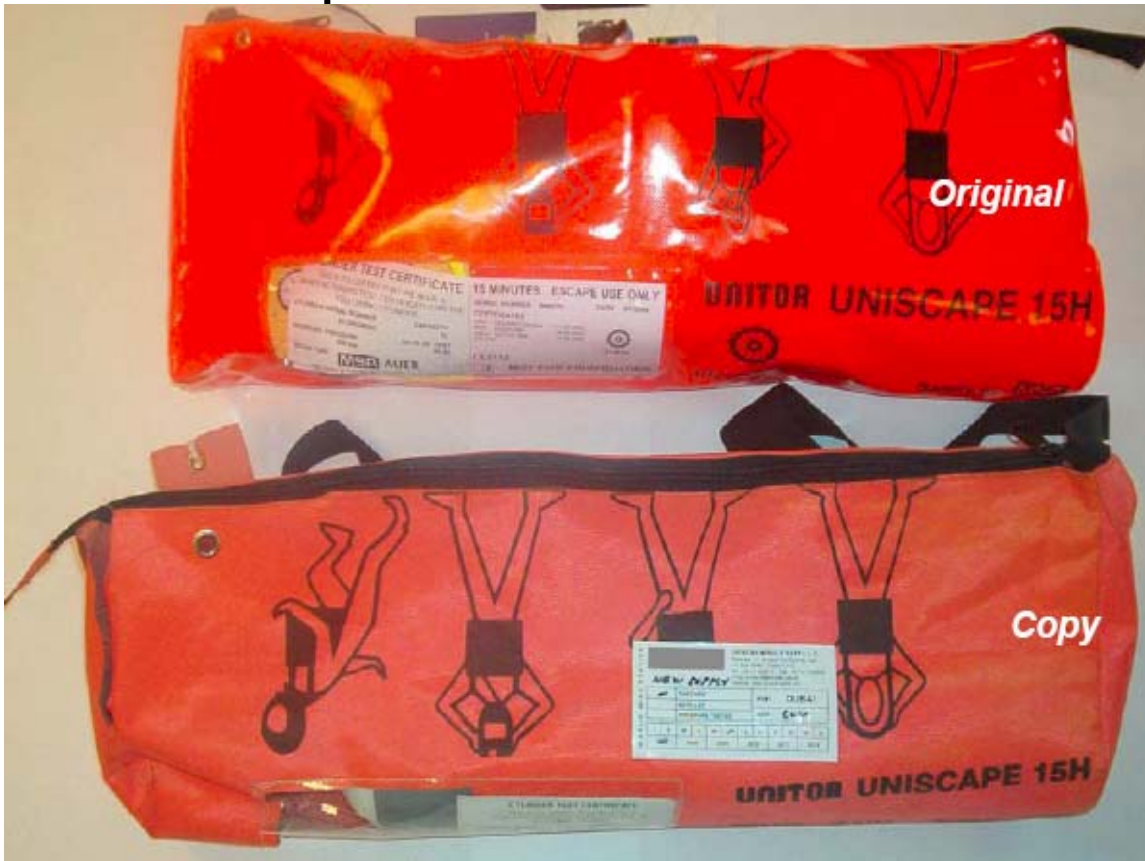
## Unitor EEBD copies in circulation

### Upper:

Original Unitor EEBD with shiny PVC bag

### Lower:

Copied equipment, with dull canvas-like material

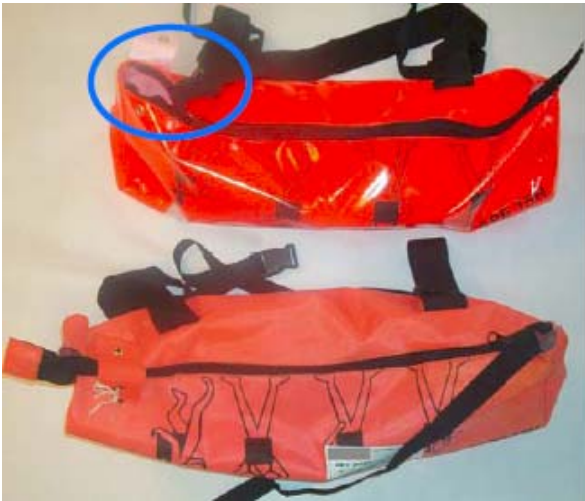
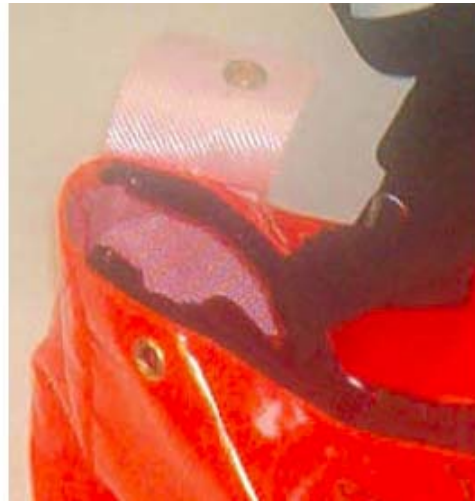
### Original Unitor EEBD:

Zipper has 2 cm opening on the teeth  
Zipper closes from right to left

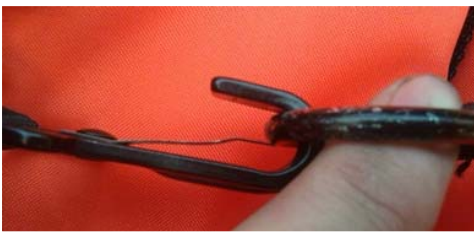
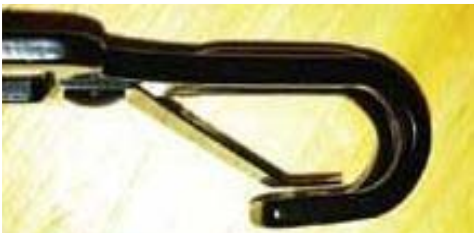
The issue is the spring-loaded tab in the snaphook on the waist belt affecting **some REVERE** lifejacket models 198 RT and 160 RT. The tab has been found to be too long for both the thick or thin design,. When the D-ring of the main waist belt is "hooked," the length of the tab prevents it from snapping closed. With the hook remaining open, the D-ring is not fully secured. (top photograph) The spring-loaded tab may also lose its resiliency. (bottom photograph)

The Coast Guard recommends that owners/operators that have Revere model 198 RT or 160 RT lifejackets or vests on board their vessels inspect them closely for this potential defect.

Persons who discover problematic snaphooks should either call 904-562-5900, or email [jacksonville.sales@survitecgroup.com](mailto:jacksonville.sales@survitecgroup.com) for specific directions on how to obtain replacement snaphooks.

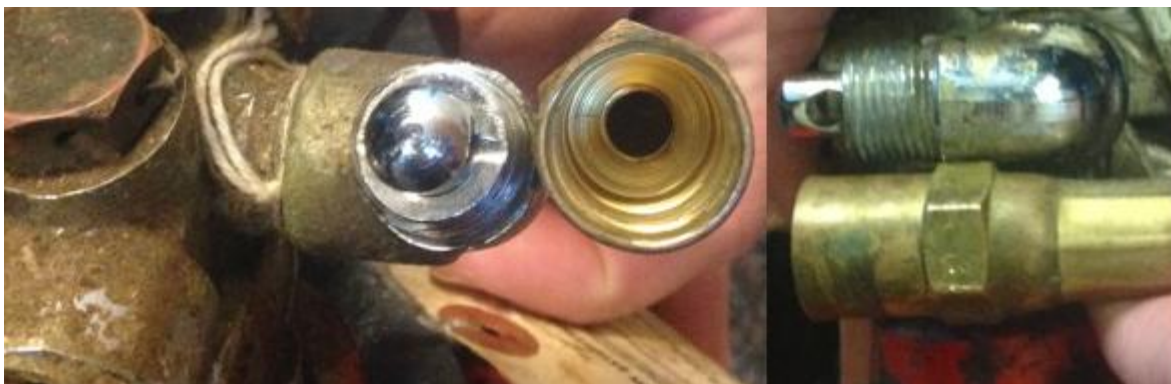
The investigators had the extinguisher examined at a fire-fighting equipment service center. They determined that the hose and discharge horn had been replaced at an earlier time. The end of the hose screws on to a diffuser on the side of the discharge valve/handle assembly of the extinguisher. The diffuser is a ported protrusion on the male end of a ninety degree fitting. On the side of the protrusion are orifices through which the CO<sub>2</sub> flows. The examination revealed that the spherical end of the protrusion, which contains no orifices, bottomed out against the orifice in the connection fitting that leads to the hose and horn assembly. The flow of CO<sub>2</sub> was thus completely blocked.

It was further noted that the male threads of the diffuser were tapered US national pipe threads, while the female threads of the hose connection were straight. This difference likely allowed the hose connection to be tightened further than intended on the diffuser threads, permitting the spherical end of the diffuser to bottom out against the orifice in the tube. This may have also resulted in the reported leakage from the neck of the extinguisher due to back pressure.

The Coast Guard recommends that fire equipment service companies be aware of the potential problems described above, and ensure that all replacement components for servicing hand portable fire extinguishers are as specified by the original extinguisher manufacturer. Service companies that market replacement parts should also note the importance of these concerns and advise their customers accordingly. If the appropriate replacement parts are not available, the extinguisher should be replaced.

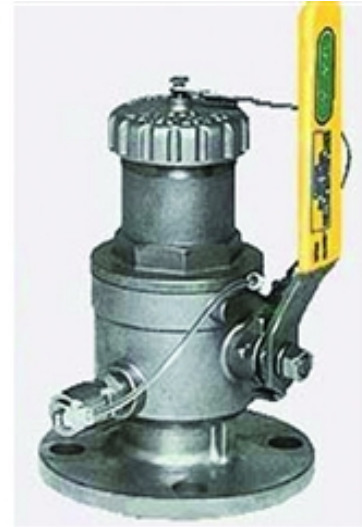
The exposure occurred during a tank vessel exam onboard a tank vessel carrying Grade E Sour Crude. A PSC team requested a ship's crew member check cargo tank oxygen levels using the ship's portable gas meter. The crew member accessed the cargo tank via a deck sounding valve similar to the adjacent photo. When the valve was opened the pressurized cargo tank atmosphere escaped releasing inert gas and H<sub>2</sub>S vapors.

During the evolution the personal gas meters of two individuals involved (one CG and one crew) alarmed for H<sub>2</sub>S. The CG officer whose alarm sounded was standing 1–2 feet downwind from the sounding valve. Within days the CG officer developed severe exposure symptoms consistent with H<sub>2</sub>S exposure. The other two CG officers involved were standing upwind. Afterward, one reported experiencing a minor headache.

- Be familiar with and adhere to ISGOTT safe work practices.
- Assess personnel risks.
- Don appropriate personal protection equipment including gas monitoring detectors, respirator or SCBA.
- If gas monitoring detectors are used ensure:
  - detectors are maintained and properly calibrated
  - alarm settings values are properly set
- Be aware and familiar with the hazards of the cargos involved as well as exposure indicators and emergency response procedures.

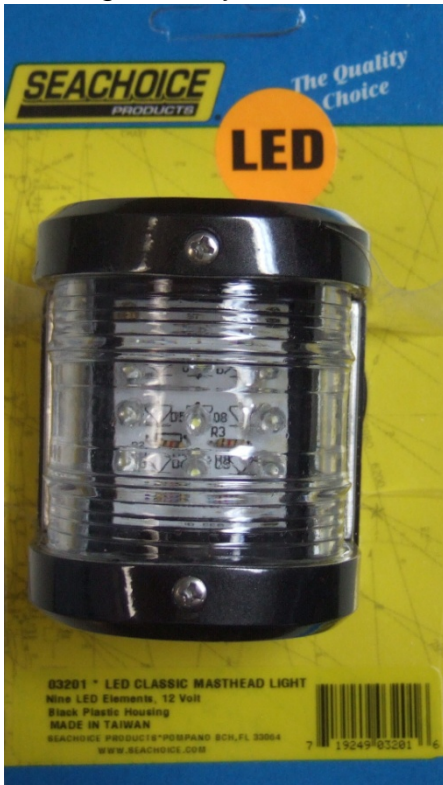
The Coast Guard has recently become aware of the uninspected towing vessel industry using inappropriate navigation lights that fail to meet the criteria for use onboard any vessel; SEACHOICE Products LED Navigation Light, SCP #03201 shown below. Online research shows many outlets for the sale of this product. It is possible that this product may be in widespread use in the recreational boating industry as well.

The SEACHOICE Products and other catalogs advertise it as a “LED classic navigation light.” Packaged individually, the item looks as shown on the left. The package indicates incorrect usage as a “masthead light.” When web-searched the retrieved information presents it as a “masthead” or “navigation” light. Neither of these applications are correct and the fixture should not be used on any vessel in an effort to meet the navigation rules.

Masthead lighting requires an arc of 225 degrees visibility and stern lighting requires an arc 135 degrees visibility, for a total range of 360 degrees visibility. Depending on the type of vessel there are also light, color and range of visibility requirements.

The Coast Guard **strongly recommends** that owners / operators of any vessel who installed this particular SEACHOICE product (#03201 only) as a masthead, stern or other type of navigation light to remove it and replace it with a proper light that meets the requirements for the vessel and application.

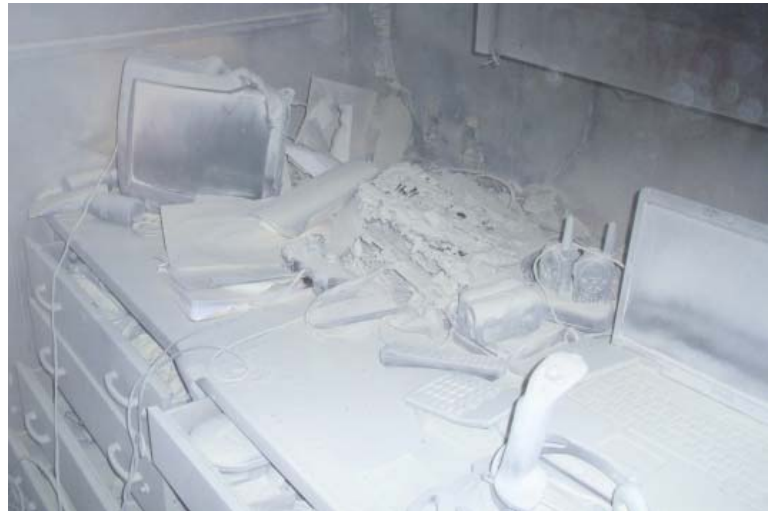
A marine casualty investigation of two separate stateroom fires onboard a U.S. Flag Container ship revealed that the sources of the fires were attributed to the use of SPDs plugged into a lighting circuit. It was discovered that a ground had developed on another circuit that was connected to the same distribution panel providing power to the staterooms. This ground created an imbalance of voltage between the two power conductors supplying the SPDs which caused excessive currents, overheating, and subsequently, a fire. In this instance, even if the SPDs automatically tripped as designed, only one power conductor would have been secured while the other would continue to provide power, possibly shorting to the device's ground wire and the structure of the vessel.

For shipboard applications, it is critical for a device to interrupt both power conductors. ~~Underwriters Lab Standard UL Marine 1449 addresses this issue and applies to the use of SPDs.~~

The Coast Guard **recommends** that vessel Owners, Operators, Class Society Surveyors, Insurers, and other inspection personnel examine the risks associated with the use of SPDs aboard their vessels, and if necessary ensure their organizations have policies and procedures relating to their use. Vessels should have defined procedures for checking the condition and grounding capabilities of personal/portable electrical equipment, and trained shipboard personnel should be assigned to check and approve all SPDs in use or brought on board for compatibility with the vessel's electrical distribution system prior to use. Routine checks of switchboard and distribution system 120 VAC ground detection systems are necessary to detect the presence of grounds that may cause similar circumstances with non-marine type SPDs. These recommendations are not mandated rather just an advisory based on lessons learned from the casualty.

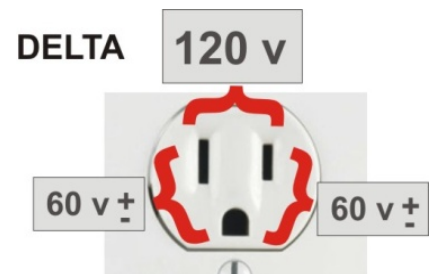
Using a voltmeter, a marine electrical professional will note that a Delta wired circuit will read the voltage across the terminals as shown in the image on the right. The Delta configuration has two hot leads one at +/-60 VAC, the other at +/- 60 VAC, simultaneously to provide the 120 VAC potential. **Here lies the problem with inexpensive and older SPDs that only disconnect one “hot” terminal lead. The other “hot” terminal remains hot if the circuit breaker supplying the receptacle and SPD does not trip.**

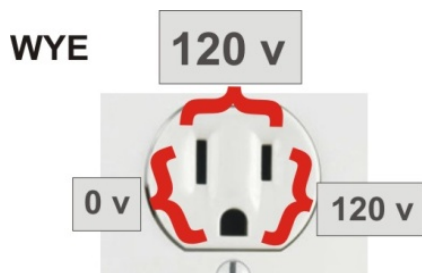
A marine electrical professional using a voltmeter on a WYE wired circuit will read voltage across the terminals as shown in the image on the left. For a WYE configuration 120 VAC is established between the hot terminal and the neutral terminal *and* the hot terminal and the ground terminal of the receptacle.

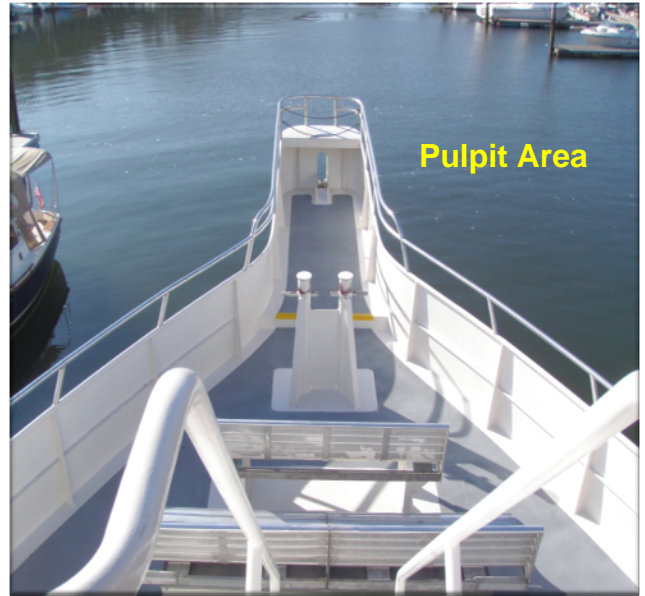
Several passengers standing in the bow pulpit of a 106' inspected whale watching vessel were injured while underway. The vessel struck a large wave, its bow rose and slammed down causing the passengers in the pulpit to lose their balance and fall to the deck. Injuries ranged from cuts and bruises to a broken patella (knee) and jaw. Although there were many other passengers on board at the time, only the passengers standing in the pulpit were injured.

- Proper verbal briefings regarding unfavorable weather conditions were made to the passengers; however, some passengers had disregarded these safety warnings.
- The vessel did not have a policy which outlined operational conditions as to when the bow area and pulpit should be vacated.

As a result of this casualty, the Coast Guard **strongly recommends** that all vessel owners/operators operating vessels with bow areas open to passengers establish written policy and procedures for vacating the area when operational conditions present risks of injury. The policy and procedures should address the vessel's speed and sea state, in addition informing passengers during the pre-departure safety brief of the restrictions prior to getting underway.

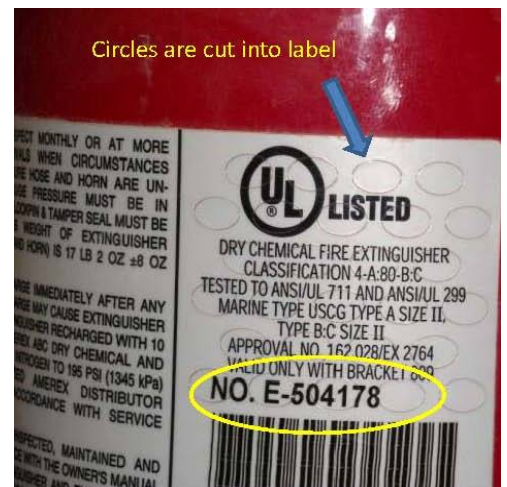
The labels on counterfeit extinguishers may be simply printed. Labels on genuine approved extinguishers will include a security imprint / texture behind the UL LISTED logo, classification, testing and approval data. Genuine Amerex Corporation extinguishers will have a pattern of scored "circles," and genuine Buckeye Fire Equipment extinguishers will have the letter "S" scored into the label.

The Coast Guard **strongly recommends** that vessel owner / operators inspect their equipment. Inspectors, surveyors, owner / operators and others suspecting that they may have identified counterfeit extinguishers should contact the Coast Guard Office of Design and Engineering Standards immediately. Please provide a description of the suspect units, including if possible photographs showing full front, rear, and bottom views of the extinguishers, along with close-ups of all labels, and submit this information to [typeapproval@uscg.mil](mailto:typeapproval@uscg.mil) with a copy to [anticounterfeiting@us.ul.com](mailto:anticounterfeiting@us.ul.com).

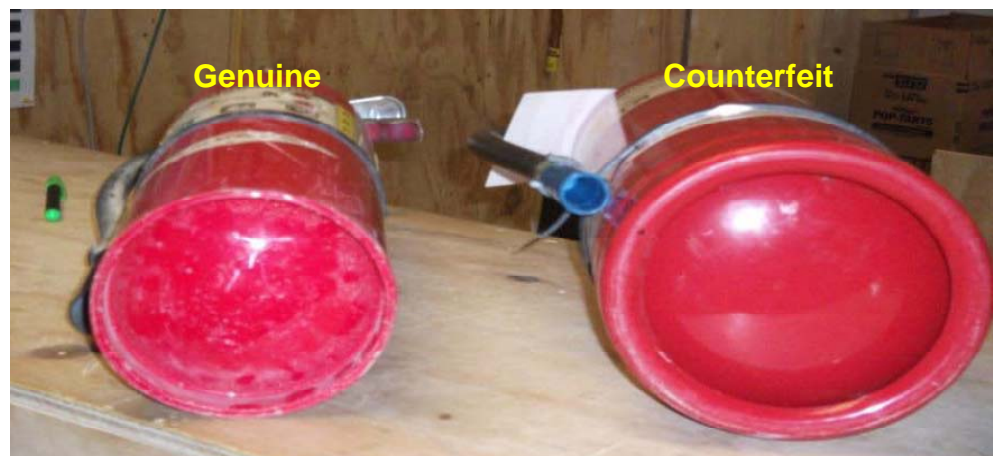
The bottoms of the counterfeits have a rounded curved-in lip as shown on the right side of the image on the right. The bottom of a genuine Amerex extinguisher is shown on the left side of the image. Genuine Buckeye extinguishers will have a date stamped on the bottom.

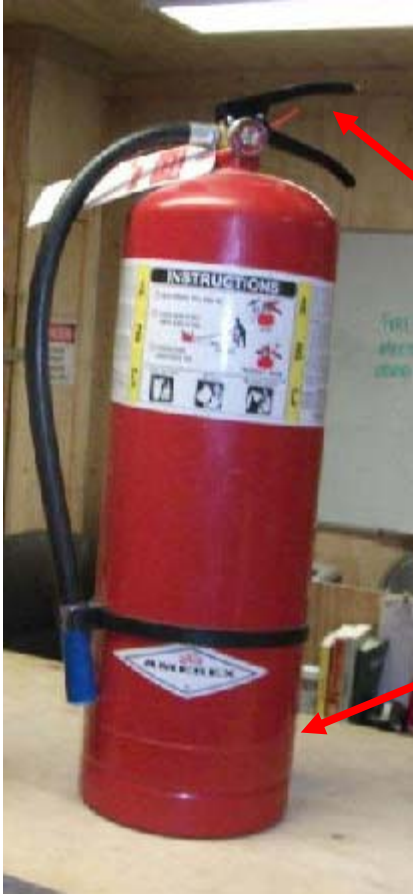
The counterfeit extinguishers have been reported to have black or red plastic handles. Genuine approved dry-chemical B-II extinguishers typically have handles that are constructed of silver-colored aluminum (although there are some with plastic handles).

Pressure gauges on the counterfeit units may be the wrong color. The gauges on genuine approved Buckeye dry-chemical extinguishers will have a red background.

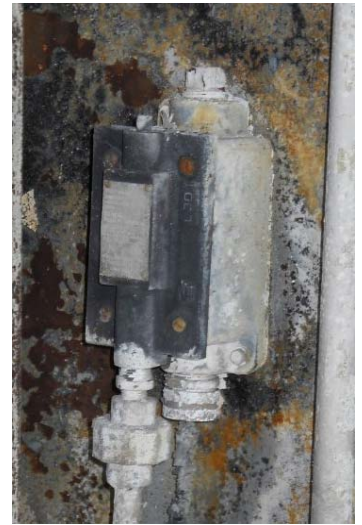
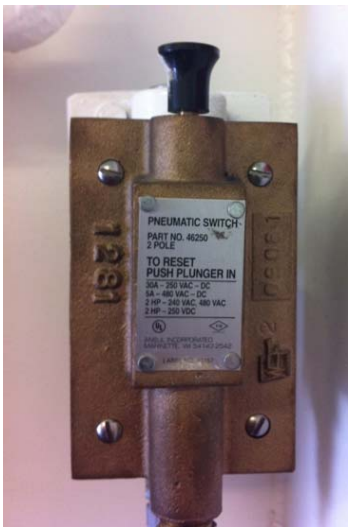
Recently, a vessel with an installed fixed CO<sub>2</sub> fire suppression system, suffered extensive damage due to a fire that started in the engine room. During the firefighting efforts the crew reported that the engine room ventilation could not be secured. A post casualty damage survey of the vessel revealed that the pressure switch used to secure the ventilation was located within the engine room. See the photograph of the damaged pressure switch at the right and new switch below.

Fixed CO<sub>2</sub> systems on inspected/regulated vessels need to be type approved and installed in accordance with applicable regulations; 46 CFR 25.30-15, 46 CFR Subpart 76.15, 46 CFR Subpart 95.15, 46 CFR 118.410, etc. These regulations require all controls and valves for the operation of the system to be outside the space protected, and notes they cannot be located in any space that might be cut off or made inaccessible in the event of fire in the protected spaces. The Coast Guard considers pressure switches that are used in such systems a "control."

The Coast Guard ***strongly reminds*** Owners and Operators of vessels with installed fixed fire suppression systems to ensure that these switches are properly located aboard their vessels. If the pressure switch or switches are located within the space being protected, they should be relocated by a properly trained fire suppression service technician. Doing so will assist in ensuring system functionality and accessibility in the event of an emergency. Failing to do so could have serious consequences to the vessel, its crew and the environment.

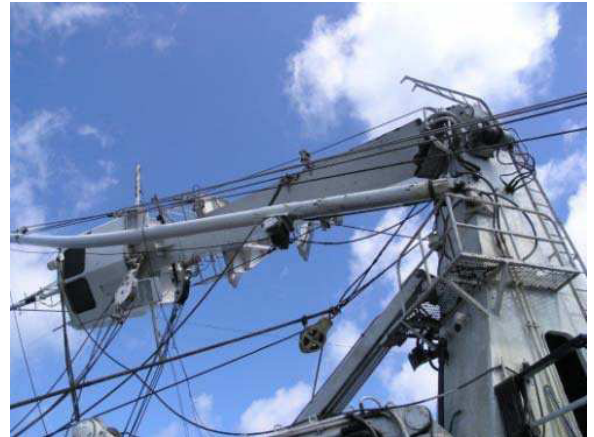
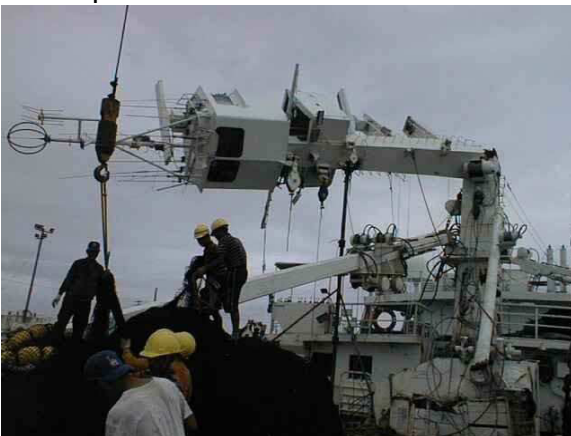
Recently, several catastrophic failures of masts, booms, and lift cables have occurred on purse seine fishing vessels that have resulted in loss of life and severe injuries. Over the years many casualties have occurred onboard all types of fishing vessels attempting to haul in catches that exceeded the capacity of their winches, hoists, and associated equipment. These types of casualties are not unusual. This alert serves to remind all purse seine fishing vessel owners/operators and other fishing segments to ensure safe use of the haul equipment particularly matching the size and the capacity of the nets to the rated size and capacity of the winch/haul/hoist equipment, taking into account safety factors for various species, and other concerns such as the variable platform that a rolling fishing vessel and variable catch presents.

Owners / operators, and vessel *Insurers* must ensure that vessel winch, haul and hoist systems are not modified by crew members to increase the lifting capacity beyond the rated design which in some cases can be done very easily. Such boosting of hydraulic systems must be prohibited and certain components should be protected with special seals. The machinery should be properly maintained and records kept in a historical log. It is imperative that owners / operators ensure every load bearing structure and its associated components are maintained in original condition, that they will be operated as designed using all appropriate safety margins for anticipated working

- Know the design limits of load bearing structures and winches, hoist, and haul components;
- Ensure they are not modified by crew members; properly maintained; and are inspected and tested on a regular basis. Repair/replace components immediately when deficiencies are discovered;
- Evaluate and revise operational procedures as needed.

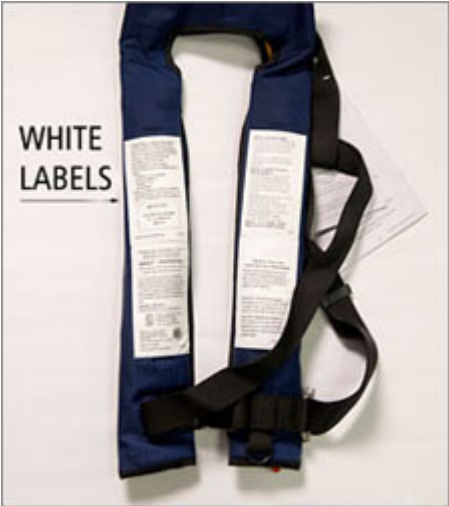
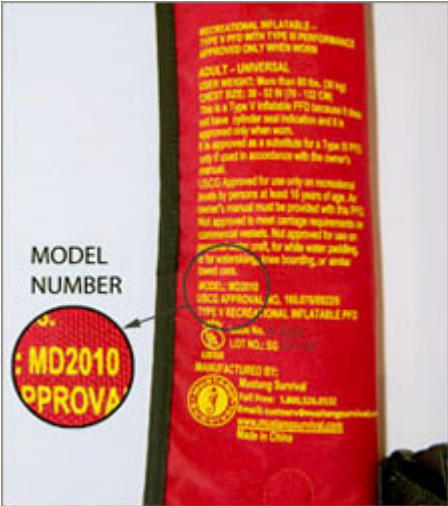
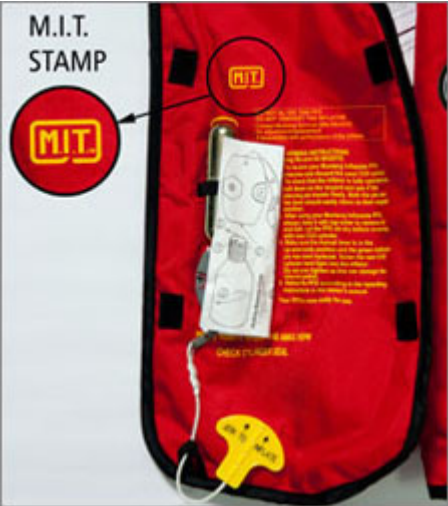
<p><b>Image 1</b> Product with white labels are <u>not</u> part of this recall.</p>	<p><b>Image 2</b> Check for the model number on the back of the PFD above the UL logo.</p>	<p><b>Image 3</b> Any MD2010 or MD2012 with an "MIT" stamp is OK to use and does not need to be returned.</p>

This recall is being issued for the inspection and repair of an inflator installation inconsistency that may prevent some units from fully inflating with CO2 (oral inflation functions normally). Mustang Survival has developed a solution that corrects any affected product and prevents re-occurrence of this issue. The inspection and repair can only be performed at a Mustang Survival factory.

**BUT - Any MD2010/MD2012 missing the "MIT" stamp should be returned to Mustang**

**All MD2010 and MD2012 PFD's without the stamped MIT logo as shown in Image 3 (above) should be returned to Mustang Survival for inspection.**

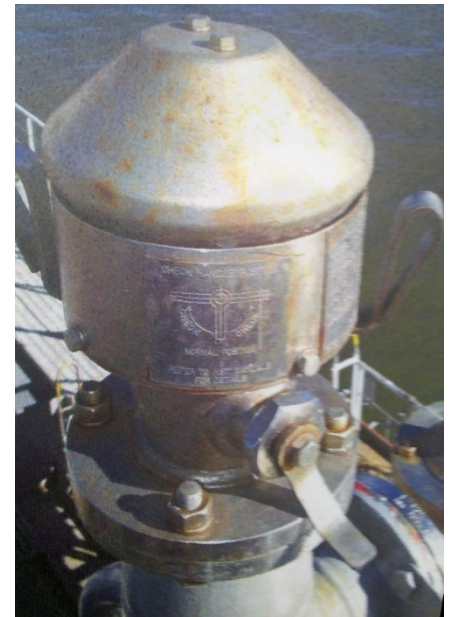
The investigation is nearly complete and investigators have identified several causal factors, one being the failure of the high velocity vent valve which did not open and prevent over pressurization of the tank while it was being filled.

After this specific casualty, the high velocity vent valve of the tank being filled was found stuck closed and inoperable using the manual test lever. A valve for another tank was also found stuck. Scientific testing of the substance between the stuck valve disc and the seating surfaces indicated the presence of oxidized vegetable oil or fat likely from previous cargoes. It appears doubtful that crewmembers exercised the valves prior to their cargo operations as per their operating procedure.

As a result of this casualty and others involving similar circumstances, the Coast Guard **strongly recommends** to vessel Owner / Operators, Crewmembers, Classification Society Inspectors, Vetting, and other inspection personal ensure that tank high velocity vent valves and vacuum valves, or combination pressure / vacuum valves are maintained in operating conditions at all times and are routinely checked as procedures require.

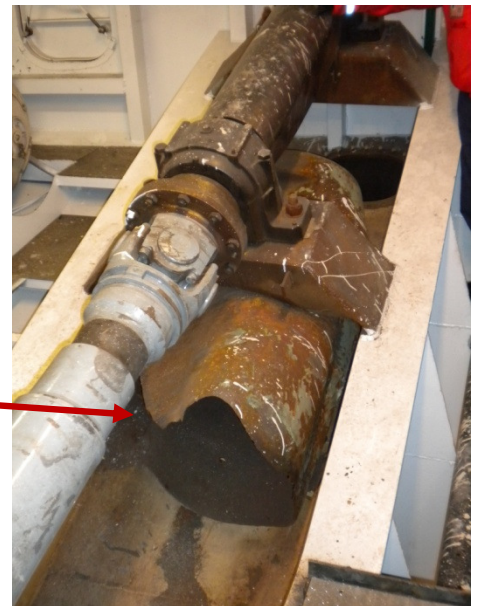
(Parted air receiver.)

Not long ago, an air receiver unexpectedly ruptured with terrible results onboard an UTV on the Upper Mississippi River. A crewmember was seriously injured and paralyzed. Several causal factors were noted during the casualty investigation; the lack of a relief valve to protect the system and significant corrosion within the receiver. It's important to note that on unprotected systems, all it takes for the system to be over-pressurized is for the compressor's pressure switch/contacter or unloader to fail and not shut off the machine. Further, internal corrosion on aged tanks present a latent unsafe condition and may go unnoticed if not inspected.

As a result of this casualty and other similar incidents, the U. S. Coast Guard **strongly recommends** that UTV Owner/Operators, vessel engineers, insurance surveyors and other inspectors **ensure** that:

- A proper sized pressure relief device is installed on all air receivers. The pressure relief device should not be rated higher than the Maximum Allowed Working Pressure (MAWP) stamped on the air receiver's data plate;
- A data plate is attached to the receiver and pressure relief devices. If missing or damaged the UTV representative should provide evidence to prove the components were constructed to an approved standard. Otherwise this equipment should be taken out of service or replaced;
- The data plate associated with the receiver and pressure relief device remain unpainted and legible. Take care to minimize damage to the plates if paint needs to be removed. Pressure relief devices should not be painted as paint can interfere with the lifting of the valve. Those that are painted should be lift tested to ensure proper operation;

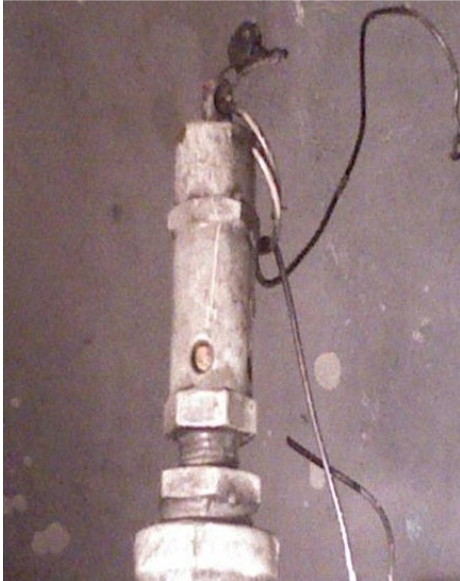
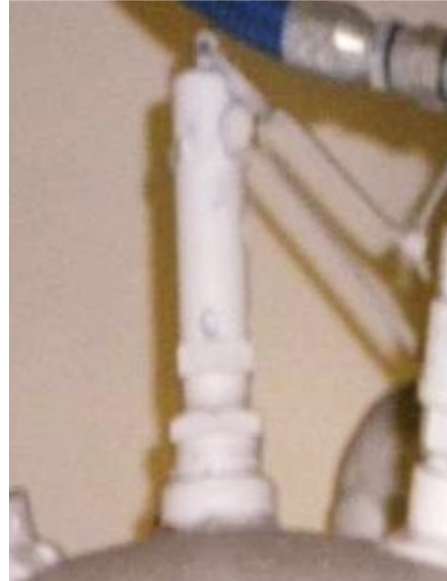
**RELIEF VALVES MUST NEVER BE SECURED IN THE CLOSED POSITION**

- Pressure relief devices are not capable of being isolated or their operation prevented by being wired or secured in a position that prevents the valve from opening;

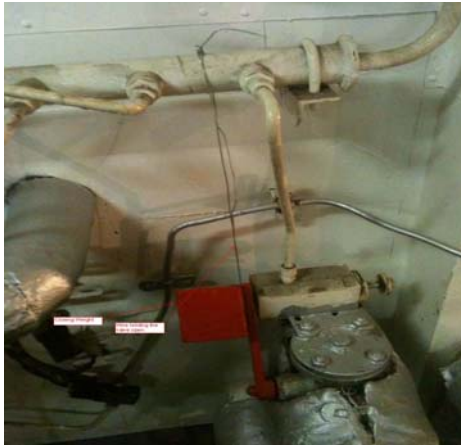
QCV blocked utilizing wire to hold closing weight up and the valve in the open position.

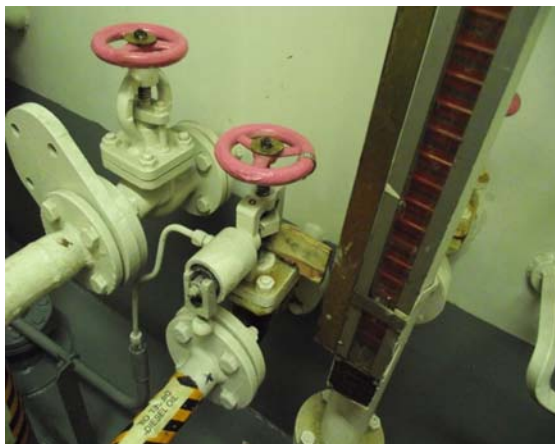
QCV blocked utilizing a wooden block to hold the valve in the open position.

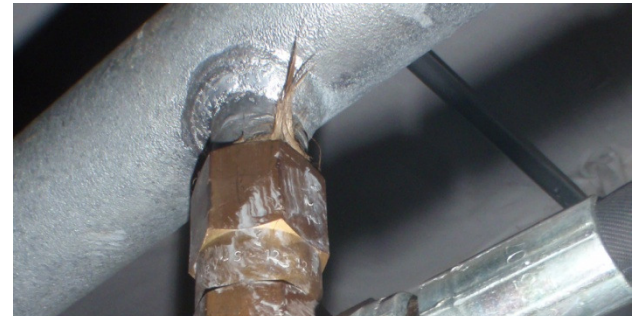
- Hemp type pipe sealant was used extensively on pipe threads throughout the system and in some instances seems to have entered the system. (Photograph at right.)

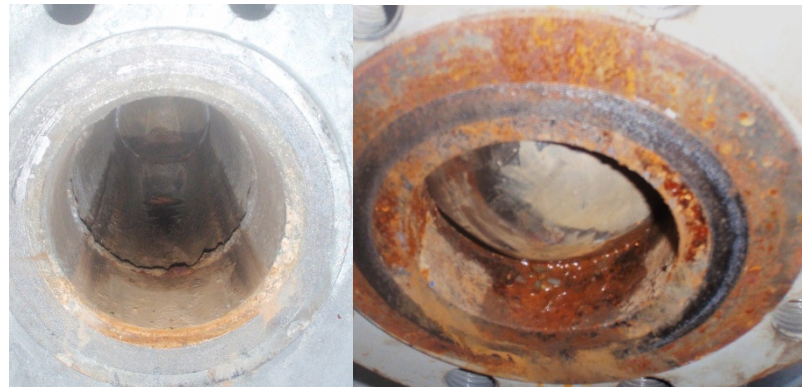
- Certain elements of the distribution manifold contained low points which allowed the accumulation of water within piping that could not be drained. Such a circumstance could cause corrosion that could possibly negatively effect operation of other components. (Photographs at right.)

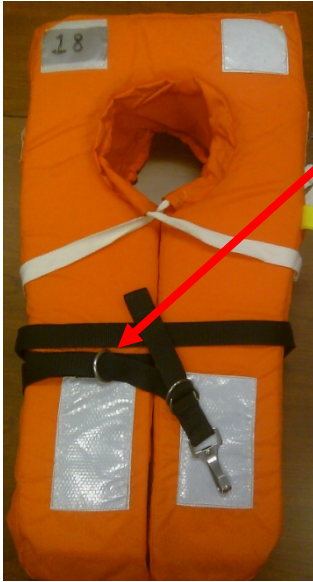
Recent Coast Guard inspections of Type I Personal Flotation Devices, (PFDs) in both adult and child size, identified a potential hazard that could prevent proper donning in the event of an emergency. The chest strap was threaded through the fixed "D" ring that the strap is intended to clip to when worn. *(Image left)*

It was discovered that several PFDs were assembled this way at the factory and if not corrected could create a hazardous condition during an emergency when they are donned.

Instead of the strap falling away, allowing the wearer to wrap it around him or her, the clip end of the strap could snag in the "D" ring preventing the wearer from getting it around their body. *(Following image)*

The Coast Guard **strongly recommends** that vessel owners/operators using the PFDs listed above check each lifejacket for proper routing of the strap. Completely unwrap the primary strap to ensure it is free and capable of being adjusted for any wearer. The strap of the lifejacket must not be threaded through the fixed "D" ring. If routing is satisfactory, the strap may be wrapped around the life jacket and clipped to the fixed "D" ring for storage. *(Right image)* If the strap is incorrectly threaded through the fixed "D" ring, the snap hook assembly should be carefully removed from the strap, the strap pulled out of the fixed "D" ring, and the snap hook assembly re-attached.

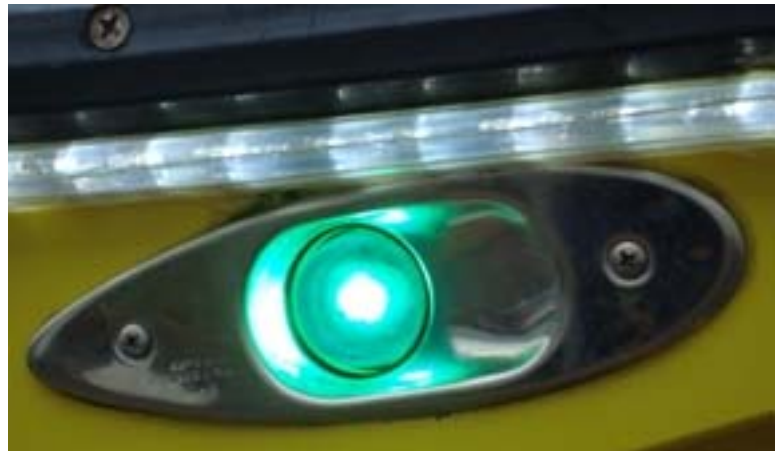
The Coast Guard recognizes that many vessel owners choose to place decorative lights onboard their vessels during the Holiday season. The Coast Guard **strongly reminds** vessel owners not to illuminate such lights during routine navigation unless operating in a Holiday boat parade or when the vessel is secured dockside. This issue was highlighted during a recent casualty whereby the owner of a passenger vessel had installed decorative Holiday type LED (Light Emitting Diode) lighting around the periphery of the vessel. The LEDs were contained in a clear flexible hose and securely attached. Near the bow of the vessel the lighting was adjacent and slightly above the port and starboard navigation lights. At night this installation, can impair the "distinctive character" of the navigation lights as set out in Rule 20 of the Navigation Rules. (Photograph below shows daytime view.)

Additionally, Rule 22 of Navigation Rules states that vessel sidelights have a two mile range for vessels 12 meters or more in length but less than 50 meters in length. In this particular casualty a side light navigation fixture was found installed on the passenger vessel that was stamped 1 nautical mile vice two miles. Vessel owners and operators and marine inspection personnel should ensure that the proper navigation lighting fixtures are installed, that all components operate correctly and that regulatory requirements with respect to Navigation Lighting are met.
