# U.S. COAST GUARD

**SAFETY ALERTS  
1996-2014**

**PREVENTION**

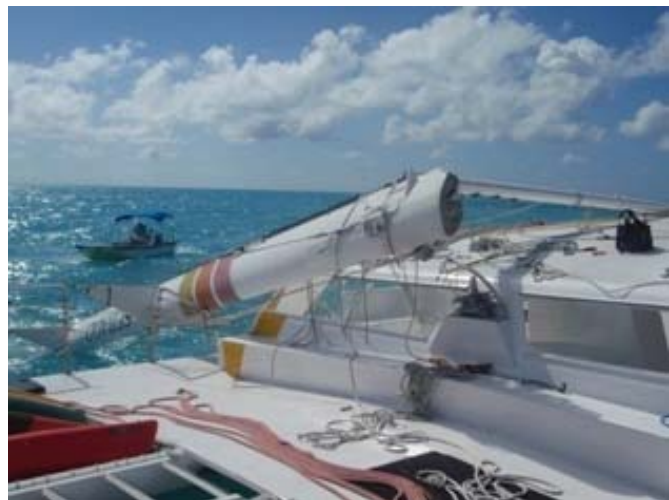
Common among the dismasting casualties was the failure of the mast's standing rigging. While this investigation is ongoing, initial forensic metallurgical analysis of the failed cable strands showed visual corrosion and evidence of fatigue failure. The shroud cable and swageless end fitting had been installed seven years prior.

The Coast Guard **strongly reminds** all commercial vessel owners/operators, especially those of passenger carrying sailing catamaran's of similar build, of their responsibility to maintain their vessels, associated equipment, systems and components in a satisfactory condition suitable for their employed service at all times. Owner and operators should not wait until regularly scheduled Coast Guard inspections to identify problems but should be ever vigilant and implement routine inspection, maintenance, and repair procedures in accordance with good marine practice and in alignment with applicable requirements. Owners and operators should consult the vessel manufacturer or other naval architecture, marine engineering services or qualified rigger regarding any concerns they might have regarding the regular flexing and working of their vessel's standing rigging

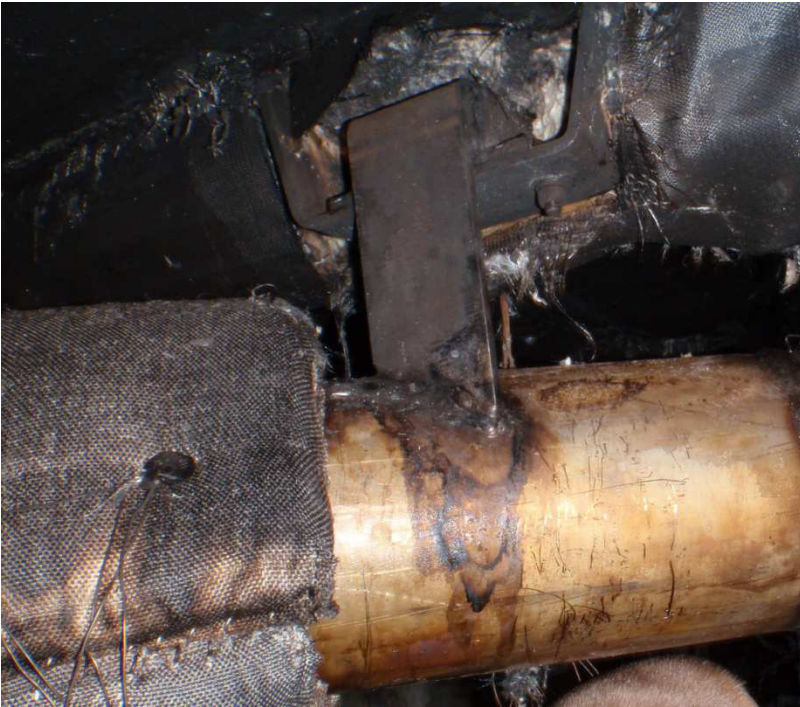
In a small engine room containing several engines and having a low overhead there are a number of locations that present enough heat to cause a fuel to flash and ignite other components. Turbocharger and exhaust piping insulation while serving to reduce heating of external areas also helps reduce the immediate availability of ignition hot spots. Care should be taken to ensure insulation wraps and blankets are kept tight and fastened in a manner to prevent dripping or spraying fluids from traveling to an exposed hot spot. Insulation seams should be made tight and where possible aligned in a manner to prevent pooling of fluid and to repel dripping. Likewise good marine practice may also dictate and ensure that braces which are welded directly to the exhaust pipe which serve as hangers or supports

also be insulated. Heat conducting from the exhaust pipe to the brace could be substantial allowing the exposed bracket to become nearly as hot as the exhaust pipe. The brace in the photo above was only partially covered with the insulation that was wrapped around the exhaust pipe. As with the other concerns in this document, owners and operators of any type vessel, as well as those persons involved with the inspection of vessels should be aware of the potential risks associated with improper or inadequate installation of insulation.

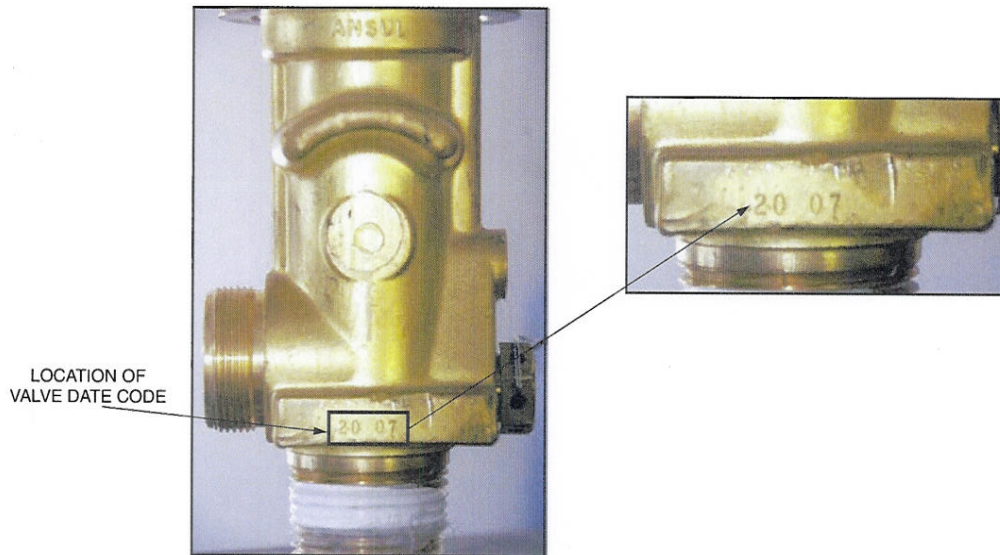
**Marine High Pressure CO<sub>2</sub> valves with a date code range of 10-07 to 06-08.**

This date code range is conservative and may be further narrowed through additional testing. The date code is located on the flat opposite of the valve outlet. The date code represents the week and year the valve was manufactured.

Carbon dioxide cylinders which are installed, or could be installed on a ship with a valve date code between 10-07 and 06-08 **MUST** be identified. If you identify cylinders with valves in this date code range, please contact ANSUL Quality Assurance **IMMEDIATELY** for further information and authorization for replacement of these cylinders.

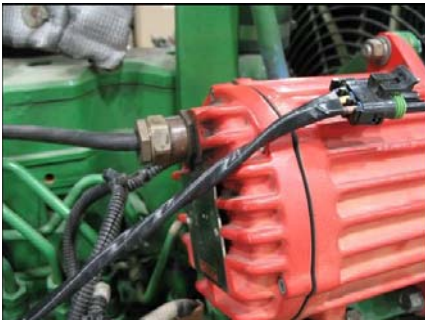
In some installations, cables between the alternator and battery were cut and a connector put in place to allow easier servicing. This alteration is not appropriate for hazardous locations. The cable seal on this alternator may not be the one approved for the alternator and may have to be examined.

Cable entries on flameproof or explosion proof enclosures require sealing fittings that are suitable for the enclosure.

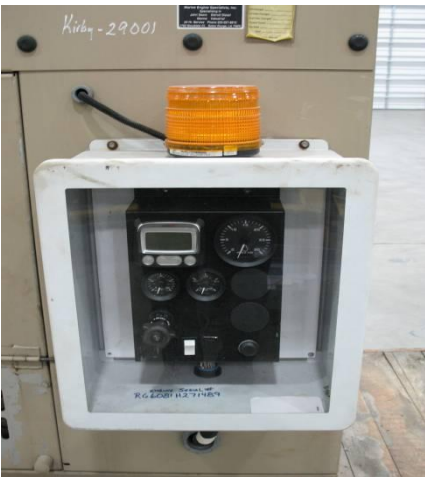
Typical unacceptable electronic display. This is not in an explosion proof enclosure. The beacon installation shown here outside of the enclosure is also unacceptable.

**Electronic displays** should be enclosed in explosion proof enclosures.

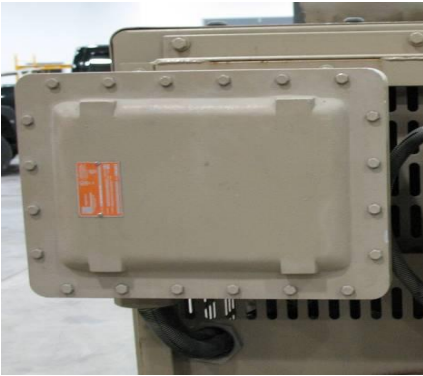
On this particular ECU, a large hole was drilled in the bottom of the enclosure with multiple wiring harnesses coming into it and installed without any sealing compound installed in the cable gland. This is not acceptable in hazardous locations.

**Engine control units (ECU) should be installed in an explosion-proof enclosure or outside the hazardous zone.**

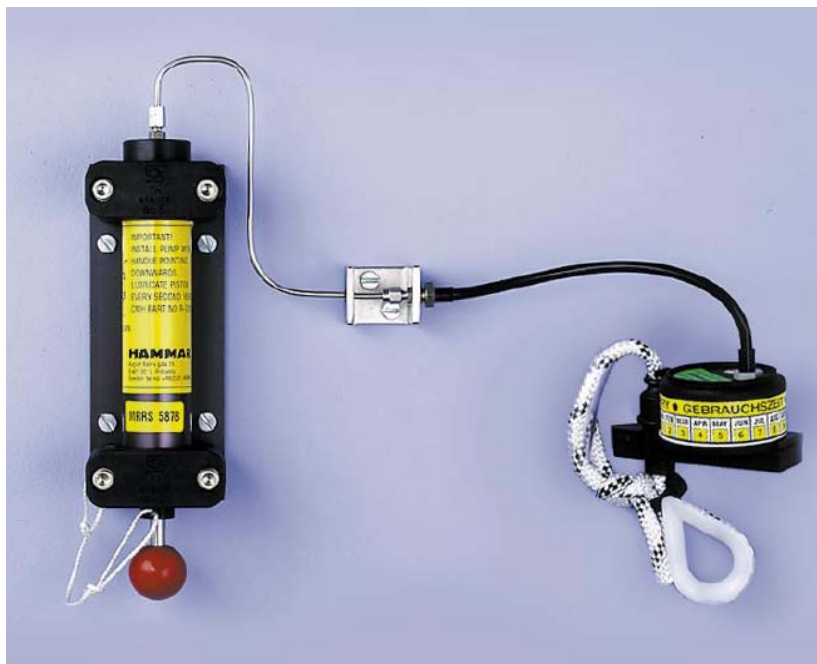
An investigation into the circumstances surrounding a recent passenger ship grounding revealed difficulties the crew had in manually deploying the vessel's liferafts from their mounting cradles. The liferafts were fitted with individual Hammar Manual Remote Release System (MRRS) pneumatic vacuum pump units. When the pumps are manually operated a vacuum is quickly and easily created that actuates a corresponding Hammar H2O hydrostatic release unit. In this case a large number of those pumps failed to activate the hydrostatic release units and, ultimately, the crew had to manually cut the liferaft canister lashings. The crew was able to launch all of the vessel's liferafts successfully in this manner.

MRRS pump units are clearly marked in black letters on a yellow background on the cylinder housing, "Lubricate piston every second year." The pumps that failed had not been lubricated as required. The malfunctioning MRRS pumps were replaced in kind with new units; USCG inspection showed that the new units operated properly. Owners, operators, port engineers, inspectors and others involved in vessel safety should ensure that all appropriate steps are taken to properly maintain survival equipment.

The casualty investigation is not complete and additional recommendations are likely to follow. However, in the interim, the United States Coast Guard strongly recommends that Hammar MRRS pneumatic pump units, as well as all other survival equipment, be maintained in accordance with the manufacturer's recommended maintenance schedules.

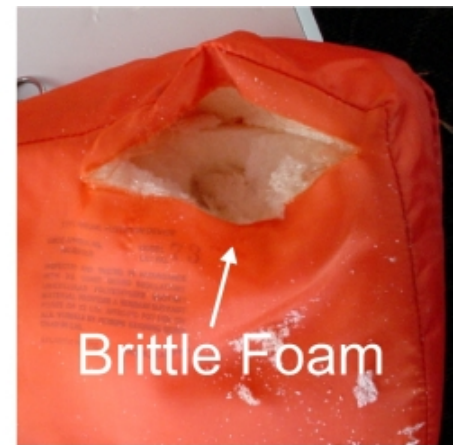
Additionally, follow-up buoyancy tests of suspect PFDs performed by the Marine Inspectors resulted in numerous failures. All PFDs that had failed were condemned and each exhibited noticeable shrinkage and compression. Many of these PFDs have been in use since the 1970’s and may have reached the end of their service life.

Left image shows an example of a vinyl dipped PFD with compressed or hardened foam. Right image illustrates a fabric covered PFD with brittle foam.

The US Coast Guard **strongly recommends** that owners and operators carefully inspect all of their older Type I unicellular plastic foam PFDs. Potential indications that a Type I unicellular plastic foam PFD may no longer be serviceable are:

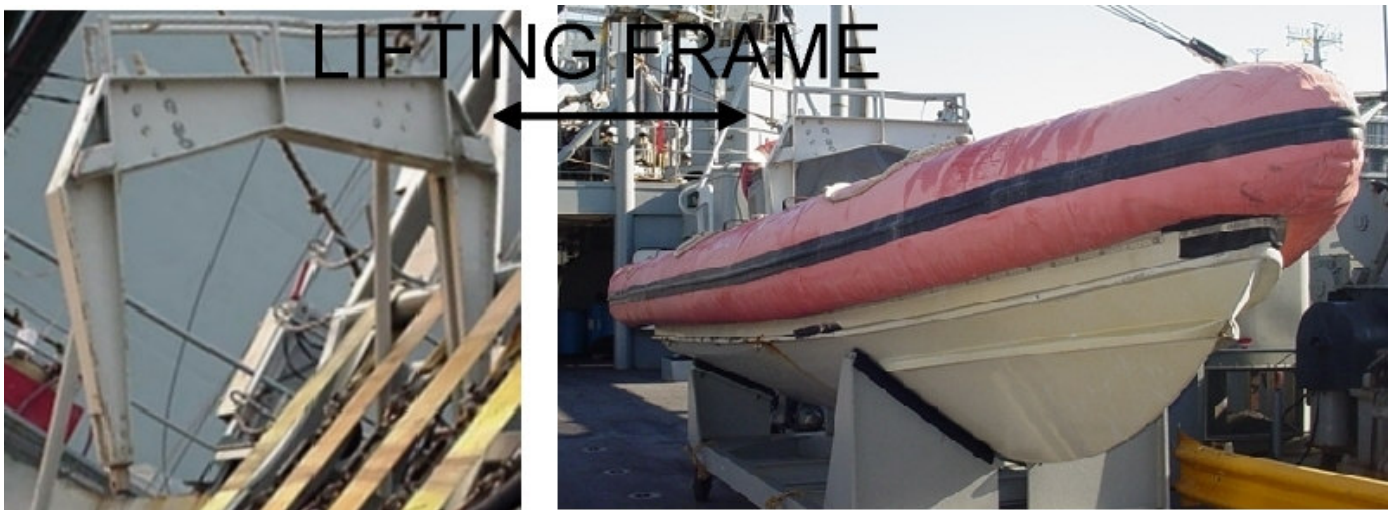
MODEL: Pacific 22 NK III

Recently a large deep draft vessel was hoisting aboard its rigid hull inflatable (RHI) rescue boat when it's lifting frame, an inverted u-shaped component, separated from the brackets that attached it to the deck. As a result, the boat fell back into the water and its attending crewmember was ejected. The uninjured crewmember was promptly recovered and damage to the rescue boat was negligible.

An investigation revealed no specific maintenance requirements or manufacturer recommendations for periodic inspection of the lifting frame bolts. A vessel officer reported that limited visual inspection took place monthly but indicated that a "hands-on" equipment check did not occur.

To prevent a similar casualty the U.S. Coast Guard strongly recommends that vessel owner operators having vessels equipped with RHIs manufactured by Osborne Rescue Boat Company or other equipment constructed in a like manner -

- ensure that existing inspection and maintenance procedures include all critical components,
- carefully inspect the equipment for loosening of key components, and;
- where needed make authorized modifications.

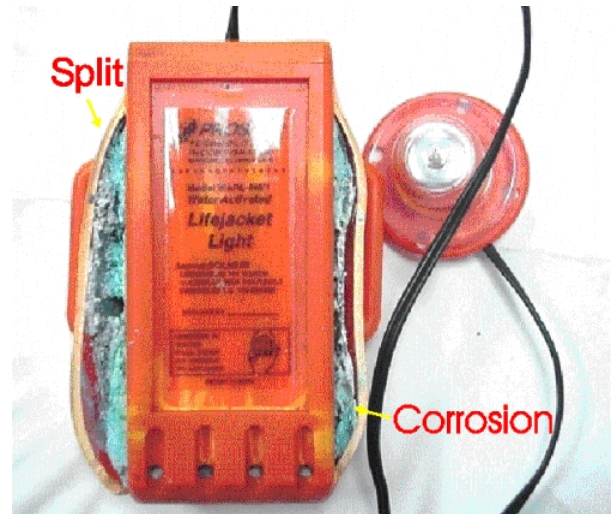
Recently during routine inspections several U.S. Coast Guard offices have discovered defective lifejacket lights made by PROSAR Technologies. Some of these lights were found with very noticeable deformations due to battery corrosion while others appeared perfectly normal but did not work when tested. Attempts to contact the manufacturer for repair or replacement of this equipment failed because the company is no longer in business.

The Coast Guard **strongly recommends** that vessel owners and operators using any of the PROSAR Technologies equipment listed above replace those items with other USCG approved safety equipment. For a complete list of U.S. Coast Guard approved products please visit our CGMIX website at <http://cgmix.uscg.mil/Default.aspx> and conduct a search for the product desired.

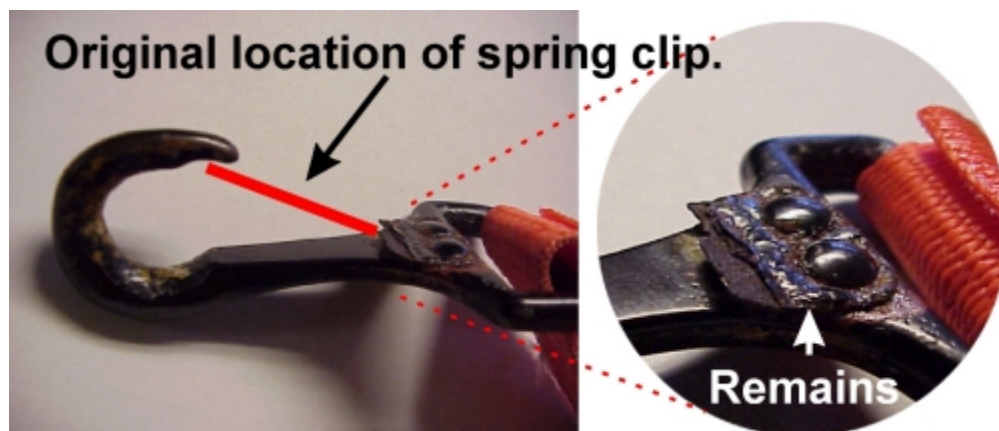
Improper materials were used during the manufacturing process. Consequently, due to the corrosive nature of marine environments it is only a matter of time until these defective snap hooks deteriorate and fail to operate as designed.

The image below illustrates a defective hook and the remains of a corroded spring clip. This snap hook is reported to have been in service for less than one year.

Cal-June Inc. has acknowledged that the snap hook springs are defective and is committed to replacing all defective snap hooks with new snap hook assemblies at no cost to lifejacket owners. They have determined that the defective snap hooks were only used on lifejackets having lot numbers identified in the table below. A total of 5,371 lifejackets were manufactured with the defective snap hooks and sold between October 1, 2002 and March 15, 2004.

- The entire snap hook including the clip should be made of non-magnetic materials such as bronze or stainless steel. Defective hooks will have spring clips that may be identified by signs of corrosion. A magnet may also be used to identify improper material. Simply touch the magnet to the surface of the spring clip. If the magnet is attracted to or attaches to the clip, then the snap hook assembly must be replaced.
- Contact Cal-June immediately to obtain replacements for spring clips that are corroded or determined to be magnetic.

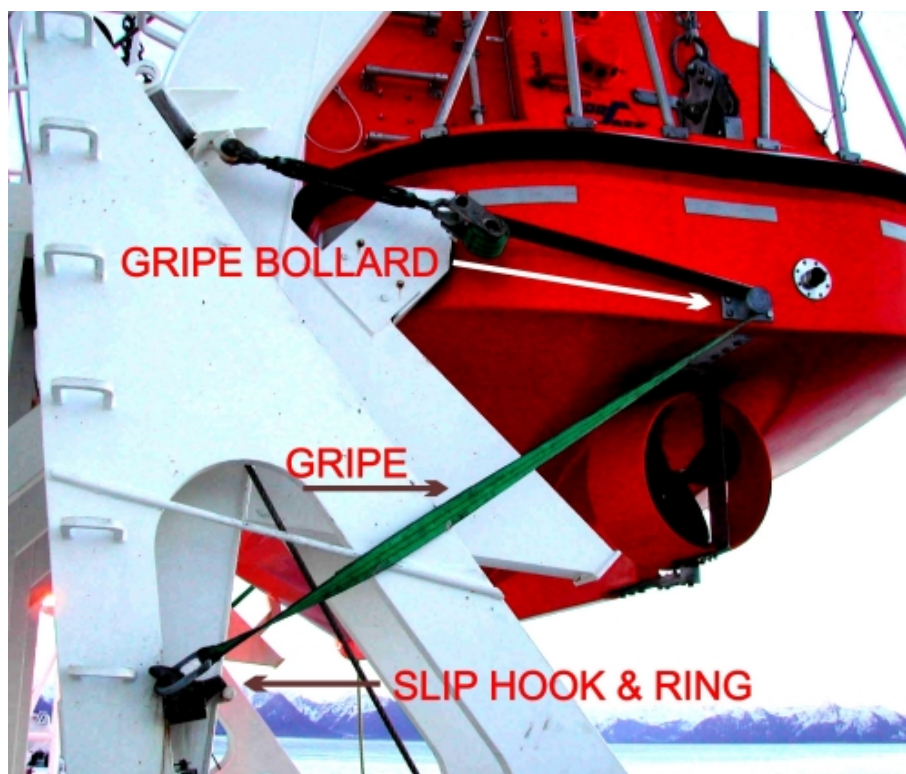
It is reported that on several occasions during lowering of a 6.7 meter totally enclosed lifeboat, the ring on the released end of the aft gripe snagged the boat's "gripe bollard." The "gripe bollard" may be known as a "stern post" or "lashing chock."

The purpose of the gripes is to secure the lifeboat against the davits when in the stowed position. The gripes are essentially straps which attach to the ends of the boat and are secured to the davits. One end attaches to a tightening and turnbuckle device, while the other end is attached to a ring that is placed over a slip hook. When the lifeboat is brought to its stowed position, the free end of the gripe is payed over the gripe bollards on both ends of the vessel and the rings are placed over the slip hooks. The slip hooks are then shifted to their closed position.

The Coast Guard **strongly recommends** that owners and operators of vessels having any type of webbing or wire cable used in a griping/securing system -

- contact the respective lifeboat manufacturers and class society representatives to find out what type of gripe entanglement incidents have been reported, and
- develop appropriate solutions that will minimize potential risks associated with such designs.

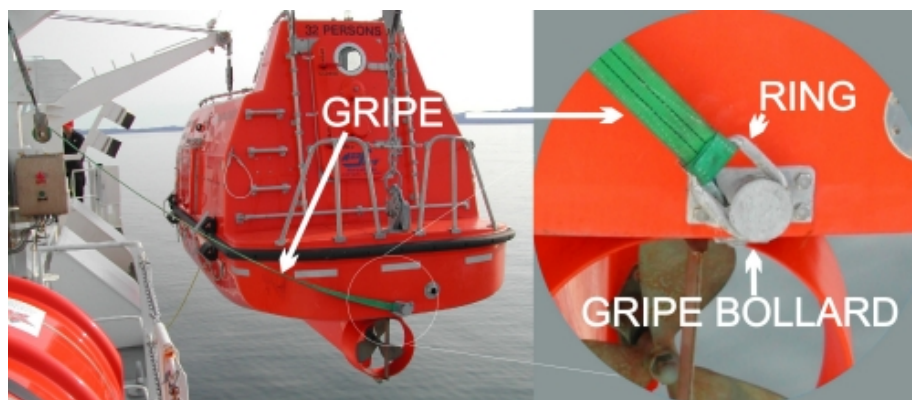
Because the ring at the free end of the gripe is larger than the circular outer edge of the bollard, the ring can catch the bollard. Level lowering will continue until the gripe takes the load at which point the end of the vessel which hasn't snagged will continue to lower. The gripe may or may not break when the lifeboat begins to hang. **This condition is unacceptable** and may contribute to the loss of life during emergency evacuations or drills.

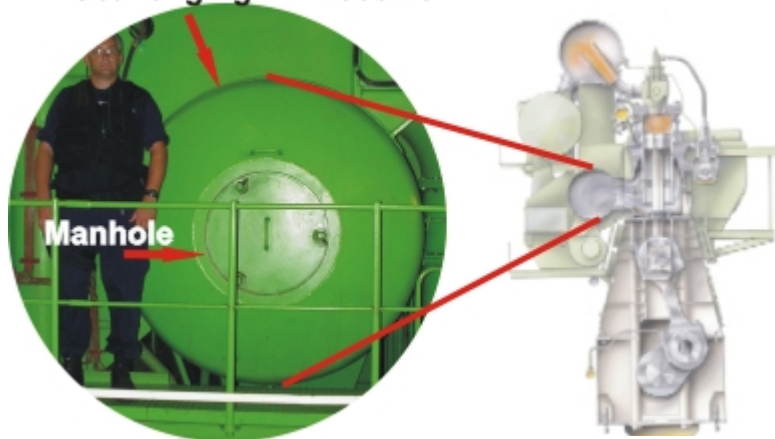
#### Scavenging Air Receiver

The vessel was powered by a Burmeister & Wain, 9 cylinder two stroke engine that develops over fifty-five thousand horsepower. The engine's scavenging air space can be accessed by two manholes located on both ends of the scavenging air receiver.

These circular manholes are secured by three L-shaped dogs having an outer edge that is tightened against an inner circumferential lip on the edge of the access hole. Tightening is achieved by the use a handled fastener.

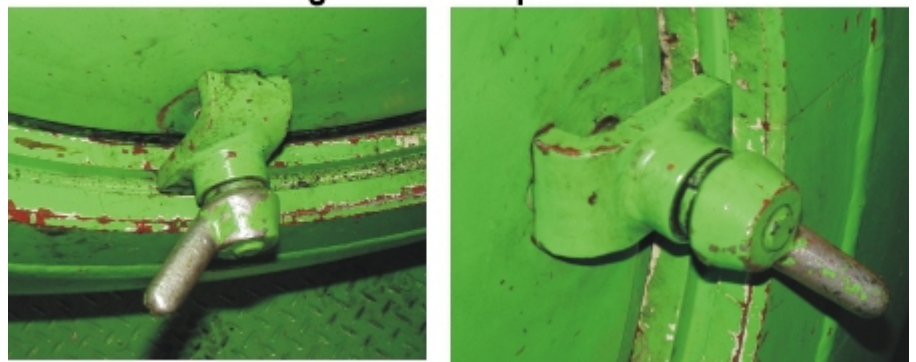
#### Dogs in latched position.

engine maintenance was performed in that space while at the first port and he may have returned to inspect the area for left behind tools and materials or to retrieve something. It appears that after his entry, the easily moved hinged / inward-opening door accidentally closed. Investigators believe that at that time, the upper left dog due to its weight and perhaps the vibration of the door as it closed, caused the dog to move allowing its edge to catch the circumferential lip at the opening. Once caught, even with the loosened fastener the door could no longer be opened from the inside of the receiver.

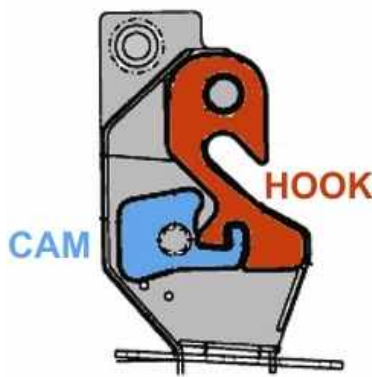
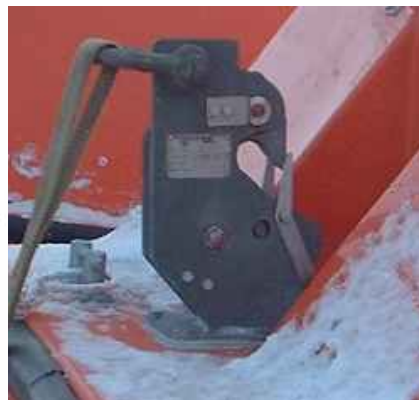
After the accident the release mechanism control lever was found in the locked position inside the boat, but it is apparent that the hook itself was not fully engaged with the cam inside the release mechanism. Subsequent investigation found that the release mechanism control lever could be placed in the locked position even though the locking cam had not properly engaged the hook. In this condition, the mechanism can appear upon casual examination to be locked and, due to the design and roughness of the hook and cam surfaces, it could bear a significant load. However, the hook can in fact release at any time without warning.

Satisfactory engagement and locking of the release device is dependent upon successful mating between the male and female portions of the cam and hook, respectively, as shown in the following drawing.

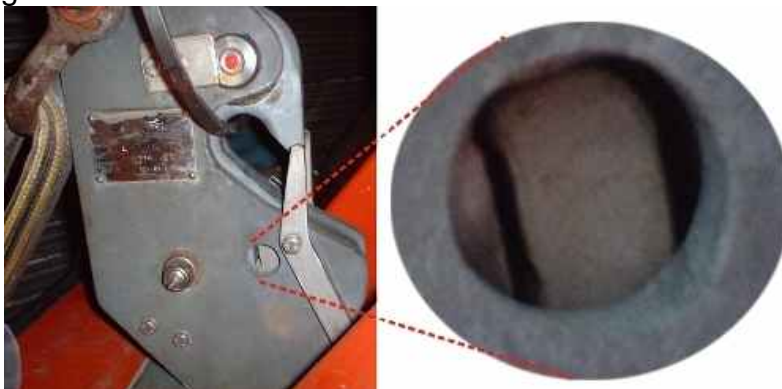
1. With the lifeboat in the STOWED position, and MAINTENANCE PENDANTS FITTED, check the inspection window of the hook (which may be outboard) to determine whether the cam and hook are completely engaged.
2. A properly engaged cam and hook will look like this:

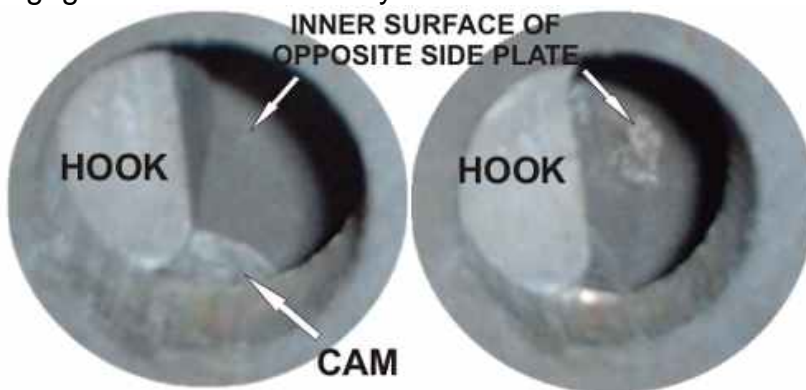
3. An improperly engaged hook and cam may look like this:

**IMPORTANT** - The inside surface of the opposite side plate (or half) of the release mechanism will be visible, unless a significant portion of the hook is out side the side plates.

4. If the cam and hook are not completely engaged, the load of the boat must be temporarily transferred from the release mechanism and on to the maintenance pendants. Next the release lever at the helmsman's station is reset while the hook is pushed into place by hand to ensure the cam and hook are completely engaged. The load may then be returned to the release mechanism after confirming complete cam engagement through the inspection window.

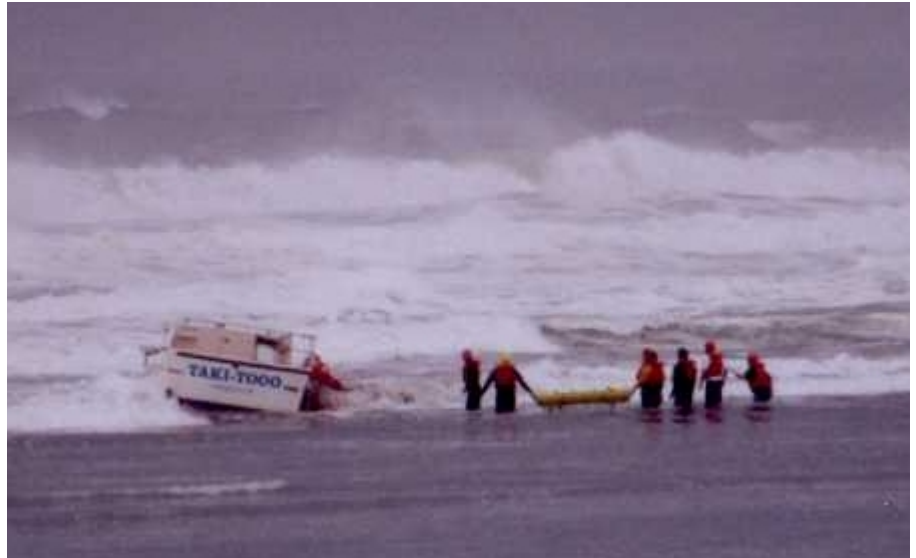
On Saturday morning, June 14, 2003 at approximately 0715 local time, the Coast Guard Inspected Small Passenger Vessel, the M/V TAKI-TOOO proceeded across the bar at Tillamook Bay, Oregon carrying 17 passengers and two crew. During the bar crossing, a large wave struck the port side of the TAKI-TOOO, capsizing the vessel. Nine people, including the master, are known dead and two are missing. The preliminary findings indicate that **none of the nine dead wore life jackets**. Six of the eight survivors wore/or held onto a life jacket.

The M/V TAKI-TOOO on the beach near Tillamook Bay, Oregon after it capsized on June 14, 2003.

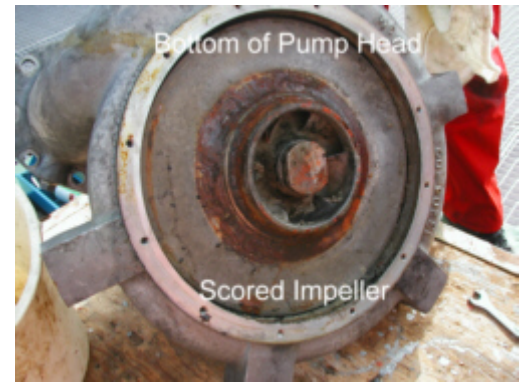
## Pump and Motor Assembly

A preliminary investigation reveals that the upper bearing of the cargo pump located deep within the tank had failed. The shaft and impeller shifted axially one half an inch causing the impeller to contact and spin against the end plate of the pump casing. The resultant friction caused extreme heat and possibly sparks which ignited the atmosphere in the tank.

When the tank top cover was opened, enough fresh air was introduced to allow the benzene vapor content to fall below the upper explosive limit and into the explosive range. The vapor in the presence of the operating but severely overheating cargo pump components ignited and caused the explosion.

- Ensure that the proper maintenance and repair as recommended by the manufacturer is accomplished for all pump, motor and drive components.

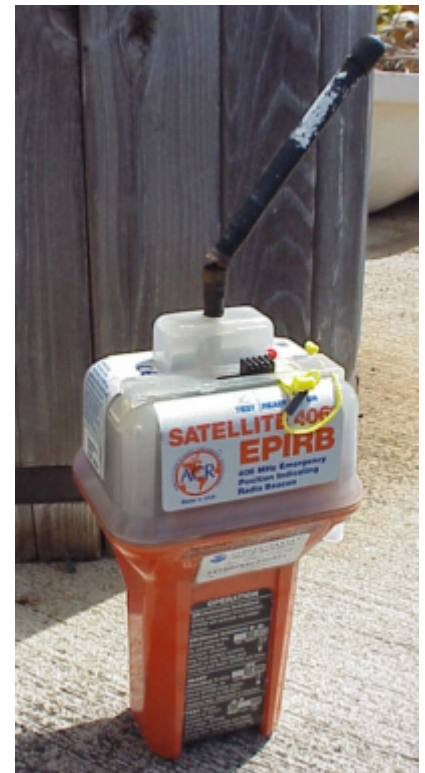
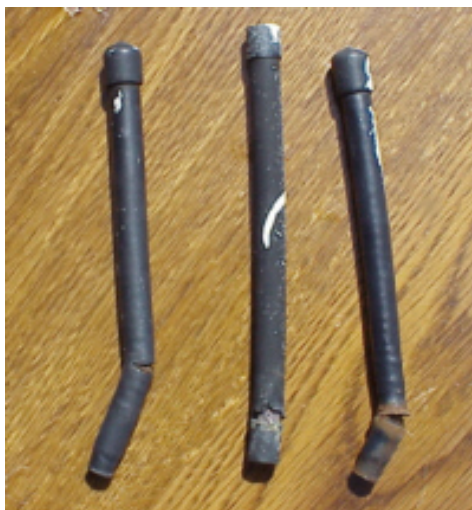
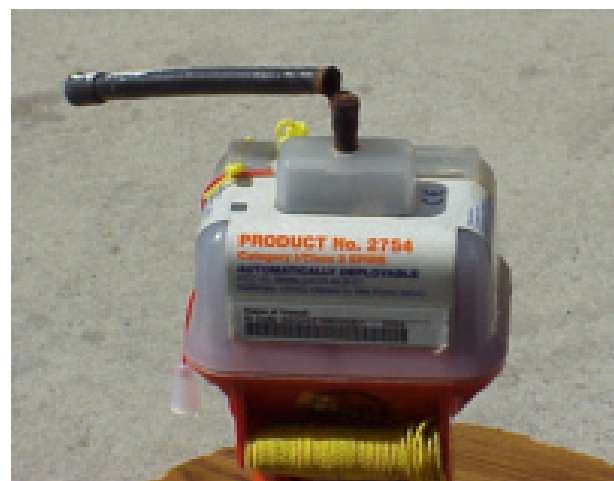
On several occasions the antenna's outer rubber coating was discovered ripped or torn. Closer inspection often revealed extensive internal corrosion. Other antennas showed no perforations on the outer rubber coating but displayed bulges on the antennae near its base. Upon closer inspection when the bulging area was sliced open, total wastage of the antennae interior was revealed.

It is reported that evidence of a corrosion failure may be discovered when the antenna is unscrewed from the EPIRB body assembly. Rusty liquid dripping from the antenna or moisture present inside the threaded section are tell tale signs of failing equipment.

The Coast Guard **strongly recommends** that vessel operators carefully inspect their EPIRB antennas - particularly if it is manufactured by ACR Electronics Incorporated.

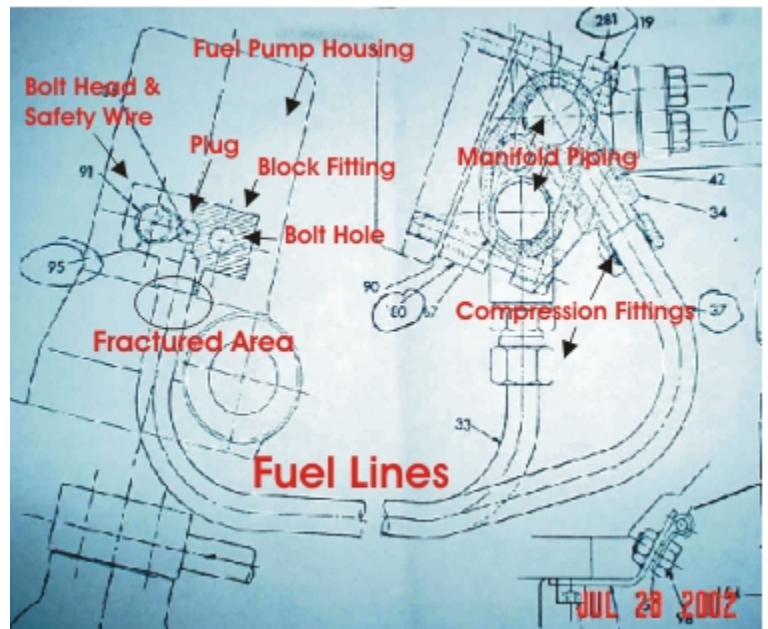
Investigators discovered that the supply line to the starboard engine number three cylinder fuel pump had fractured just below its connection into the rectangular block fitting. Additionally, shipyard personnel discovered the inboard bolt on the supply line fitting loose. Of 112 bolts securing the fuel pump fittings on the vessel's two engines, none were safety wired despite the availability of drilled bolt heads and indications of such wiring in engine schematics and diagrams.

Just under the block fitting of each connection, hose clamped around the tube joint is a rubber boot about four inches long. This boot is designed to deflect oil sprays downward should a break occur in this area. The boot on number three cylinder was destroyed in the fire.

The United States Coast Guard **strongly recommends** that owners, operators, superintendents, port engineers, shipboard engineers and crewmembers of vessels having similar equipment ensure the proper maintenance and repair of fuel and exhaust systems associated with main propulsion and diesel driven auxiliaries onboard their vessels.

The insulation of potential fuel oil ignition sources and the use of specialized fasteners and other devices to reduce the loosening of critical engine and systems components is essential for long term safe operations.

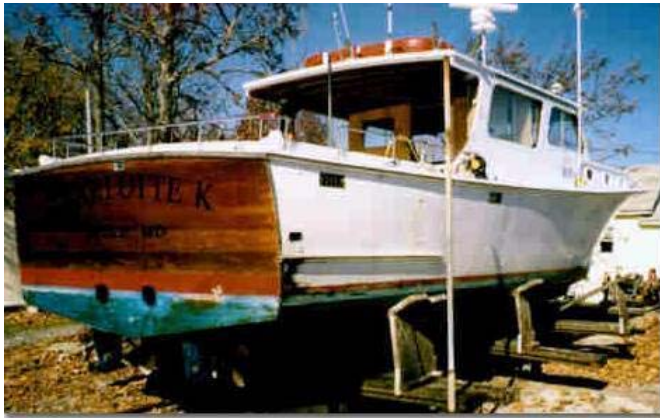
### **REPOWERING WOOD BOATS**

Upon return from a routine day fishing trip in November 1997, the operator of an inspected wood small passenger vessel reported that his vessel was taking on water at the dock after discharging passengers. Preliminary investigation indicated that the starboard chine log and outside starter plank of his 41 ft cross-planked Chesapeake deadrise hull were fractured.

Further investigation revealed that the 28 year old vessel had replaced the existing and original twin gasoline engine installation with twin diesels at the beginning of the season. Although the diesels were of comparable horsepower, they were double the physical size and weight of the original installation, with an available peak torque of over twice the existing gasoline engines. For details, see [Traveling Inspection Report](#) dated January 15, 1998 and [Safety Alert](#) message dated February 5, 1998.

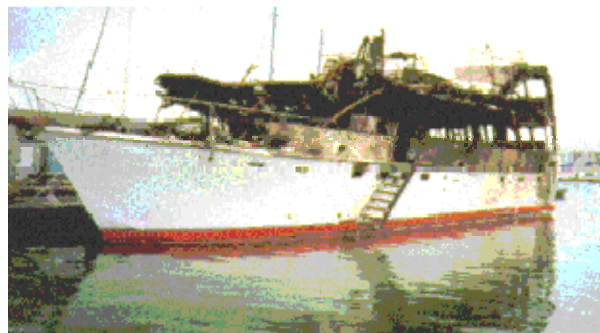
### **DRY ENGINE EXHAUST HAZARDS**

Recently, a fire erupted aboard a small wooden passenger vessel (approximately 70 ft in length) carrying over 60 people. Although the official investigation is not complete, information available at this time indicates that sparks or radiant heat from the exhaust pipes apparently ignited a fire in the vicinity of the smokestack. Crew members initially responded to the fire by discharging two carbon dioxide extinguishers at the flames. Once this action proved to be futile, the crew members deployed the vessel's fire hose. In the few short minutes it took to retrieve and lead out the hose, the flames fully engulfed the vessel; elapsed time was approximately five minutes.

The smokestack in this case consisted of several exhaust pipes passing vertically through a stack facade. The facade was fabricated of wood and sheathed in non fire retardant fiberglass. Constructed as it was, the flames quickly spread throughout the stack area and progressed unimpeded through the wooden vessel.

Owners and operators of vessels using dry type engine exhaust systems are strongly cautioned to check the condition of all exhaust pipes, insulation, and adjacent stack areas to ensure that no combustible materials come in contact with, or in close proximity to, hot exhaust pipes.

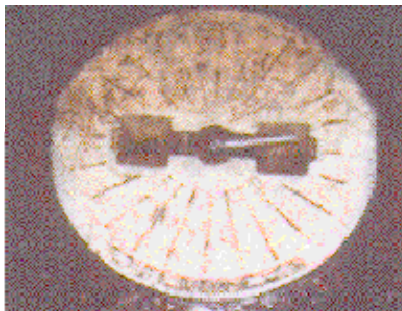
This hatch cover's broken dog handle indicates damage that may affect performance of the hatch. Commercial fishermen operating in fisheries requiring wet fish holds are requested to contact the manufacturers of hatch covers installed in their fish holds to ensure that they are designed for use in wet holds. If your hatch cover manufacturer advises you that their hatches are designed for that service, request the manufacturer's inspection and adjustment instructions to ensure that the hatch is in top condition.

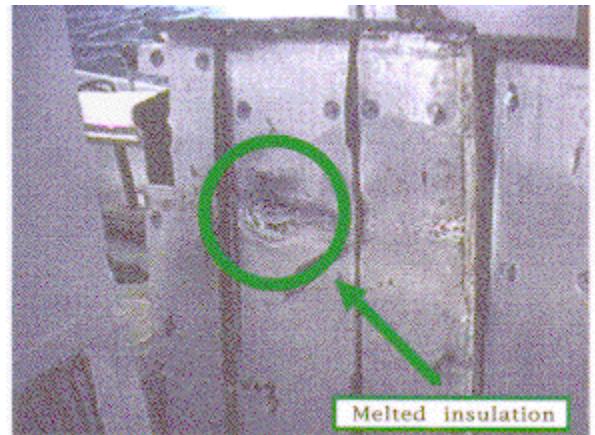
This photograph details a typical use of extruded polystyrene insulation on a commercial fishing vessel. In this application, the insulation has been installed on the engine box cover to reduce engine generated noise. On this vessel the insulation has begun to melt from engine heat. In the event of a high engine temperature or small fire, the insulation could ignite and result in a very rapid flame spread. Vessel operators with similar insulation installations should remove this material as soon as possible. The Coast Guard's primary concern with the use of polystyrene insulation is that a minor fire, which normally could be easily contained, may suddenly result in rapid flame spread and large amounts of black smoke which could disable or trap crew members. Additionally, heat generated by the combustion of polystyrene insulation could ignite other materials, resulting in the loss of a vessel.

All vessel owners and operators are requested to carefully inspect their vessels for this fire hazard. If extruded polystyrene insulation is found onboard your vessel it may present a fire hazard and it should be immediately removed and replaced with insulating materials suitable for high heat locations and marine use. These materials may be marked with USCG approval number 164.009. Although the use of noncombustible materials is not specifically required on commercial fishing vessels, their use is highly recommended. Coast Guard assistance is available to any vessel owner or operator to help determine if fire hazards exist onboard their vessels. For further information contact the U.S. Coast Guard Marine Safety Office at (207) 780 3251 ext 115.

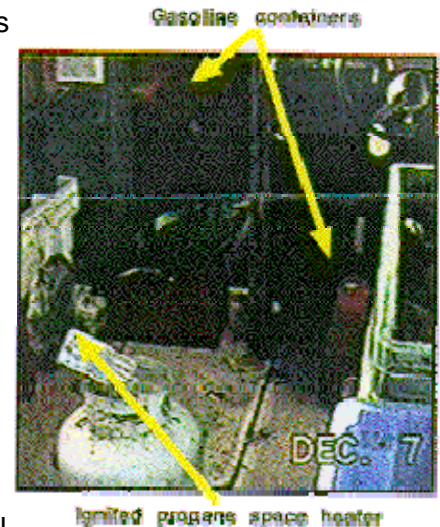
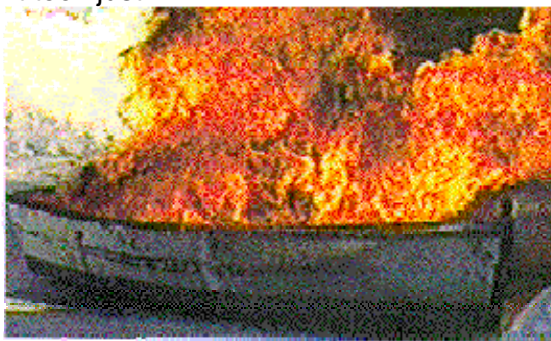
Accidental spillage of any flammable liquid, especially gasoline, in the vicinity of an open flame source can result in a catastrophic fire that will quickly engulf a vessel. To research the hazard, Coast Guard personnel recently conducted a controlled experiment utilizing a 17 foot open wood skiff. In this test, a portable propane space heater was placed in the vessel with two partially filled gasoline containers to recreate the conditions observed in the top photograph. In this experiment, one gasoline container and the ignited space heater were tipped at the same time, similar to what might be experienced from a large wave or wake from a passing vessel. The experiment demonstrated the inherent dangers of improperly stowed gasoline and portable heaters. From the time the fuel container and propane space heater were tipped on the test vessel it took just:

Test vessel burns 2 minutes 50 seconds after ignition

#### **Portable fuel containers must be secured against shifting**

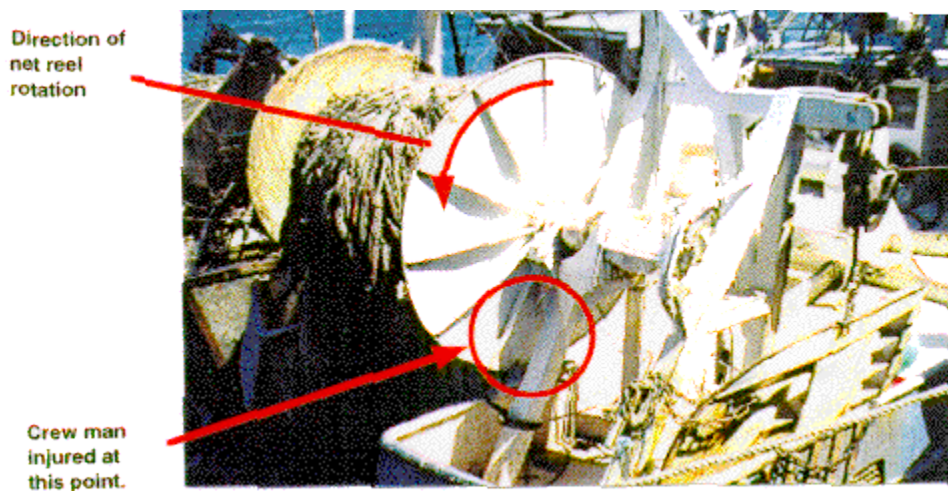
#### **Machinery Hazards**

*View of net reel arrangement on vessel (injury occurred on port side).*

Operators of commercial fishing vessels are requested to examine their vessels to insure that this particular hazard does not exist onboard their vessels as well.

Also noted during this accident was the inadequacy of the first aid kit onboard the vessel. Unlike shore based factories and businesses fishing vessels may encounter situations where persons are injured and medical assistance is hours away. Even vessel operators with professionally prepared first aid kits should insure that their vessels are equipped with extra first aid equipment, especially bandages and gauze pads to control serious bleeding.
