# PROCEEDINGS OF THE MERCHANT MARINE COUNCIL

Vol. 13

January 1956

No. 1

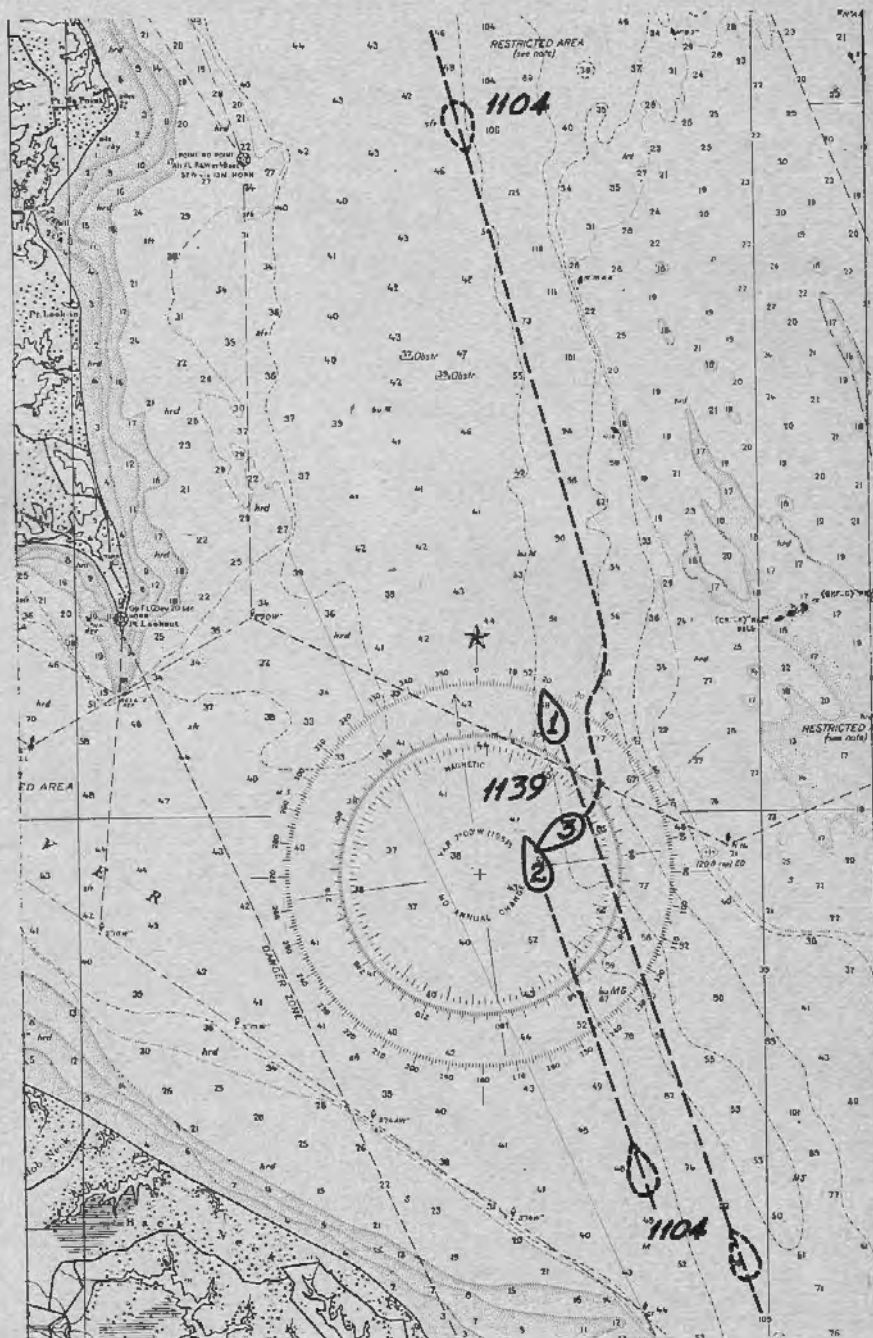
Figure 1. Chart showing Point Lookout vicinity of Chesapeake Bay where collision occurred.

during an actual casualty. A scene from real life is taking place. If we keep our eyes and ears open, we may pick up a few pointers in connection with the use of radar. (See Figure 1.)
