Proceedings

of the Marine Safety Council

Vol. 43, No. 1

January 1986

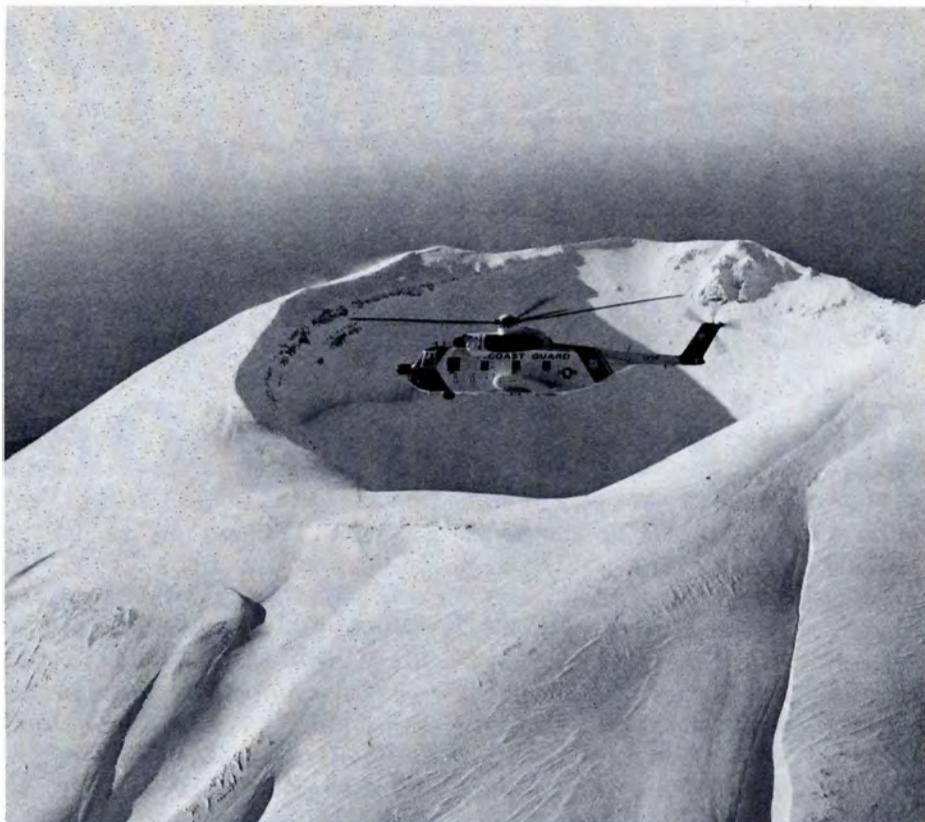
This Coast Guard H-3 helicopter from Sitka, Alaska, searched for the EAGLE's crew. Only one crew member had donned an exposure suit. He was the sole survivor. (Official Coast Guard photo)
