# Proceedings

October 1987

# The Loss of the Pride of Baltimore

CAPT J. C. Maxham and LT W. E. Diaduk

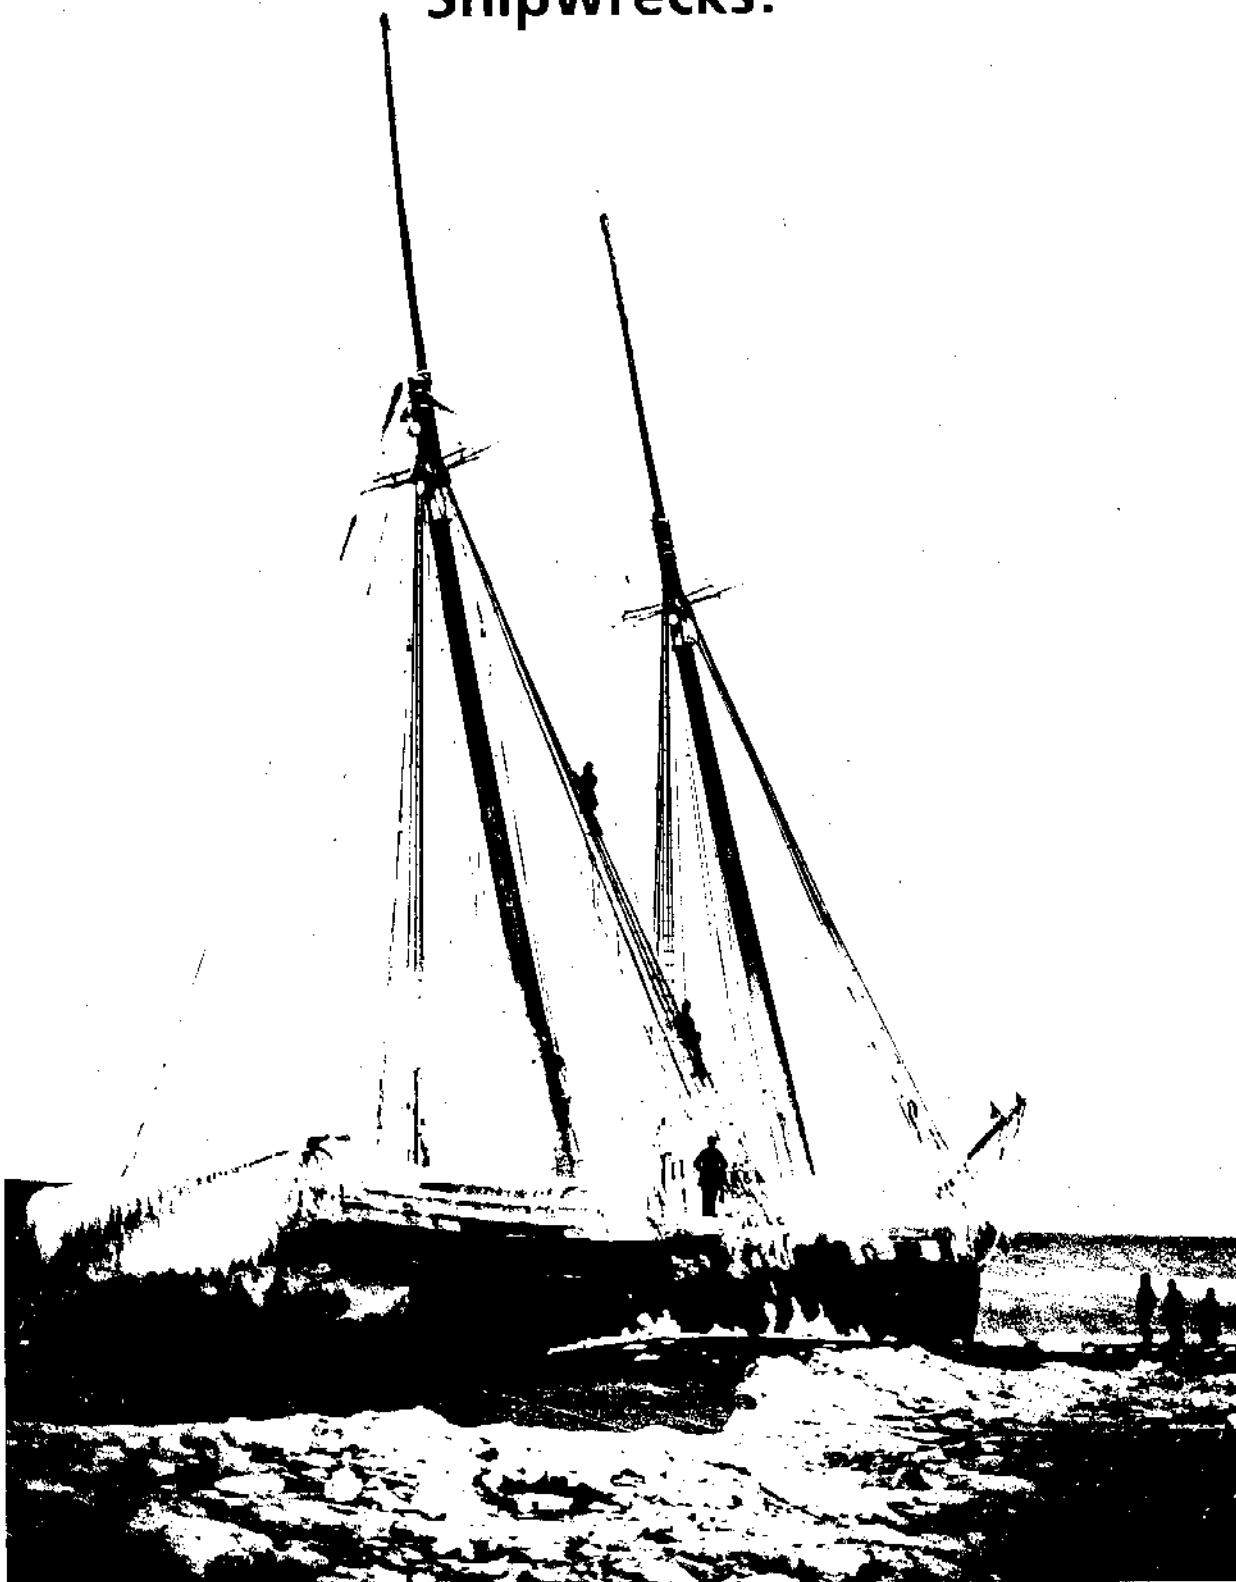
The American schooner John Rommel, Jr. came ashore at Provincetown, Massachusetts, badly iced up, during a storm in February 1875. The 185-ton ship, registered in New Haven, Connecticut, was a total loss. (Photo courtesy of Cape Cod Photos, Orleans, MA, and provided by William P. Quinn)
