Proceedings

Vol. 48, No. 3

May-June 1991

***Special issue
on marine casualty
investigations***

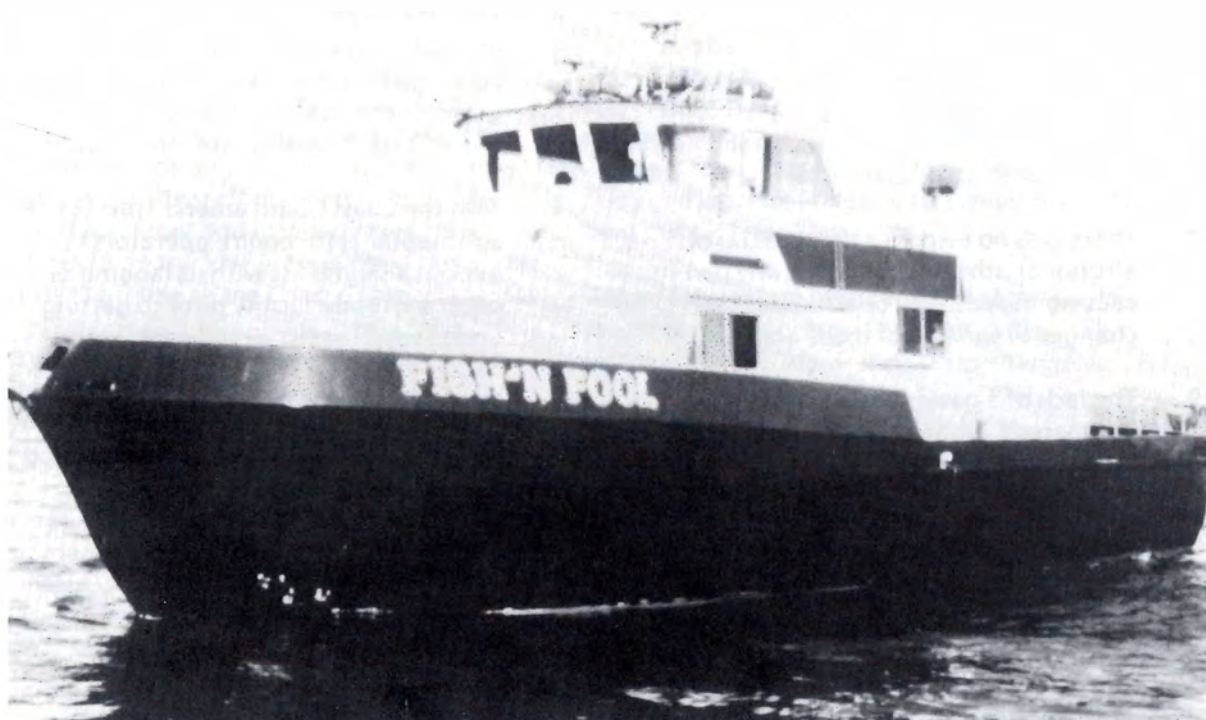
1. The proximate cause of the *Fish-N-Fool* casualty was the operator's positioning of the vessel in close proximity to and down

- swell of Ben's Rock to engage in fishing. This action placed the vessel in such a position that a large swell struck it nearly broadside, imparting enough heeling energy to overcome its inherent dynamic stability, causing it to capsize.
