# *Proceedings*

*of the Marine Safety Council*

*September-October, 1993*

**Special issue on fire protection**

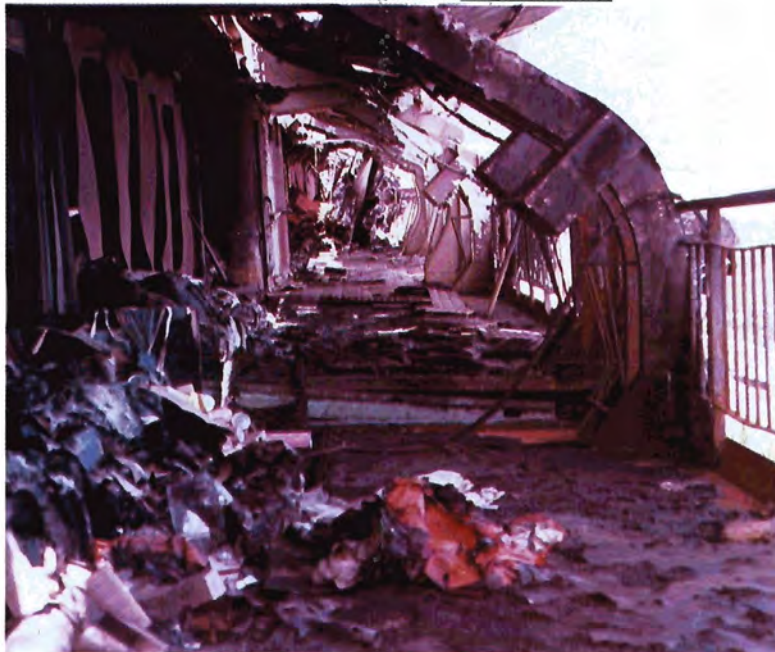
*Fire damage on the Angelina Lauro.*

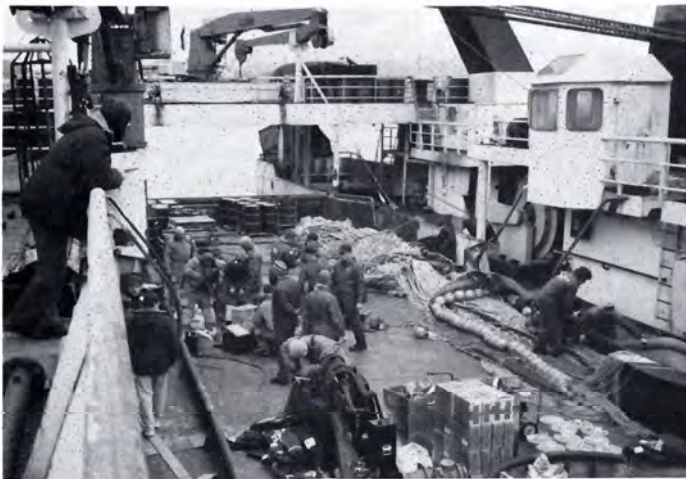
*AFFF containers, foam applicators and blowers litter the well deck of the Sotrudnichestvo.*

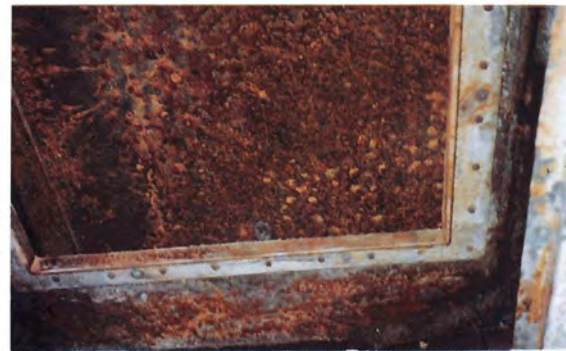
*(Left) Exhaust hood and filter arrangement.*

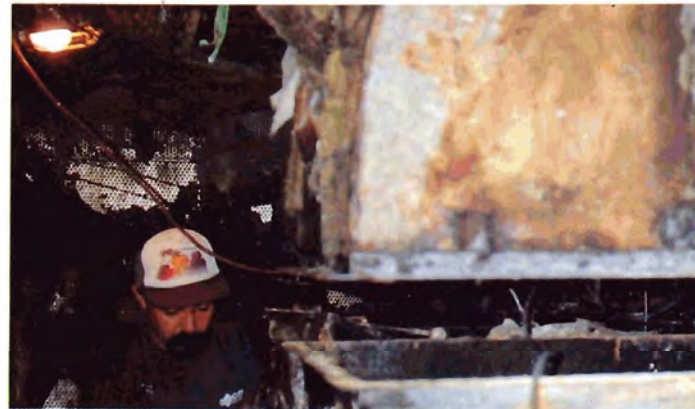
*Canvas ducting burnt away.*

The real weak link in the system was the combustible material used for the vibration dampening joints in the ventilation system. This allowed the fire in the vent ducts to cause considerable damage in the two fan rooms in which they were located. The vessel immediately began replacing all canvas vibration dampening joints with non combustible materials.

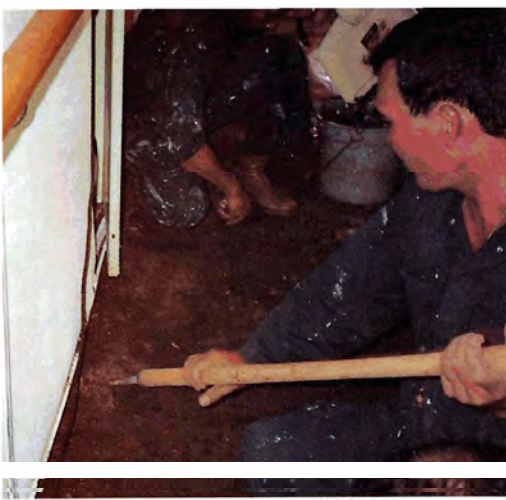
*(Left) Insulation is removed from deck above #4 fan room.*

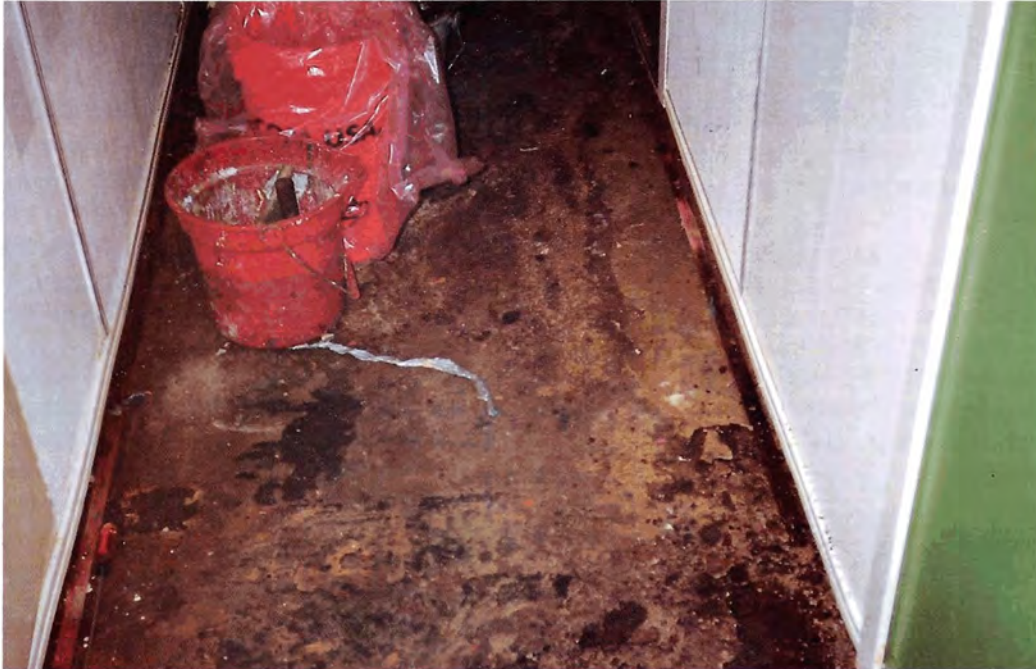
*(Below) Deck above #4 fan room after removal of carpet.*

The crew maintained fire boundaries with lots of water to cool the decks and bulkheads around the two fan rooms. There was only one area where the fire spread into an adjoining space by burning through the carpet in a corridor above the #4 fan room. This was a smoldering fire and was immediately extinguished with continuous cooling from water hoses. (The water collected on the lower deck to about two feet at one point. A bucket brigade removed it successfully with little vessel listing.)
