Summer 2006

The **COAST GUARD** Journal of Safety
& Security at Sea
PROCEEDINGS
of the Marine Safety & Security Council

Lessons Learned
from U.S. Coast Guard
Casualty Investigations

Vol. 63, Number 2

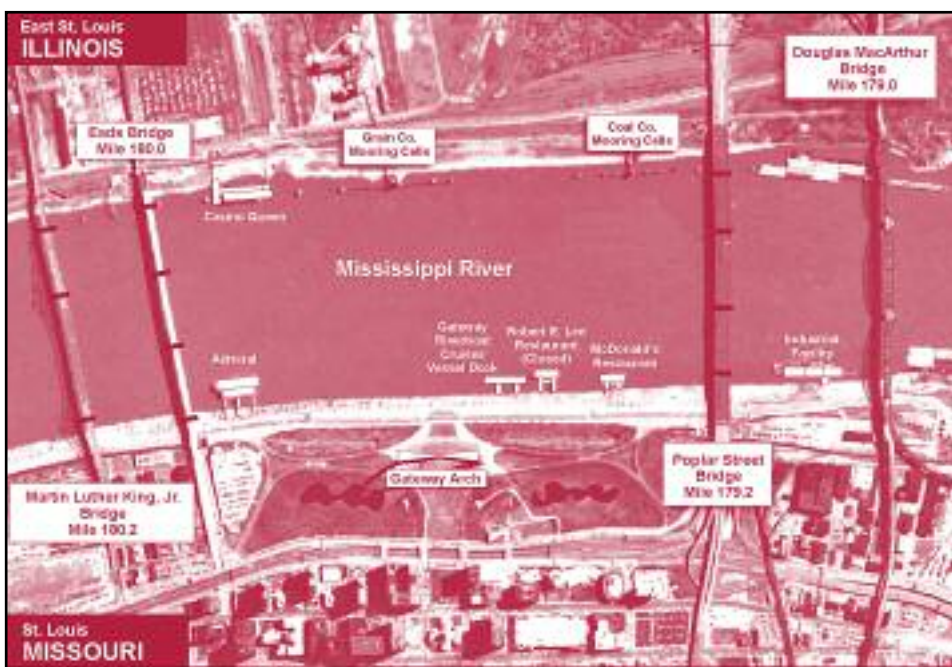
4 Partway under the bridge the vessel stalls, and the current causes the tow to drift sideways, pushing barges into a bridge support and breaking the tow coupling.

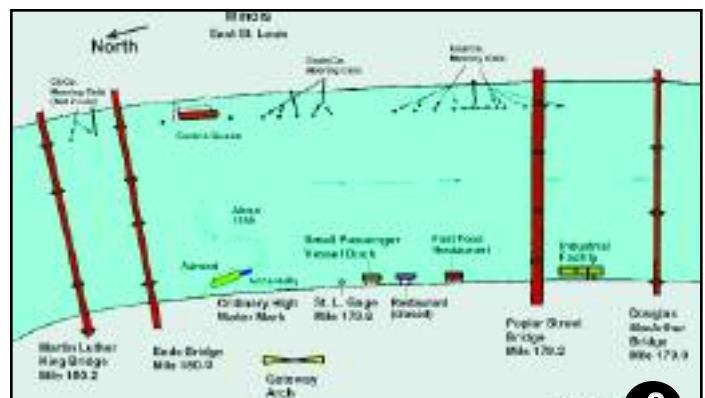
7 The captain releases the remaining barges, turns the towboat around, and places the bow against the *Admiral* as the casino’s next-to-last mooring line parts. Photos courtesy NTSB.

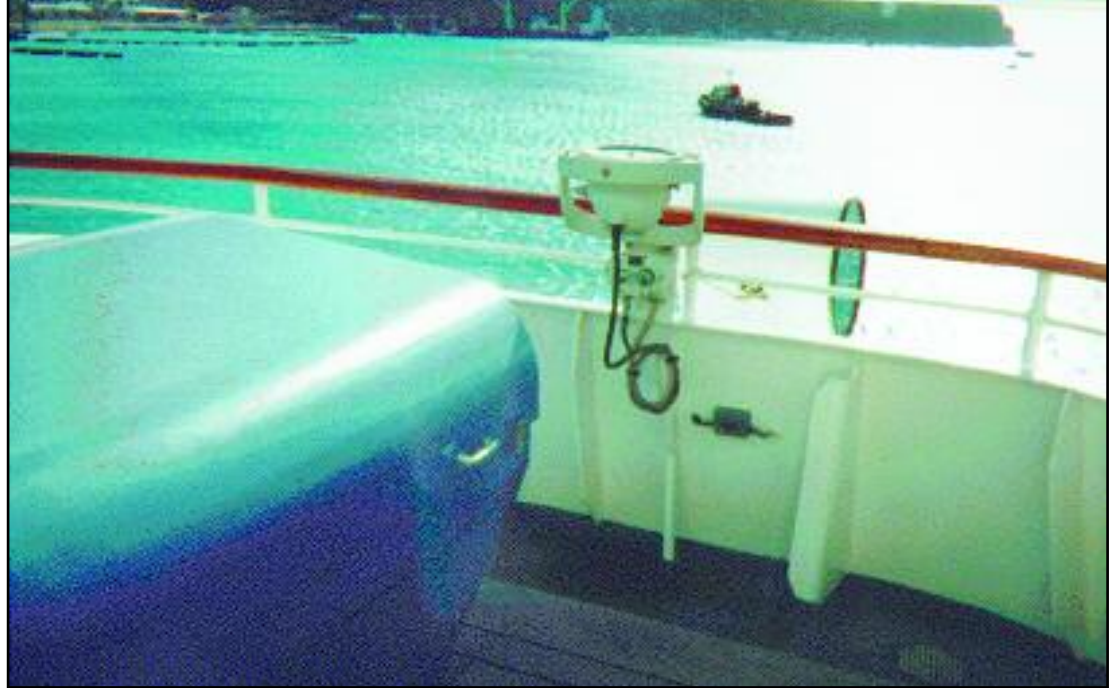
of the azimuth bearing circles on the gyro repeaters (Figure 3), taking several bearings, and then plotting them on a chart. On this vessel, this was made more difficult by the physical layout of the ship. The gyro compass repeaters were blocked by equipment cowlings that allowed only minimal physical clearance. It was no small wonder to the investigators that the navigation watchstander did not use this method to verify the ship's position at any time.

Figure 3: The exterior starboard bridging repeater. USCG photo.

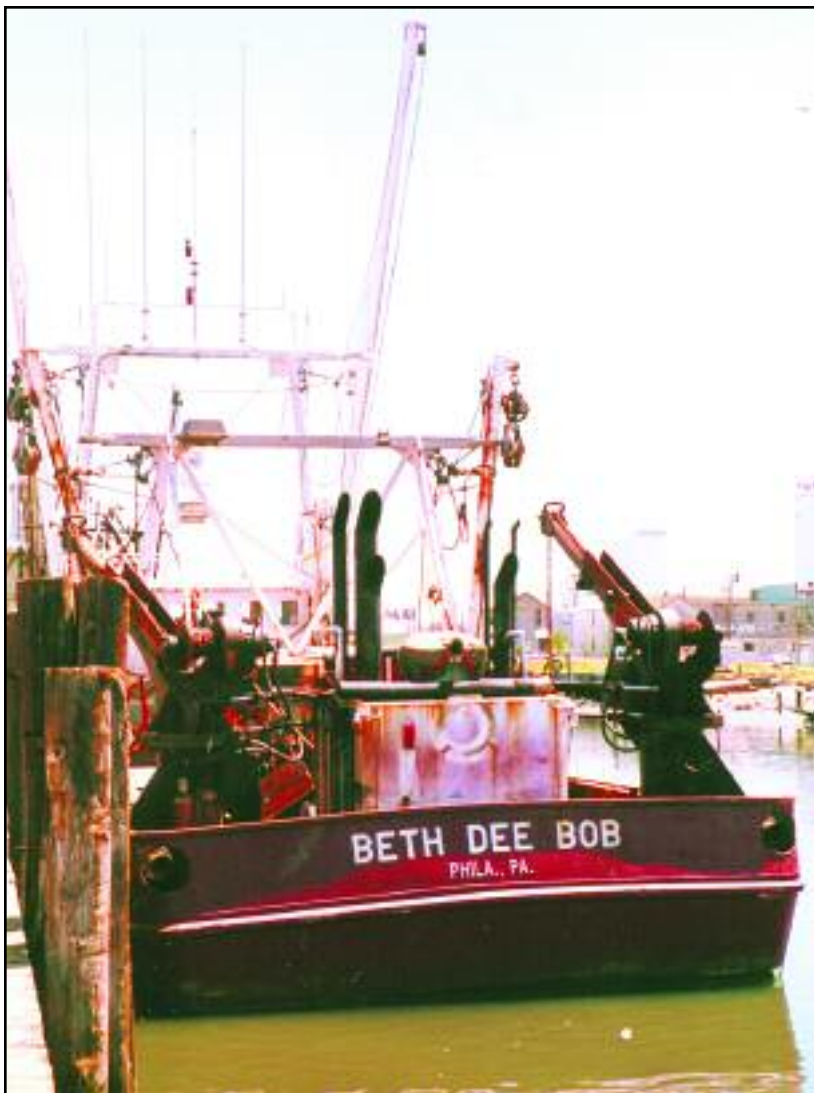
open. Also partly open was a weather-tight door in the port side “dog house.” This structure was the deck access to the engine room. It was partly open to allow an air duct to run from the engine room to the outside for greater ventilation. The sea was getting rough; a storm had moved in faster than the weather forecast had predicted. The vessel was taking water over the bow. The captain was in frequent contact with another fishing boat. It was to this second fishing boat, the *Danielle Maria* that the captain called about 1740 on

Beth Dee Bob stern before refit showing single “dog house.” USCG photo.

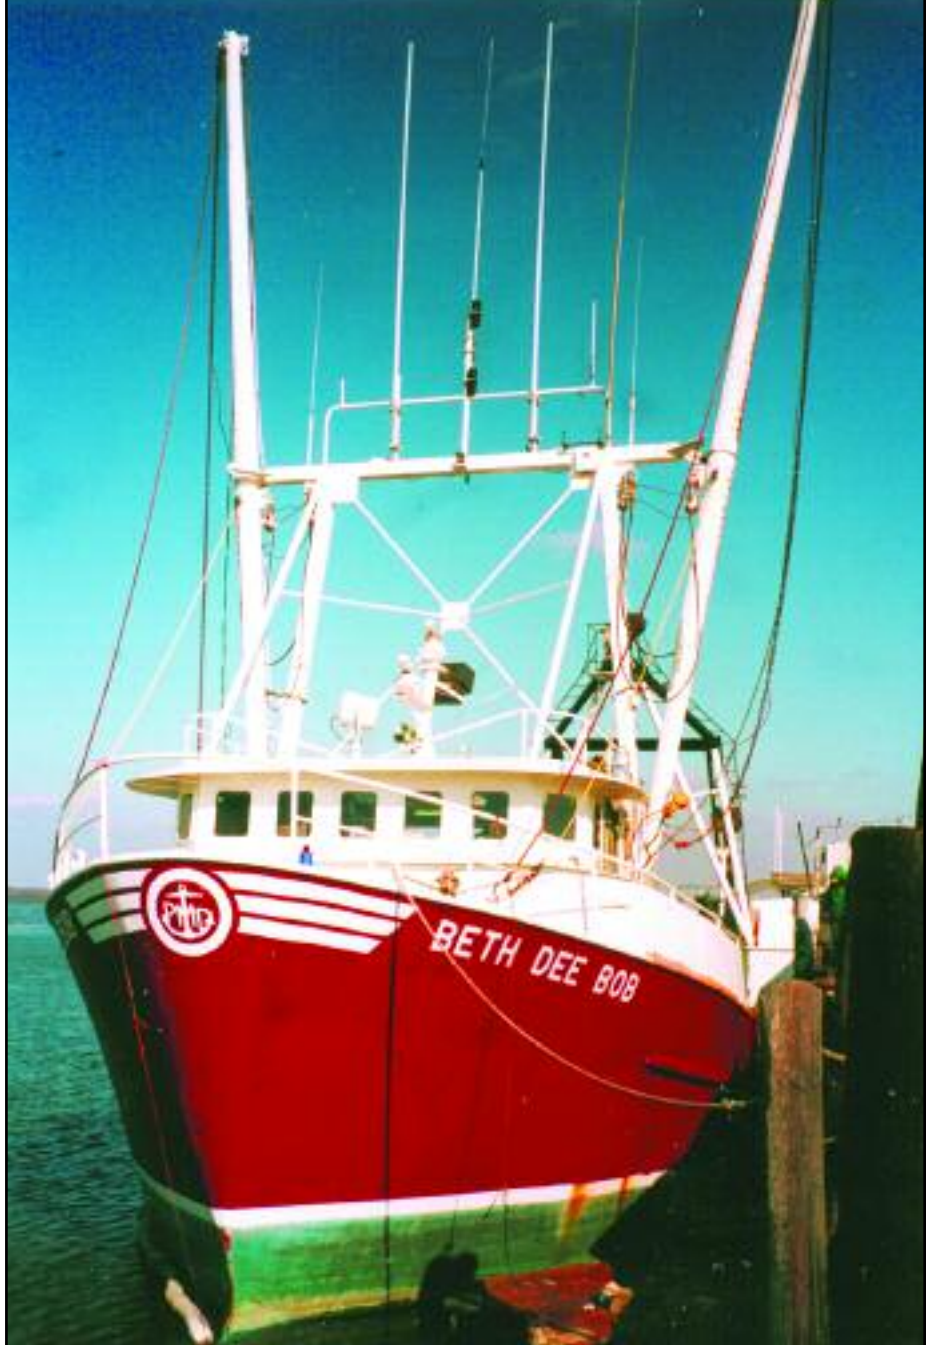
Bow of *Beth Dee Bob* after refit. USCG photo.

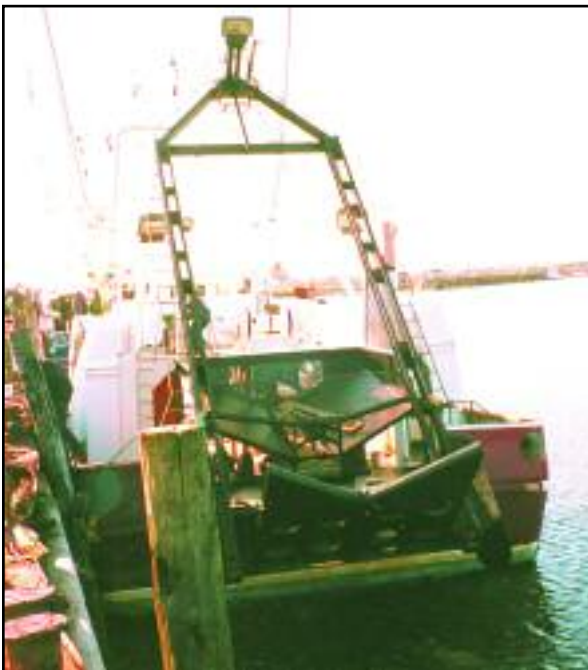
Stern of *Beth Dee Bob* after refit showing the "A" frame and dredge. The two new "dog houses" are visible on either side and in front of the dredge. USCG photo.

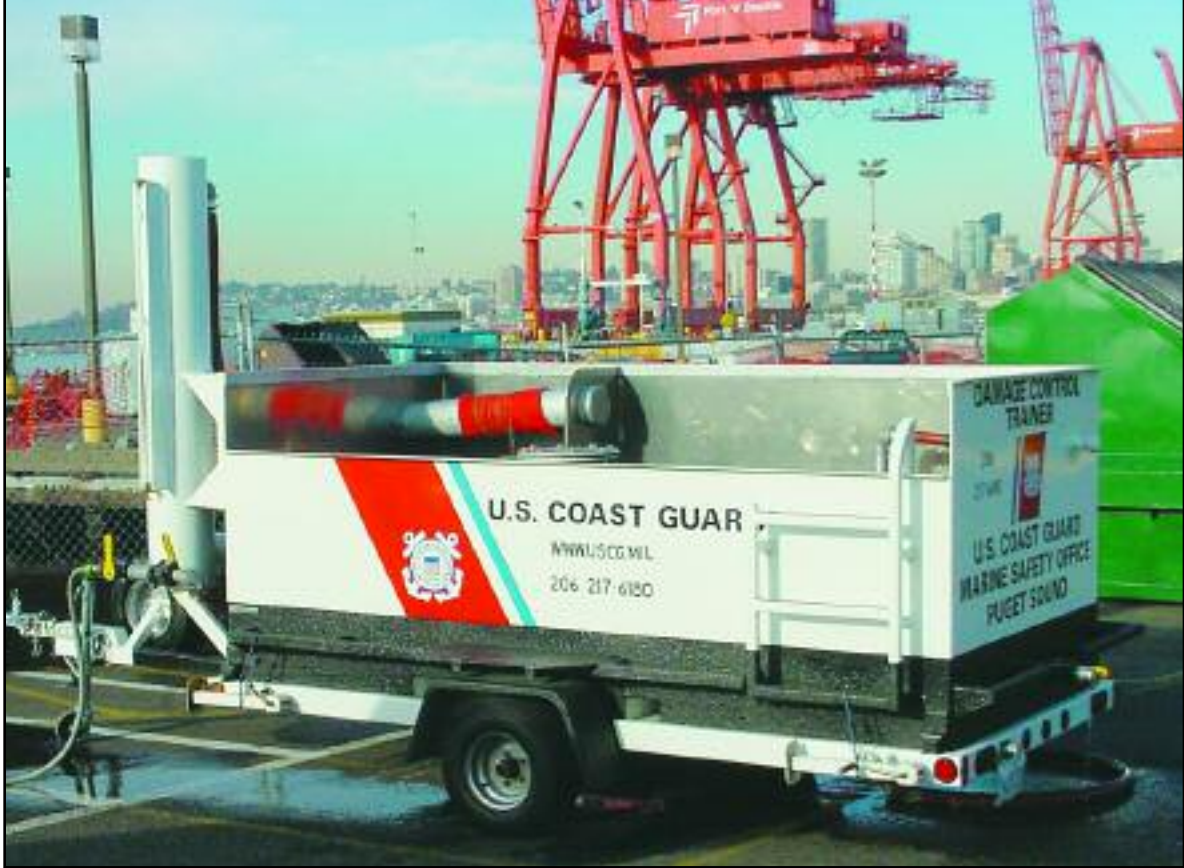
Figure 1: Damage control trainers are used to illustrate damage control procedures and increase awareness of typical flooding risks.

One of the Coast Guard’s efforts involves damage control trainers (Figure 1). These multifaceted trainers are used to show mariners basic damage control procedures and increase their awareness of typical flooding risks. Tools such as the trainer are invaluable, especially considering a recent Coast Guard analysis of fishing vessel casualties that found the leading cause of vessel losses between 1994 and 2004 was flooding.² Knowledge of stability and watertight integrity issues are paramount.
