# United States Coast Guard

**Report of the Investigation into the  
Circumstances Surrounding the Capsize of  
the Liftboat SEACOR POWER (O.N.  
1115290) Approximately 7 Nautical Miles  
South of Port Fourchon, LA in the Gulf of  
Mexico Resulting in the Loss of 13 Lives on  
April 13, 2021.**

**THE CAPSIZING OF THE COMMERCIAL LIFTBOAT SEACOR POWER (O.N. 1115290) RESULTING IN MULTIPLE LOSSES OF LIFE APPROXIMATELY SEVEN NAUTICAL MILE SOUTH OF PORT FOURCHON, LA IN THE GULF OF MEXICO ON APRIL 13, 2021**

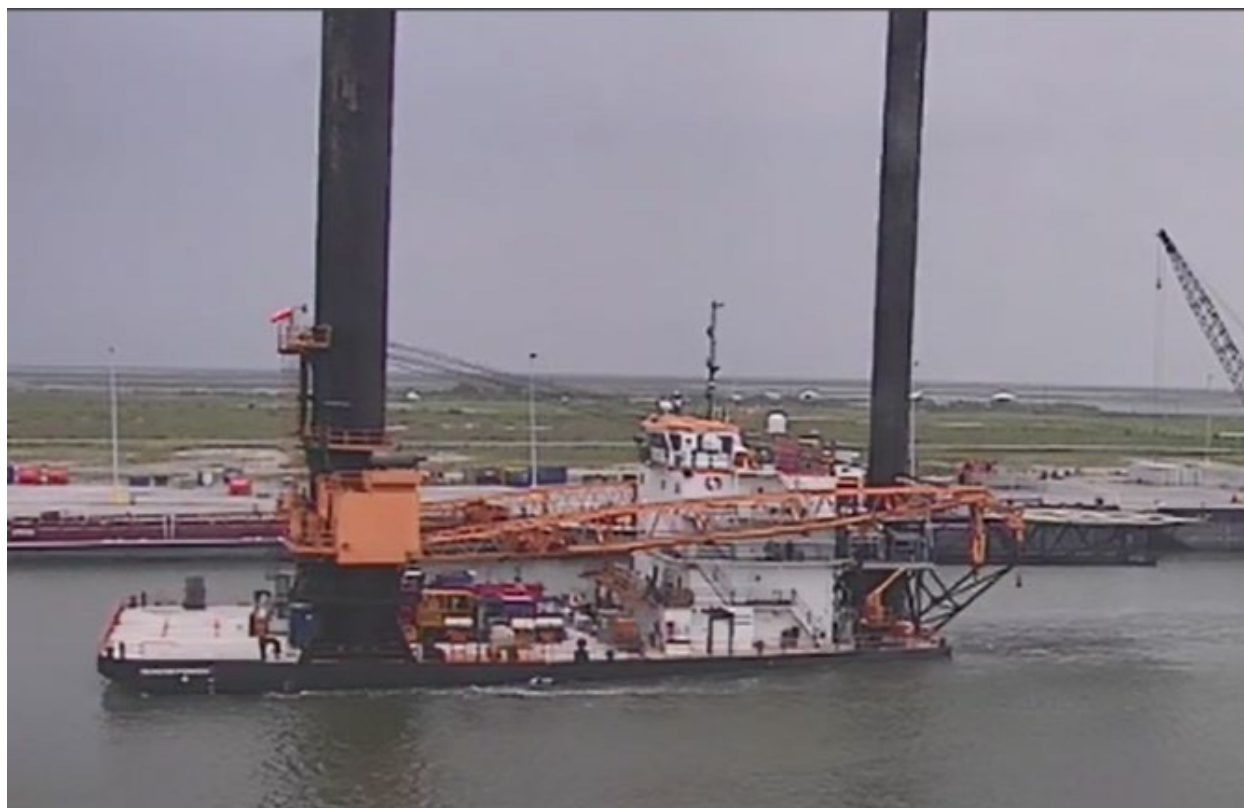
Figure 1: Photograph of SEACOR POWER departing Port Fourchon on April 13, 2021

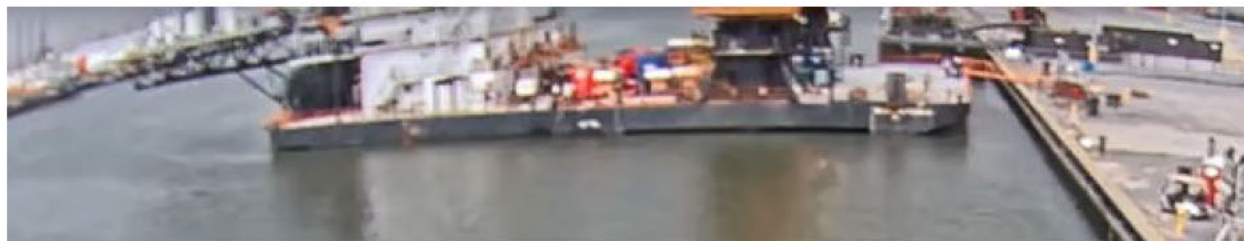
- 8.1.1. In April of 2021, SEACOR POWER was on charter to Talos. On the morning of April 13<sup>th</sup>, the vessel was located at the Bollinger North dock in the Floation Canal in Port Fourchon, LA. The vessel was in port conducting a crew change and loading equipment for a new job located in Main Pass Block Number 138.
- 8.1.2. SEACOR POWER was not tied to the dock; the vessel's three legs were resting on the bottom and the hull was lifted slightly out of the water, with a gangway extending from the bow of the vessel to the dock.

Figure 2: Cropped Image of SEACOR POWER at Bollinger North Dock on April 13, 2021

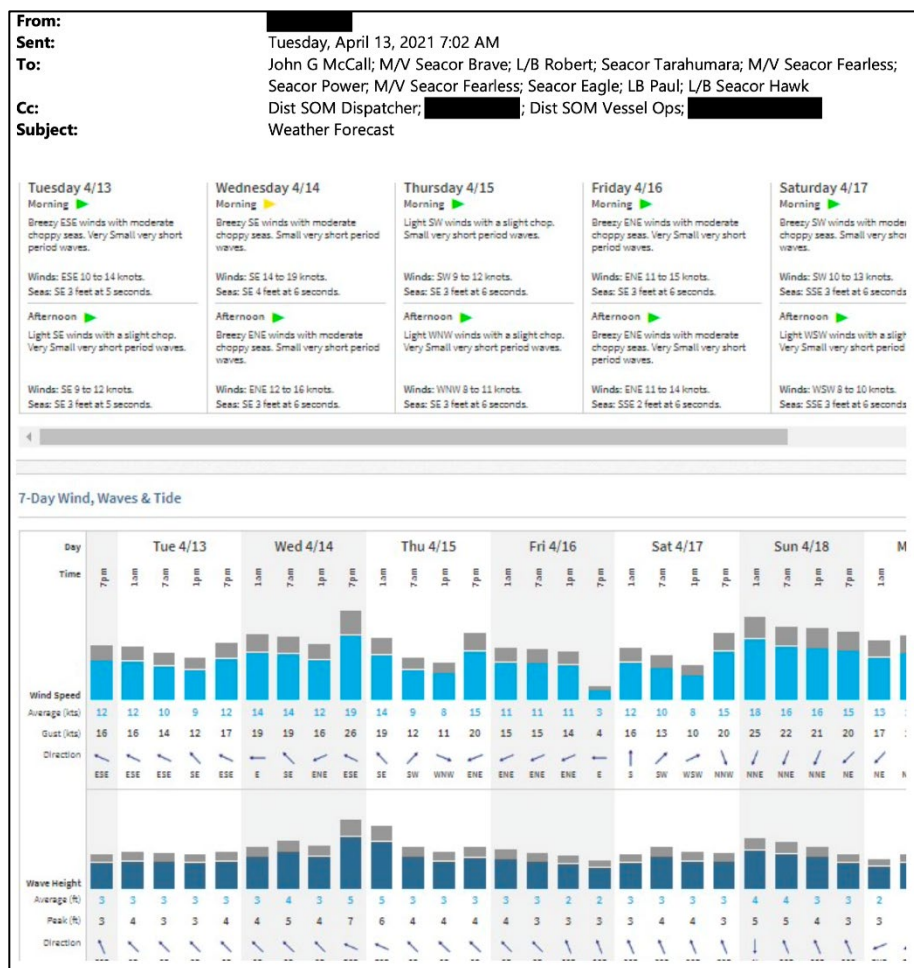
Figure 3: Weather Forecast send on 13 Apr 2021 by Seacor Dispatcher

- 8.1.8. The Seacor Operations Manager spoke with the Master of SEACOR POWER at approximately 0846 and 1033 on the morning of April 13<sup>th</sup>. The Master stated that things were going well. During the 0846 call, they discussed the weather for the mid-point of the vessel's planned trackline between Port Fourchon and Main Pass 138. The forecast for that area was three to four foot seas and 15 to 20 knot winds.

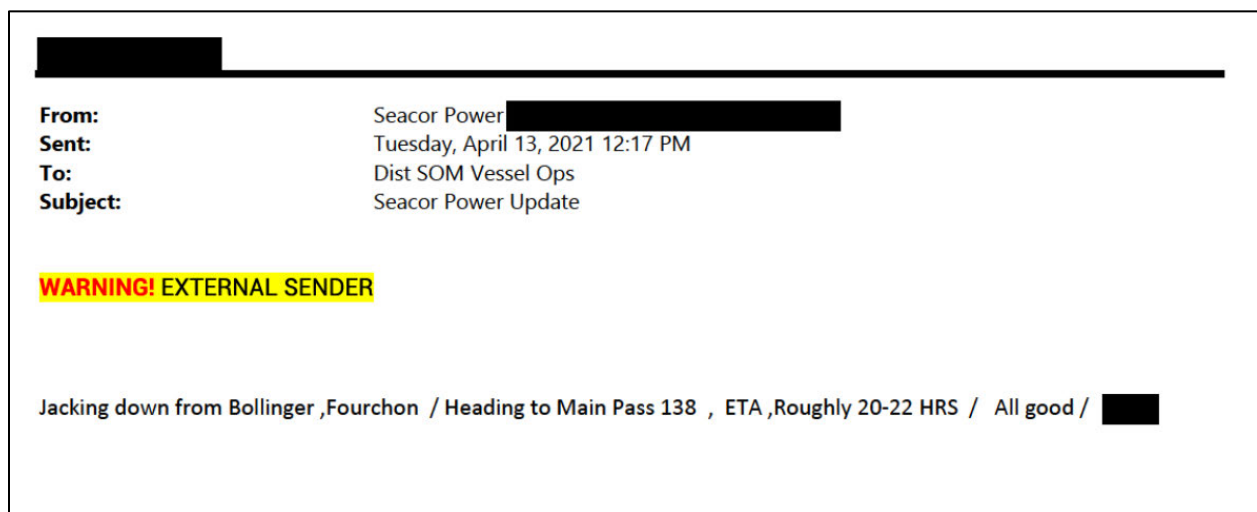
Figure 4: Departure Email from SEACOR POWER Master to Seacor at 1217

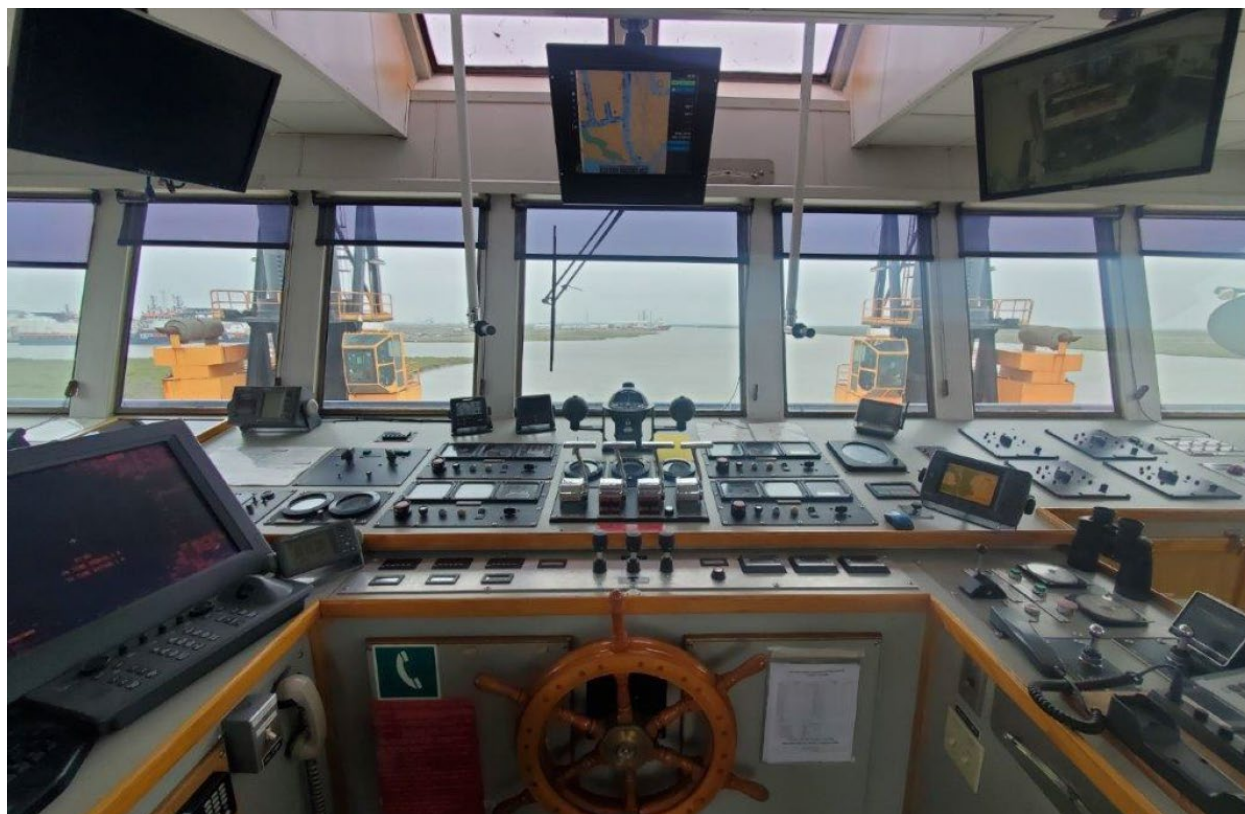
8.1.35. The First Mate observed SEACOR POWER heel 5 degrees to starboard, and he felt like the vessel was "going over." The Master took over at the controls of SEACOR POWER and attempted to steer the vessel back to starboard. The Master used the Gai-tronics public address system to instruct everyone to put on lifejackets. The First Mate activated the vessel's tilt alarm, which was located on the port side of the forward control console.

Figure 10: Wheelhouse Image of SEACOR POWER (from Exhibit 202)

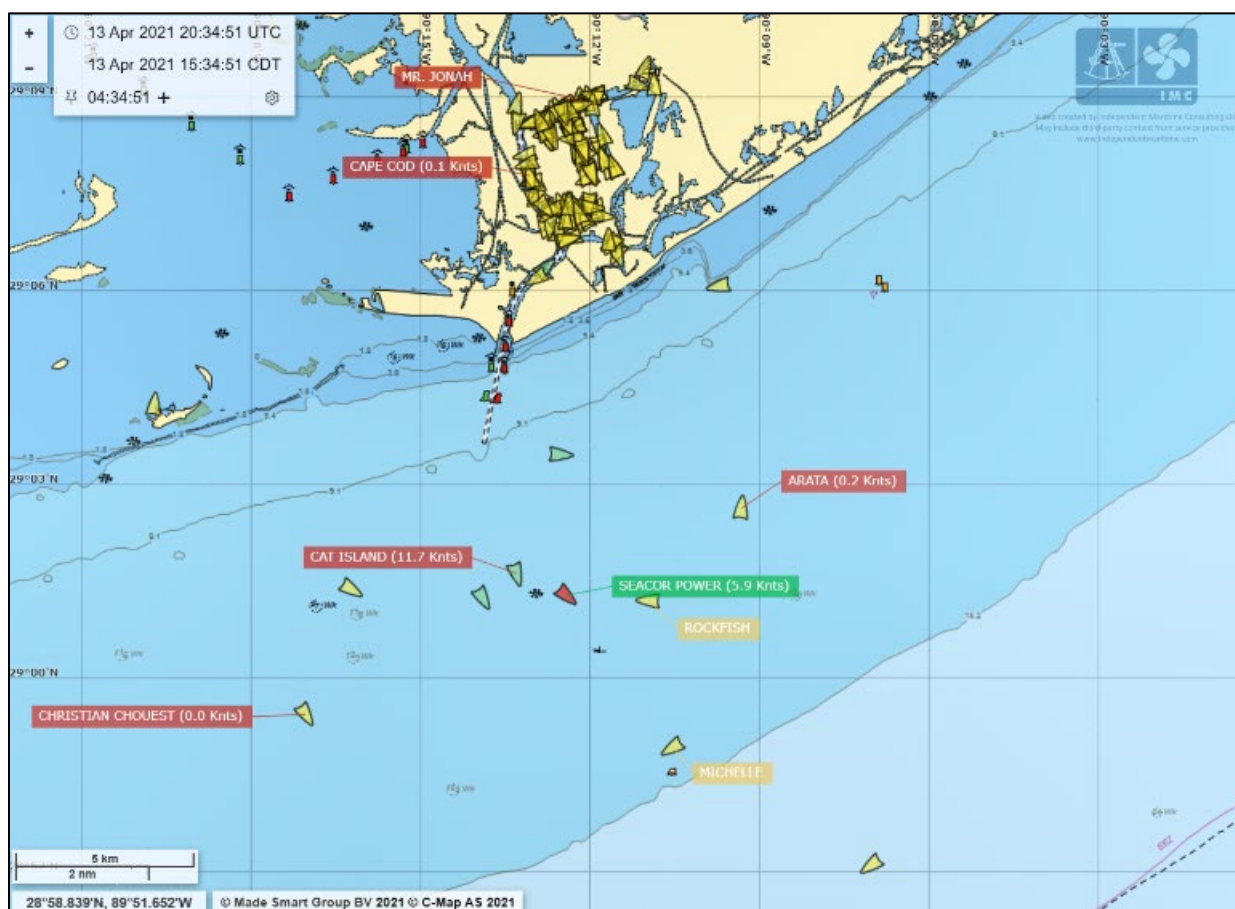
- 8.1.36. At 1537, SEACOR POWER capsized to starboard.<sup>20</sup> The First Mate grabbed onto the port side pilothouse door as the vessel rolled. He saw the Master fall through the starboard pilothouse window. The First Mate attempted to signal distress. He pressed a button on the GMDSS console until he heard an audible beep.
- 8.1.37. Data from the Automatic Identification System (AIS) indicated that at 1537, Fishing Vessel CAPT JACK II was transiting within one nautical mile of SEACOR POWER and Offshore Supply Vessel CAT ISLAND was transiting within 0.5 miles of SEACOR POWER. Liftboat ROCKFISH was jacked up at South Timbalier Block 24, 2.5 miles east of SEACOR POWER. Offshore Supply Vessel CHRISTIAN CHOUEST was located 4.5 miles west of SEACOR POWER.<sup>21</sup>

Figure 11: AIS Image of CAPT JACK II and CAT ISLAND passing near SEACOR POWER during capsizing

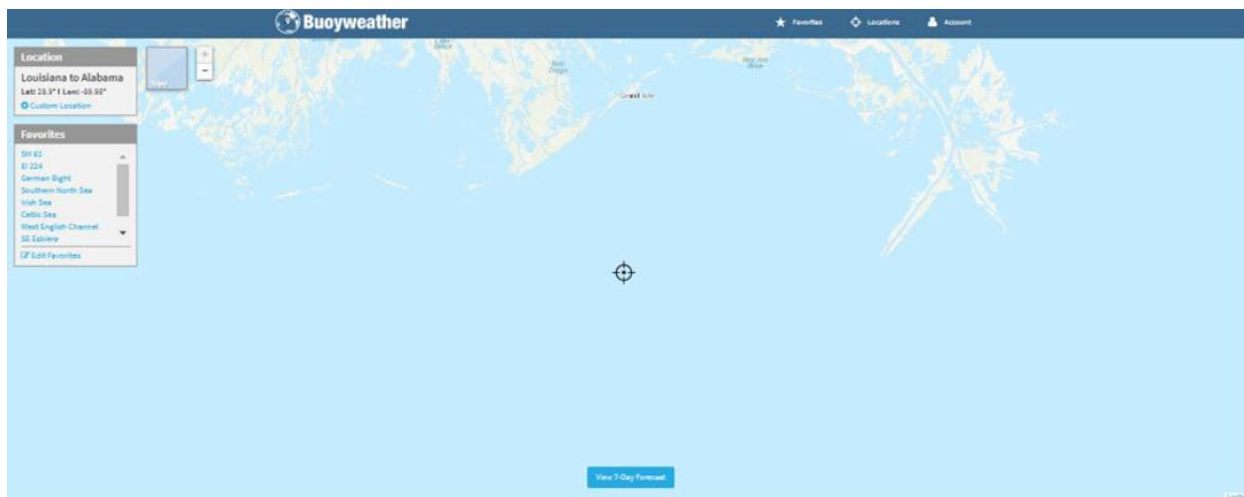
Cat Island Pass, between coordinates 28.91°N and 89.99°W.<sup>156</sup> This weather report was sent out as a general guide for Seacor vessels in that operational area.

Figure 32: Buoy Weather coordinates used by Seacor Dispatcher for weather forecast distributed on April 13, 2021 (Exhibit 203)

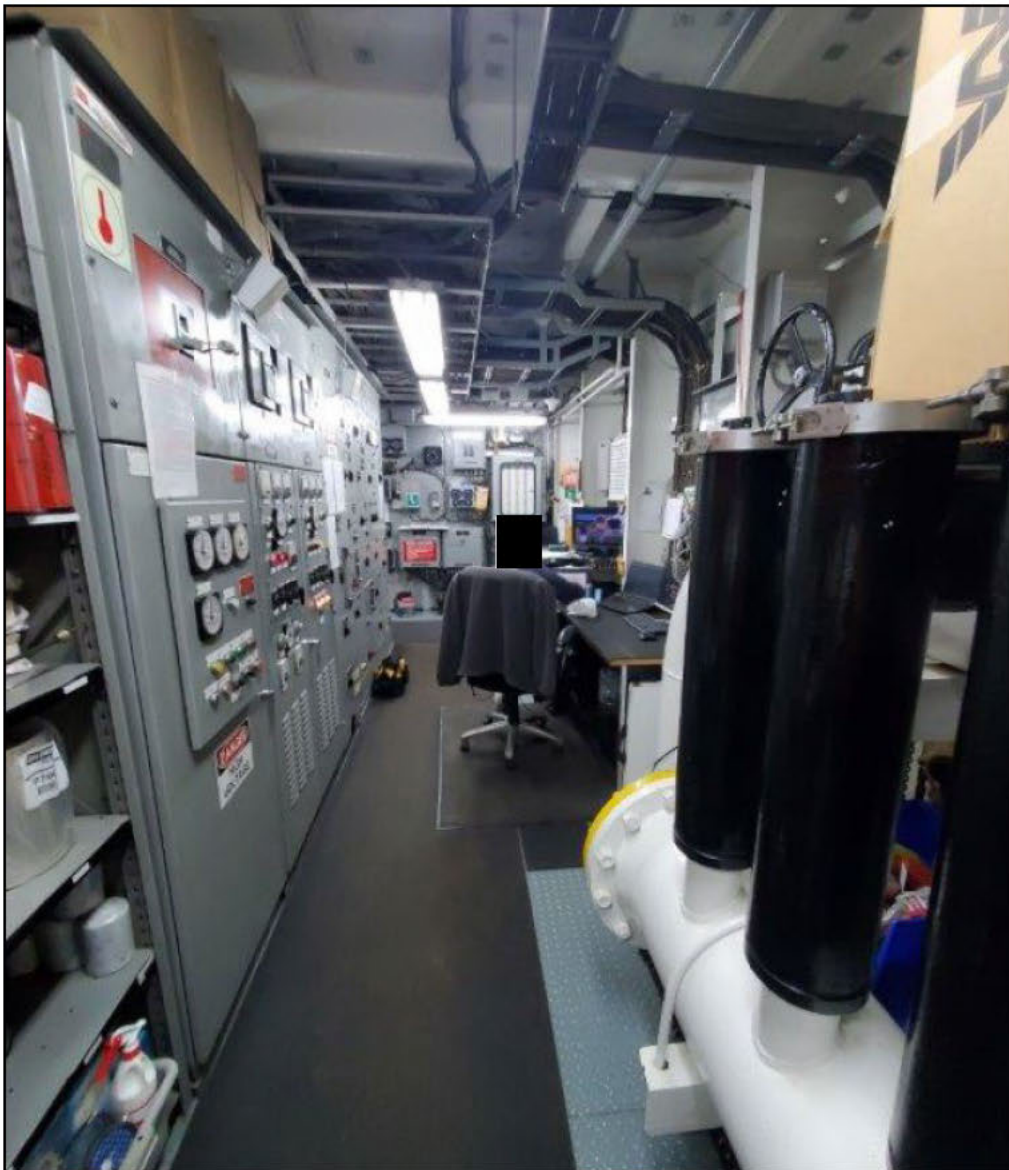
- 8.7.45. The Off-Boat Chief Engineer stated that there were not any alarms to indicate flooding in the legs.
- 8.7.46. The Off-Boat Chief Engineer stated that there were two engine rooms on either side of the vessel, with the control room in the middle. There were watertight doors on each side of the control room. If he left the engine room and went out on deck he would close the watertight door. He said the watertight doors in the engine room had indicator lights on the bridge, and those lights showed whether the doors were open or closed. The First Mate stated the same thing. There were cameras in each engine room, with display monitors on the bridge.

Figure 35: SEACOR POWER Engine Control Room (Exhibit 202)

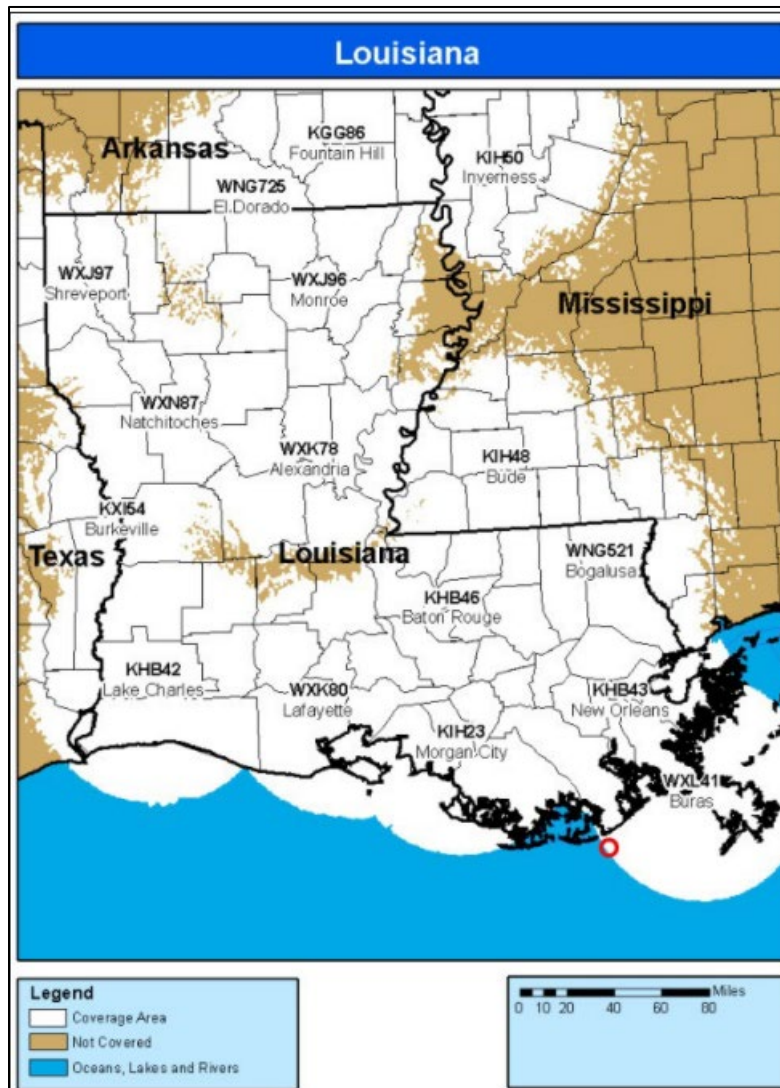
- 8.8.8. When the NWS sends out weather products over NOAA Weather Radio, the messages are sent to transmitters, which then send the messages out over VHF radio. The closest three transmitters to the area of the incident are located in Buras, New Orleans and Morgan City. Each site uses a different radio frequency. Since these are VHF systems, the broadcast range is limited to line of sight (roughly 25 miles offshore).

Figure 37: NWS Weather Radio coverage map

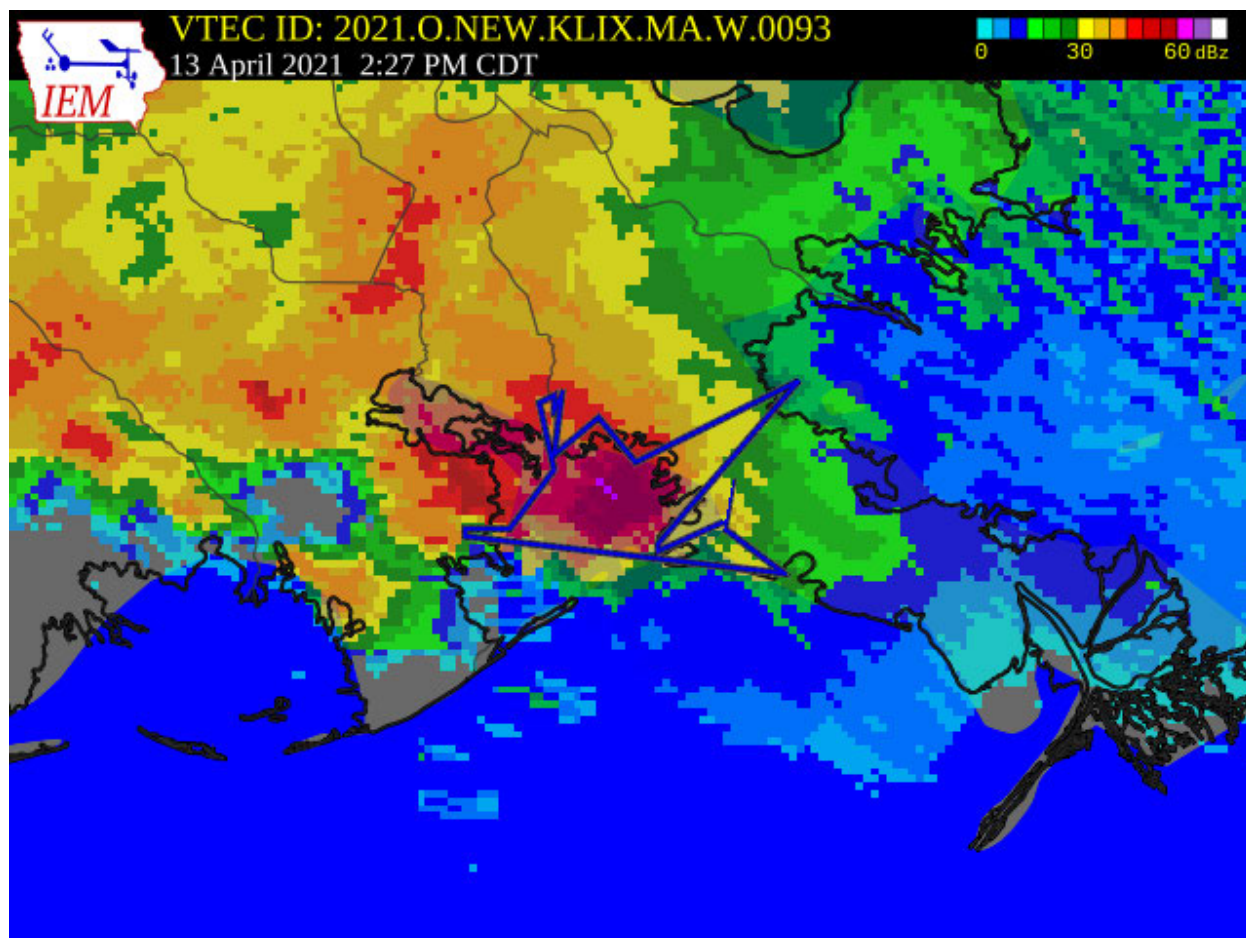
- 8.8.62. At 1427, the NWS issued a Special Marine Warning for Breton Sound, and for coastal waters, from Southwest Pass to Port Fourchon, out to 20 nautical miles. This warning noted a severe thunderstorm was located 9 nautical miles northwest of Barataria Bay (northeast of Port Fourchon), moving east at 15 knots, and impacting Barataria Bay. This did not apply to SEACOR POWER's location or planned trackline. The hazards included wind gusts of 34 knots or greater and large hail.<sup>195</sup> The Lead Forecaster stated that this warning was associated with the line of thunderstorms that was moving south. The warning pertained to the edge of the storm, which was actually moving to the east when the warning was issued. The western part of the storm was not as strong and did not warrant a warning at that time.

Figure 40: Applicable zone for and radar image Special Marine Warning issued at 1427 on April 13, 2021 (not for SEACOR POWER's location or intended location)

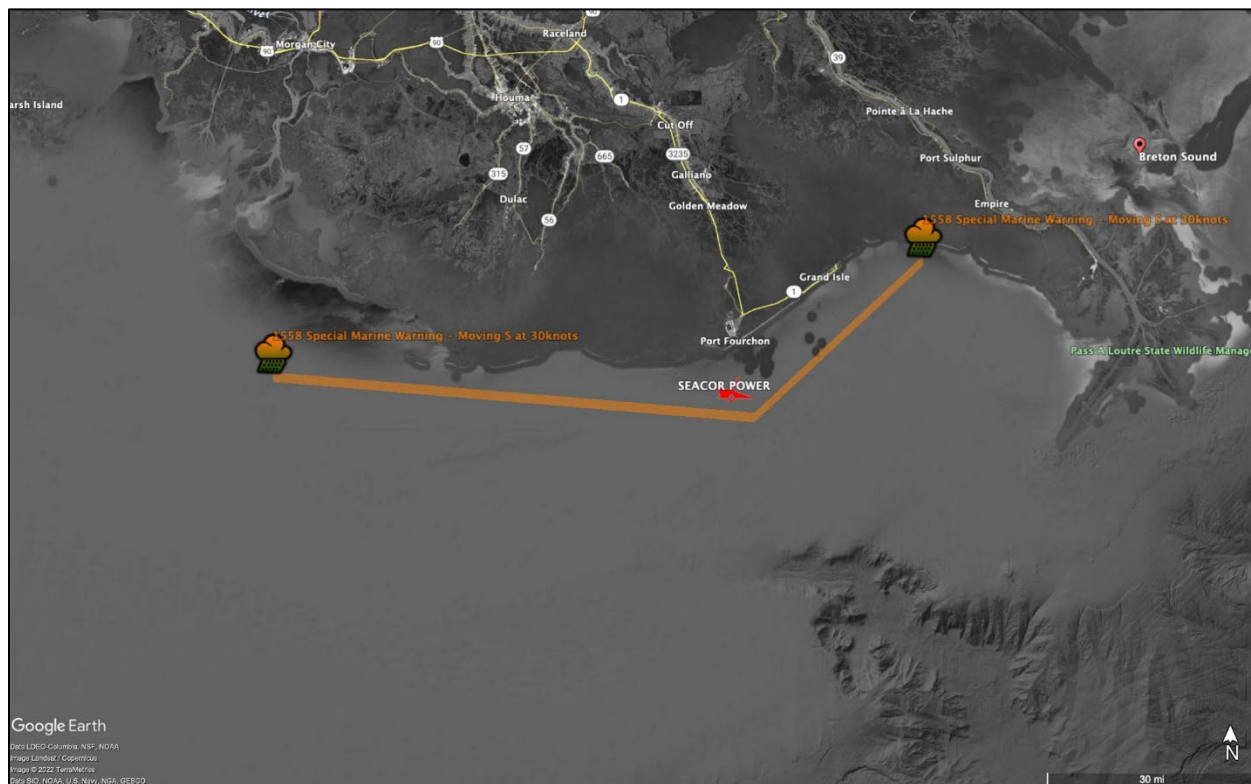
8.8.79. At 1558, the NWS issued a Special Marine Warning for coastal waters, from Southwest Pass to the Atchafalaya River, out to 60 nautical miles. This warning noted strong thunderstorms extending from 10 nautical miles southeast of Barataria Bay, to seven nautical miles northwest of LOOP, to nine nautical miles east of Eugene Island 105, moving south at 30 knots, and impacting the LOOP. This warning noted that the line of thunderstorms had already moved to the south of SEACOR POWER's location. The hazard associated with this line of storms was wind gusts 34 knots or greater.<sup>215</sup>

Figure 44: Plotted line of thunderstorms from NWS Special Marine Warning at 1558 showing the line south of SEACOR POWER

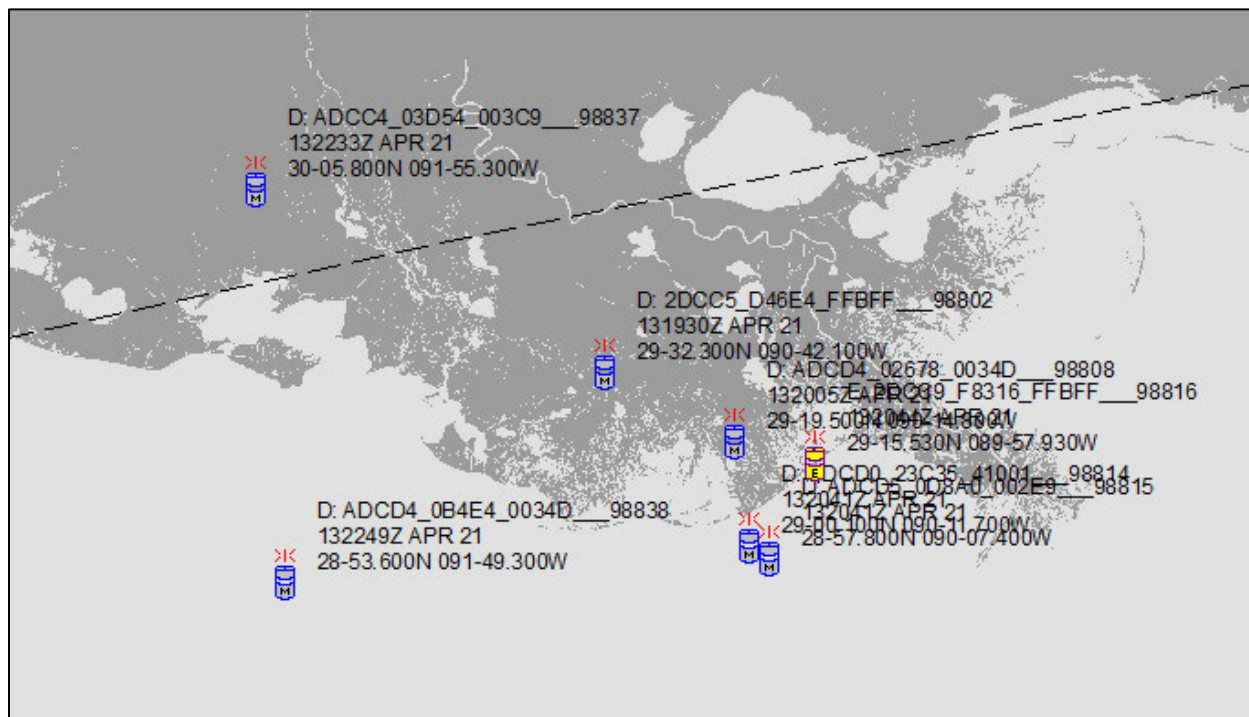
Figure 51: EPIRB Alerts received by Coast Guard District 8 on April 13, 2021

8.10.68. At 1540, Low Earth Orbit (LEO) Satellite G16 received a transmission from SEACOR POWER's Emergency Position Indicating Radio Beacon (EPIRB). This was the first EPIRB alert for SEACOR POWER, and it did not include position information. The U.S. Mission Control Center (USMCC) sent the transmission information to the Coast Guard's District Eight Command Center in New Orleans at 1542. The District Eight CDO stated that the EPIRB alert was sent to District Eight based on the location of the EPIRB registration information.<sup>257</sup>
