UNITED STATES COAST GUARD

MARINE SAFETY ALERT

Safety Alert 01-26

INCORRECT ALLOY FOR VALVE MOUNTING STUDS PRESENTS FAILURE HAZARD

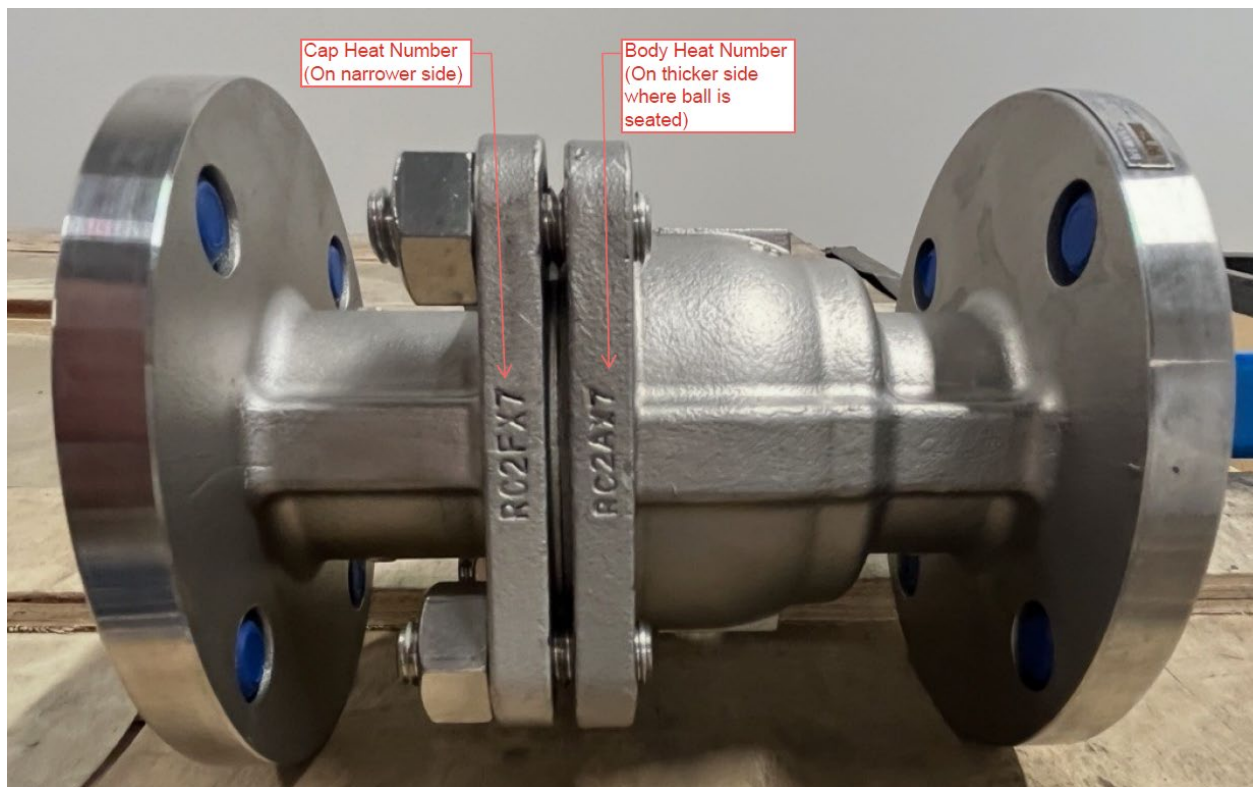
Figure 2

Below is an example of the body and cap heat number locations. Please note the valve in the picture is **not** an affected valve and only attached for illustrative purposes (see Figure 2).
