**REPORT OF THE INVESTIGATION INTO THE SINKING
AND LOSS OF LIFE ONBOARD THE
COMMERCIAL FISHING VESSEL (CFV)
CONCH'RD (NJ8244GN), APPROX. 15 MILES
EAST OF CAPE MAY, NEW JERSEY, ON
DECEMBER 03, 2020**

**CAPSIZING AND SINKING OF THE COMMERCIAL FISHING VESSEL CONCH'RD
(NJ8244GN) AND SUBSEQUENT LOSS OF ONE LIFE WHILE FISHING IN THE
ATLANTIC OCEAN APPROXIMATELY 15 NAUTICAL MILES NORTHEAST OF
CAPE MAY, NEW JERSEY ON DECEMBER 3, 2020**

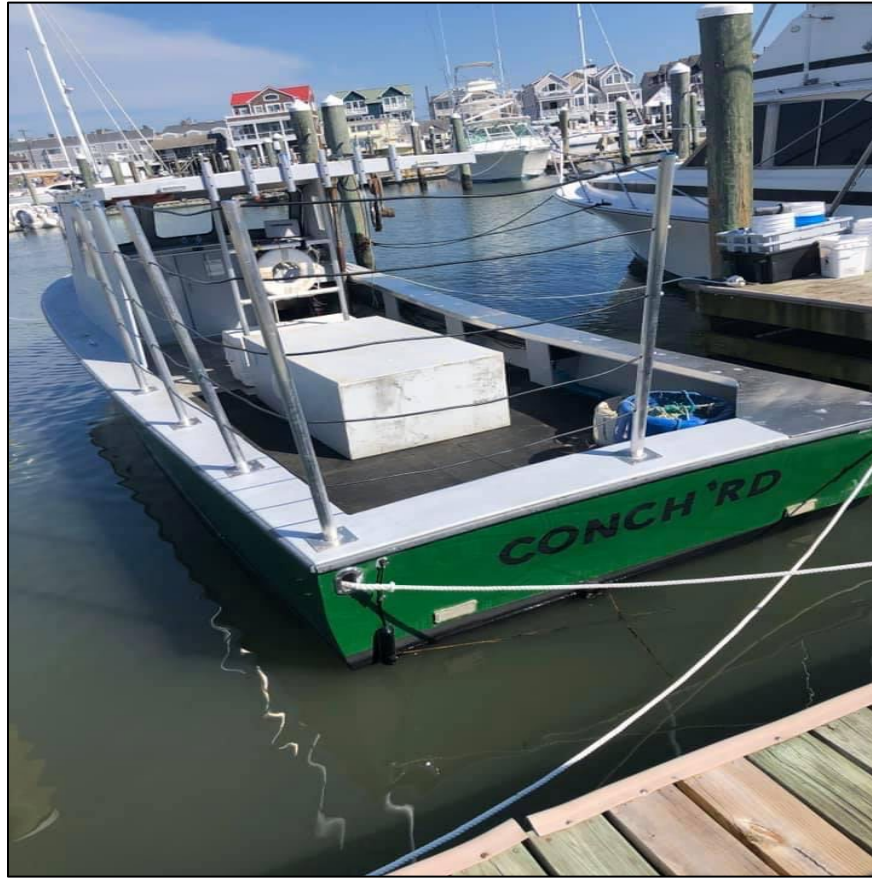
Figure 1. Photograph of the CONCH'RD provided by owner January 05, 2021.

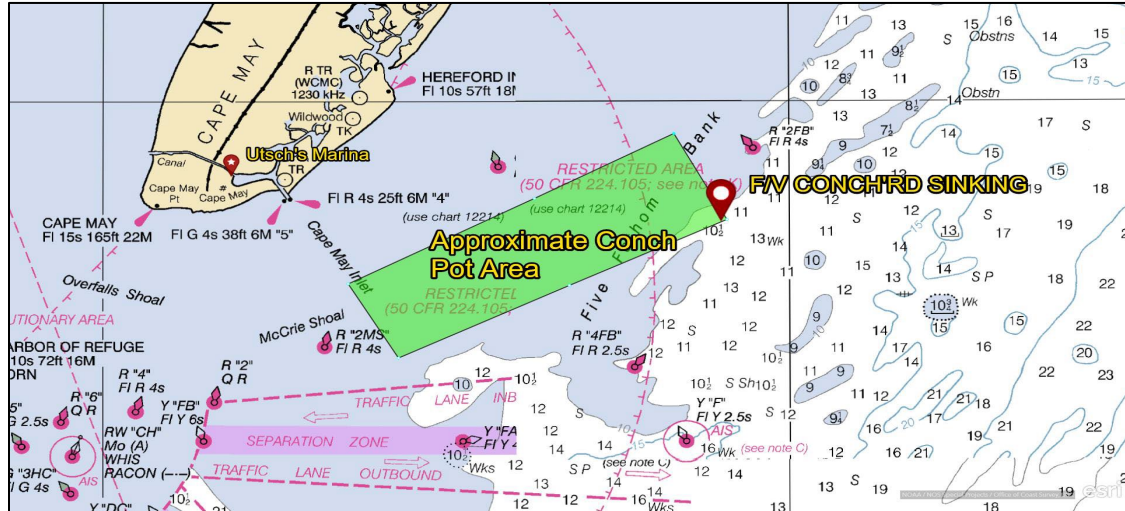
4.1.19. At 1309, on December 03, 2020, the CONCH'RD capsized in the North Atlantic Ocean in the vicinity of position 38-55.692N and 074-36.560W. The vessel's inflatable life raft that was mounted on top of the superstructure was not deployed by the owner/operator or decedent.

Figure 3. Location of CONCH'RD sinking in relation to approximate conch pot fishing area.

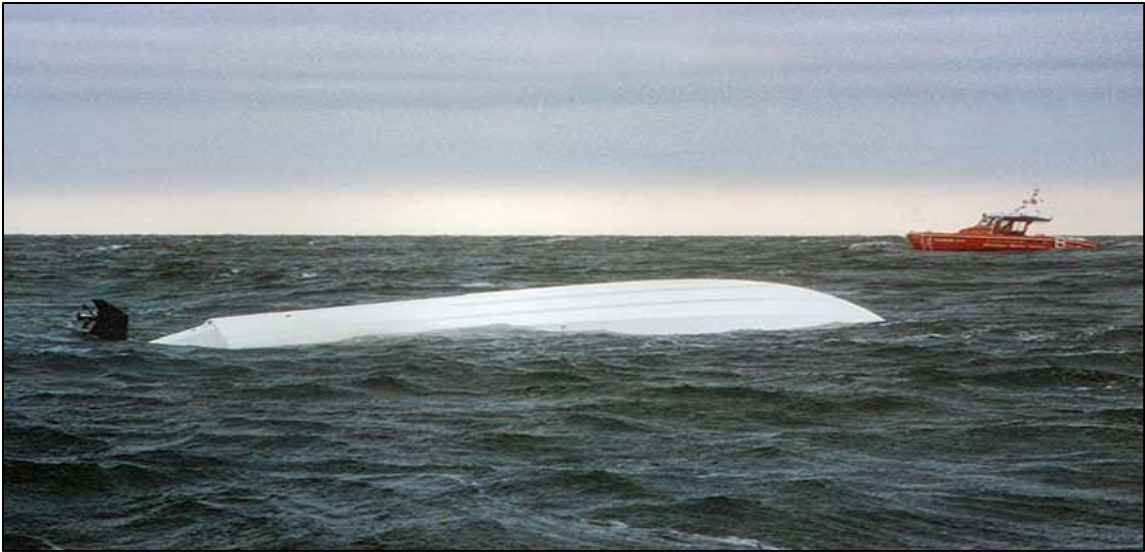
4.1.20. At 1310, the owner operator/observed the decedent climb up on top of the vessel's bottom that was now exposed above the waterline and facing upward. The superstructure and deck of the vessel was now partially submerged below the waterline. The decedent was not observed wearing a PFD or immersion suit.

Figure 4. Image of a capsized vessel taken from the internet which illustrates the position the subject vessel was believed to be in when it initially capsized.

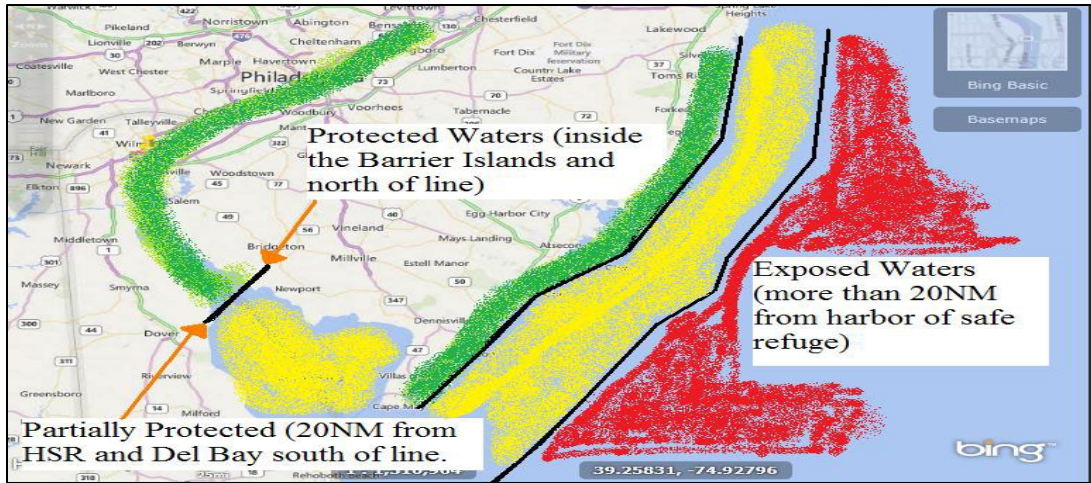
5.2.3. The CONCH'RD had two freeing ports (see figure 7) that measured approximately 8" long by approximately 2"-3" high. This provides for approximately 48 in² of drainage and is suitable only for protected waters. Protected waters are defined by Sector Delaware Bay's OCMI as "all waters inside the Barrier Islands from Shark River Inlet, New Jersey to Cape May, New Jersey from Cape Henlopen, DE. south to the MD/DE line." At the time of the sinking, the CONCH'RD was approximately 15 miles off the coast of Cape May, which would be considered partially protected waters and just 5 miles from fully exposed waters.

Figure 11. Colored chart of Protected Waters (green), Partially Protected Waters (yellow), and Exposed Waters (red) as defined in Sector Del Bay OCMI Policy.

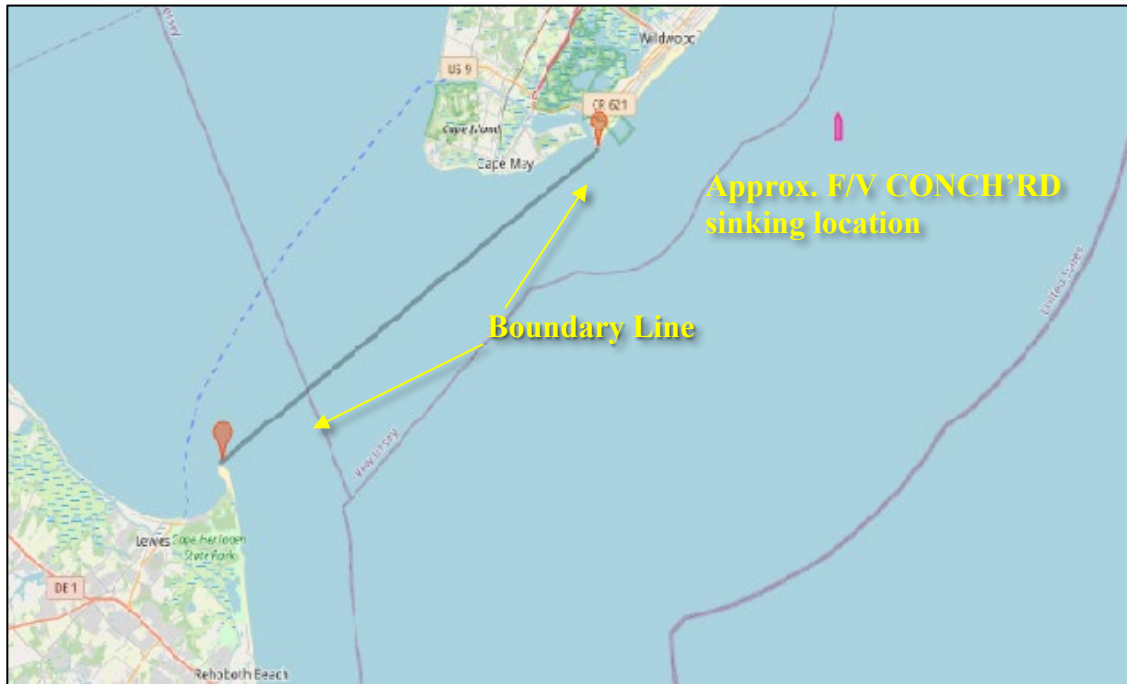
ensure drills were conducted and safety instruction was provided to crewmembers even though the vessel operated outside the “boundary line” (see figure 12). The investigation revealed that the owner/operator was generally unaware that his commercial fishing vessel was required to have a mandatory safety exam. Based on the owner’s own admittance that he was lacking in knowledge of commercial fishing vessel safety requirements, it is unlikely that he would have scheduled a Fishing Vessel Drill Conductor to conduct drills and training even if emergency drills and safety instructions were mandatory for commercial fishing vessels less than five net tons. Conducting drills or instruction of any nature and being more aware of the regulatory requirements for commercial fishing vessels may have better prepared him and the decedent for an emergency abandon ship situation.

Figure 12. Overview of COTP Delaware Bay “Boundary Line” as defined by 46 CFR Part 7.

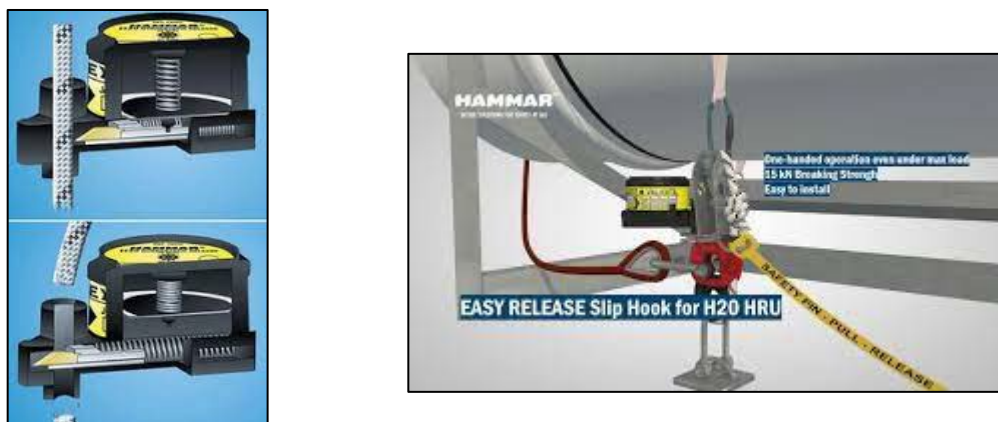
5.6.1. The investigation revealed that the vessel’s inflatable life raft did not deploy until approximately four hours after the vessel initially capsized. The decedent indicated to the owner/operator that he was going to attempt to manually launch the life raft after the vessel capsized by trying to swim underwater, locate the inflatable life raft and then manually deploy it. The investigation did not reveal if the decedent was able to locate the raft and/or make any physical attempt to deploy the raft. It could not be determined if the decedent had any success locating the raft or if his actions had any positive or negative impact on raft deployment. Interviews were conducted with the life raft manufacturer REVERE and the hydrostatic release unit (HRU) manufacturer Hammar. A technical specialist from Hammar stated that the HRU’s are designed to automatically activate when the appropriate water pressure is reached. This usually occurs when the HRU is submerged to a depth of 1.4 to 5 meters (approximately 5’ – 13’). The water pressure releases the blade in the HRU and cuts the life raft line attached from the cradle where the inflatable life raft would typically rise to the surface. As the container rises to

Figure 13. Image of a typical Hammar inflatable life raft hydrostatic release installation (left). Image of the inside of a hydrostatic release unit with blade cutting painter (right).

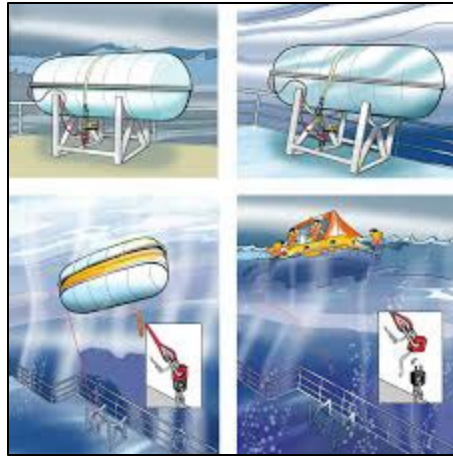
5.6.2. The representative from Hammar stated that when a vessel capsizes, it can be difficult for the HRU to reach the appropriate depth initially. Hammar also indicated that a raft will often fully deploy but can sometimes get caught underneath a vessel if it capsizes. This depends on the original location of the raft, which is often above the weather deck on most vessels. The inflatable raft onboard the CONCH'RD was located on top of the vessel's pilot house, which is above the weather deck. The raft was later observed by USCG Air Station Atlantic City fully deployed approximately four hours after the incident. The investigation could not determine if the following factors had any impact on the delay in deployment of the inflatable life raft:

- 1) The raft deployed, but was trapped underneath the capsized vessel;
- 2) The raft deployed, but became entangled by the excessive amount of pot buoys and line that surrounded the capsized vessel; or,
- 3) The raft deployed approximately four hours later when the capsized vessel reached the appropriate water depth.

Figure 14. Image of example inflatable life raft release from a sinking vessel

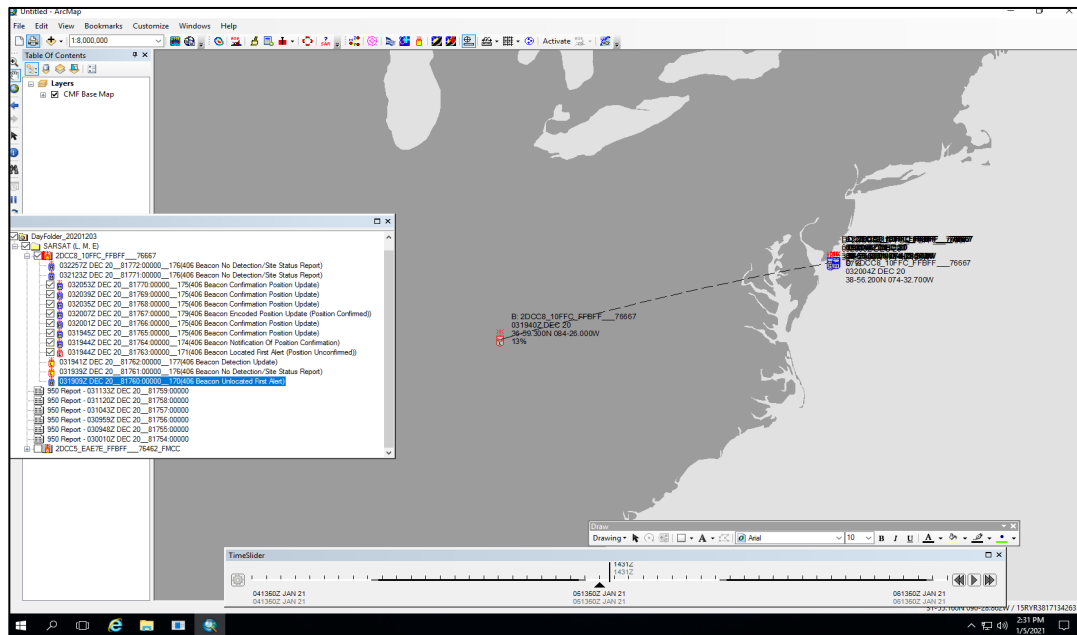
Figure 16. Image showing EPIRB satellite location GPS position transmission for the CONCH'RD and times of each transmission. Image taken from CG SAR
