# UNITED STATES COAST GUARD

**REPORT OF INVESTIGATION  
INTO THE  
FIRE THAT OCCURRED ONBOARD  
*CUYAHOGA* (O.N. 243772)  
ON MARCH 15, 2024, WHILE MOORED AT KINDER  
MORGAN PINNEY DOCK IN ASHTABULA, OHIO**

**FIRE ON BOARD THE CANADIAN FLAGGED BULK CARRIER CUYAHOGA  
(IMO# 5166392) RESULTING IN THE TOTAL CONSTRUCTIVE LOSS OF THE  
VESSEL WHILE MOORED AT THE KINDER MORGAN PINNEY DOCK IN  
ASHTABULA, OHIO ON MARCH 15, 2024**

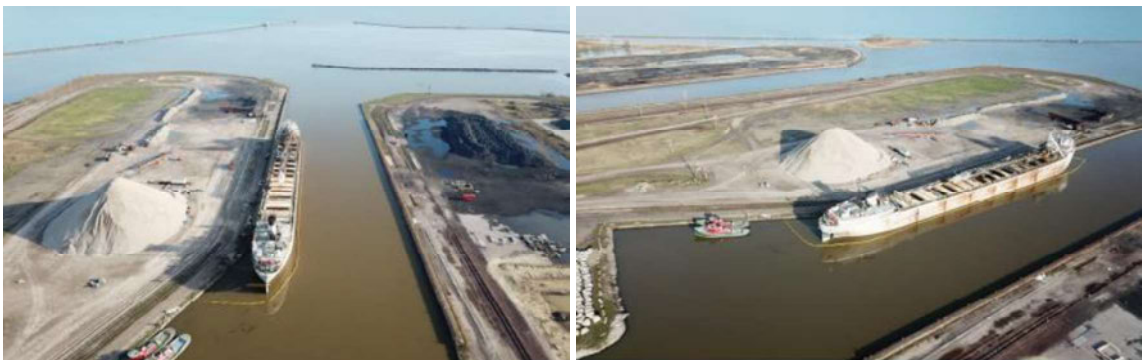
4.1.10. The 604.8' Canadian flagged self-discharging bulk carrier *Cuyahoga* (O.N. 243772) transitioned into winter layup in January 2024 and berthed at Kinder Morgan Pinney Dock in Ashtabula, Ohio as shown in Figure 2.

Figure 2. Photographs of *Cuyahoga* while moored at Kinder Morgan Pinney Dock. Source: Ashtabula Fire Department.

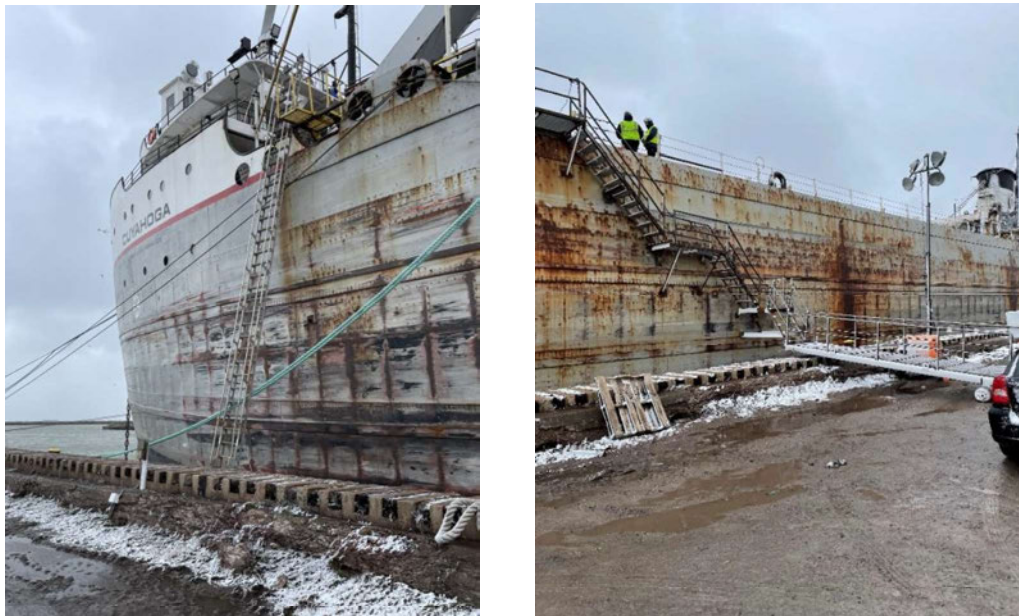
4.1.18. *Cuyahoga* was fitted with a straight metal boarding ladder near its bow that was connected to a winch and could be lowered or raised as needed. On March 15, 2024, the boarding ladder was located aboard the ship and was not placed over the side as shown in Figure 4. *Cuyahoga* was also fitted with a gangway that was welded amidship along the ship's port side as shown in Figure 4.

Figure 4. Photographs of *Cuyahoga*'s forward ladder (left) and amidship gangway (right). Source: U.S. Coast Guard.

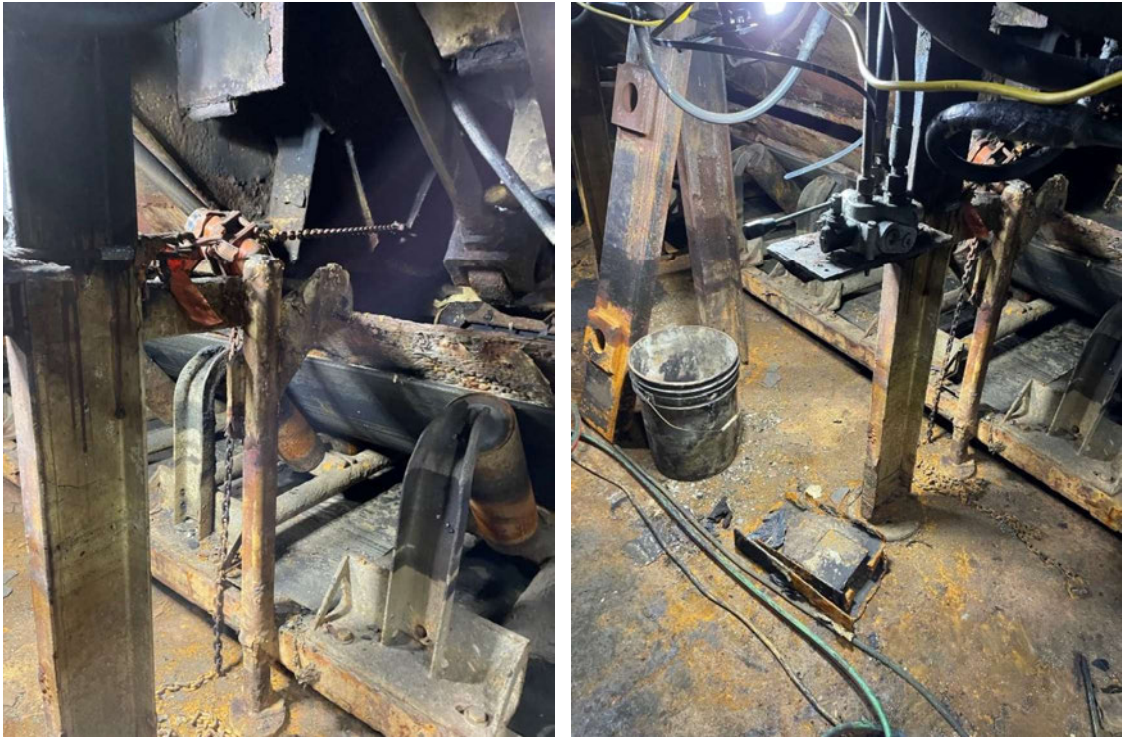
4.1.24. At 8:00 a.m., two Lower Lakes Towing LTD employees, Head of Cargo Maintenance and his assistant, worked on gate channels in the portside cargo tunnel at the forward end of gate 22 as shown in Figure 6. The work consisted of removing existing I-beams along with fitting and aligning new I-beams using a cutting torch. The I-beams are designed to reinforce the cargo belt under the gates. Welding the new I-beams was to be completed by Conneaut Creek Ship Repair, Inc. and South Marine Systems LLC employees. Gate 22 is located below Cargo Hold No. 2.

Figure 6. Photographs of *Cuyahoga*'s portside cargo tunnel at the forward end of gate 22. Source: U.S. Coast Guard.
