# UNITED STATES COAST GUARD

## REPORT OF INVESTIGATION INTO THE CIRCUMSTANCES SURROUNDING

### THE SINKING WITH LOSS OF LIFE ABOARD THE VESSEL EXITO (O.N. 273458)

**THE SINKING OF THE COMMERCIAL FISHING VESSEL EXITO (O.N. 273458)  
RESULTING IN THE LOSS OF TWO LIVES WHILE TRANSITING THE AKUTAN  
PASS, 11 NAUTICAL MILES NORTHEAST OF DUTCH HARBOR, ALASKA  
ON DECEMBER 6, 2016**

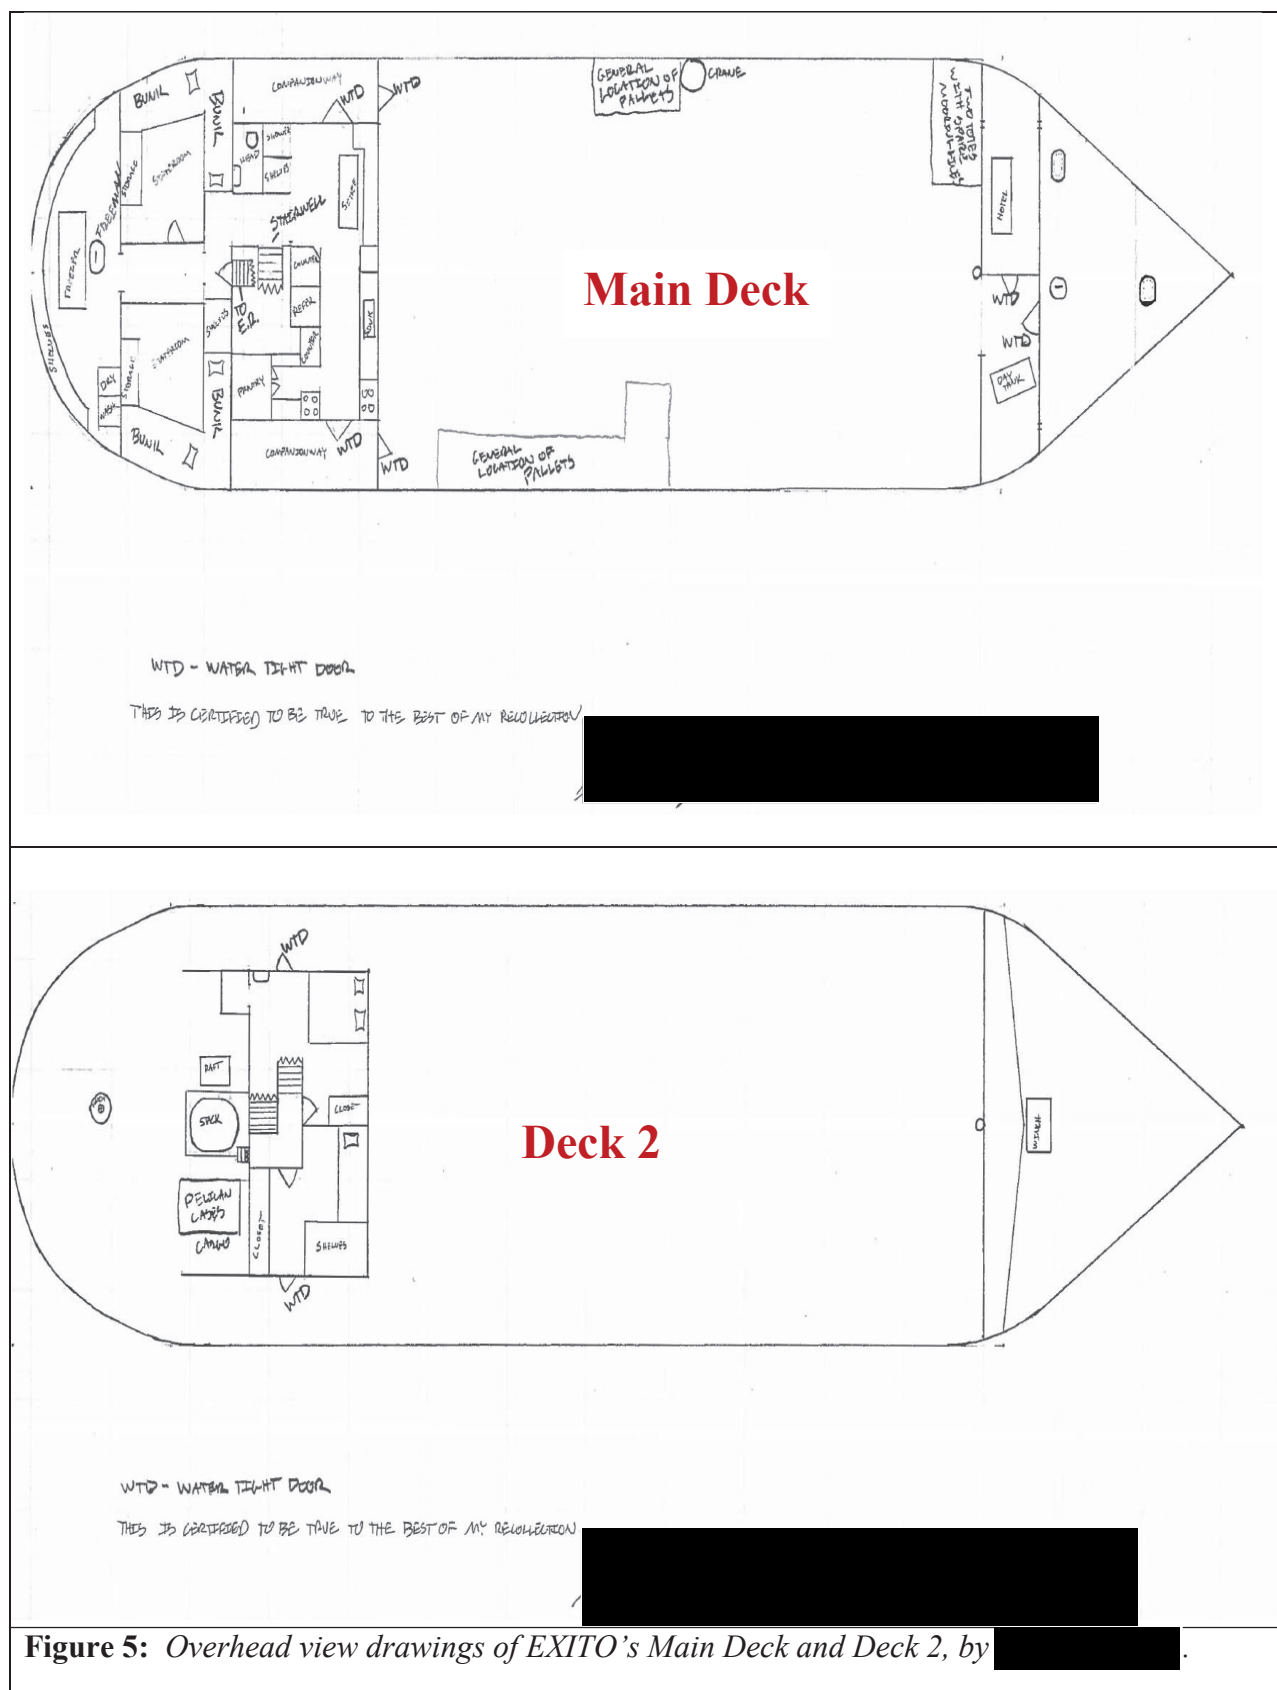
**Figure 5:** Overhead view drawings of EXITO's Main Deck and Deck 2, by [REDACTED]

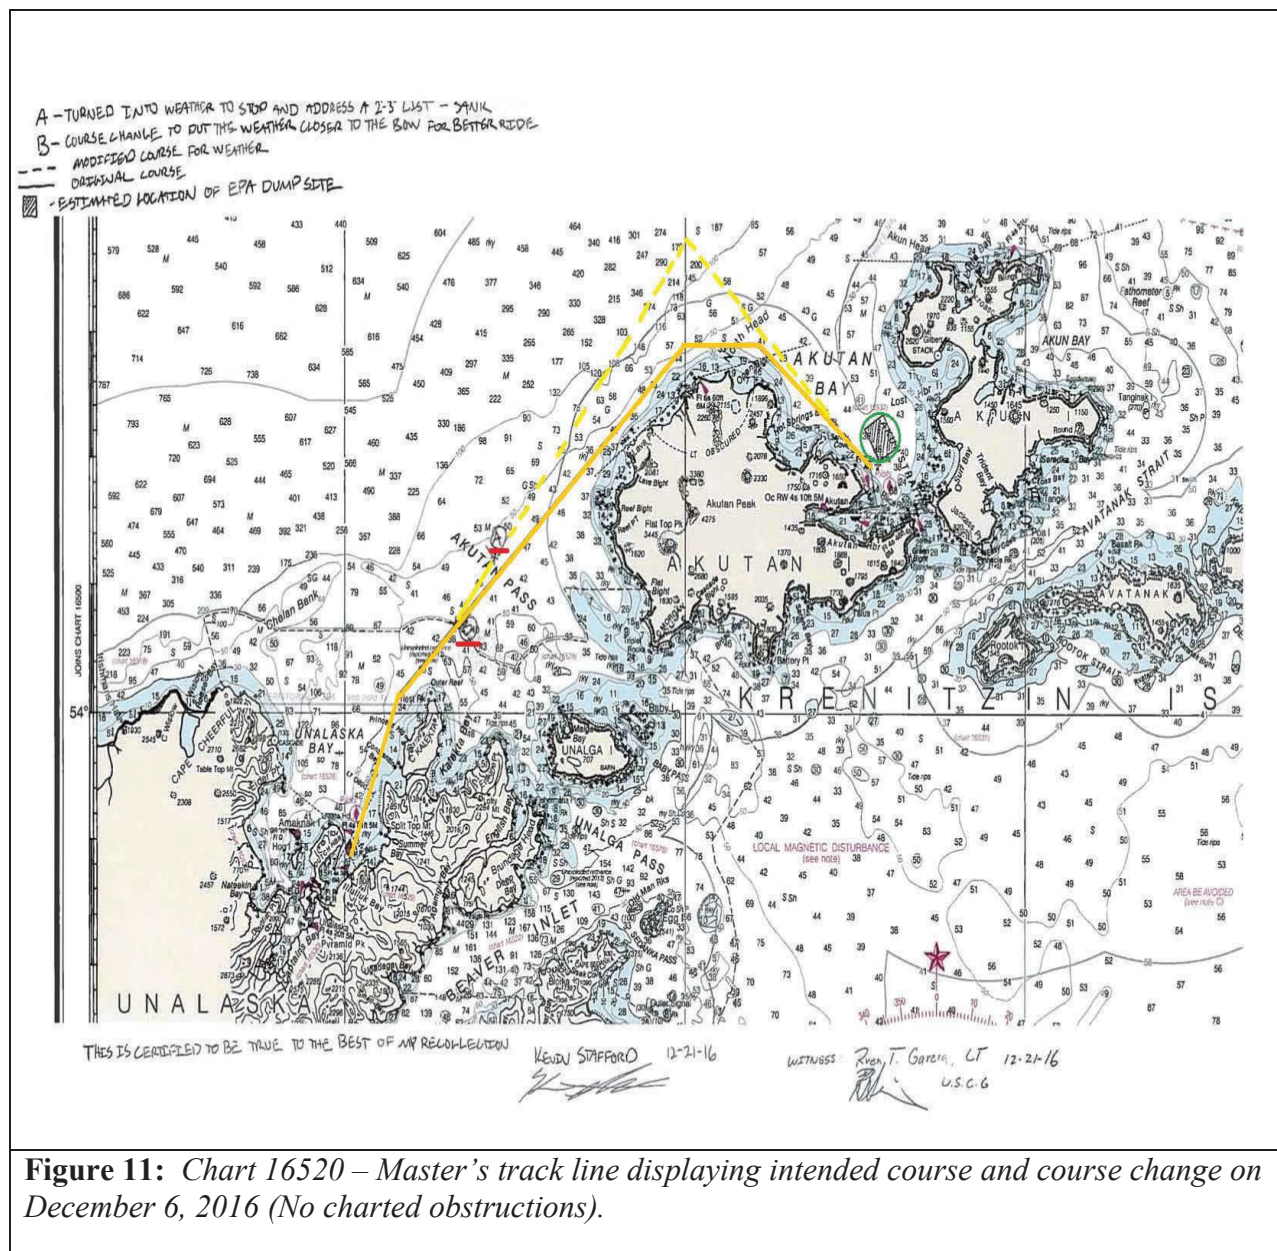
**Figure 11:** Chart 16520 – Master’s track line displaying intended course and course change on December 6, 2016 (No charted obstructions).

88. On December 6, 2016, between the time of 8:20 PM and 9:00 PM, the master made a course correction (figure 11) after noticing a change in the vessel's stability. The EXITO did not roll back to an upright position (to port) as expected, but rather held a reported 2 to 5-degree list to starboard. The master turned the EXITO into the seas and reduced its speed.
