### LOSS OF LIFE ONBOARD THE WORKBOAT LITTLE G (MC954372) WHILE TRANSITING THE ALABAMA RIVER NEAR CLAIBORNE, AL ON JUNE 16, 2023

**SINKING OF THE UNINSPECTED WORKBOAT LITTLE G (CG1818164) AND  
SUBSEQUENT LOSS OF ONE LIFE WHILE HOLDING A DECK BARGE AGAINST  
THE EAST BANK OF THE ALABAMA RIVER IN THE VICINITY OF MILE  
MARKER 9 NEAR TENSAW, ALABAMA ON JUNE 16, 2023**

### **EXECUTIVE SUMMARY**

### **INVESTIGATING OFFICER'S REPORT**

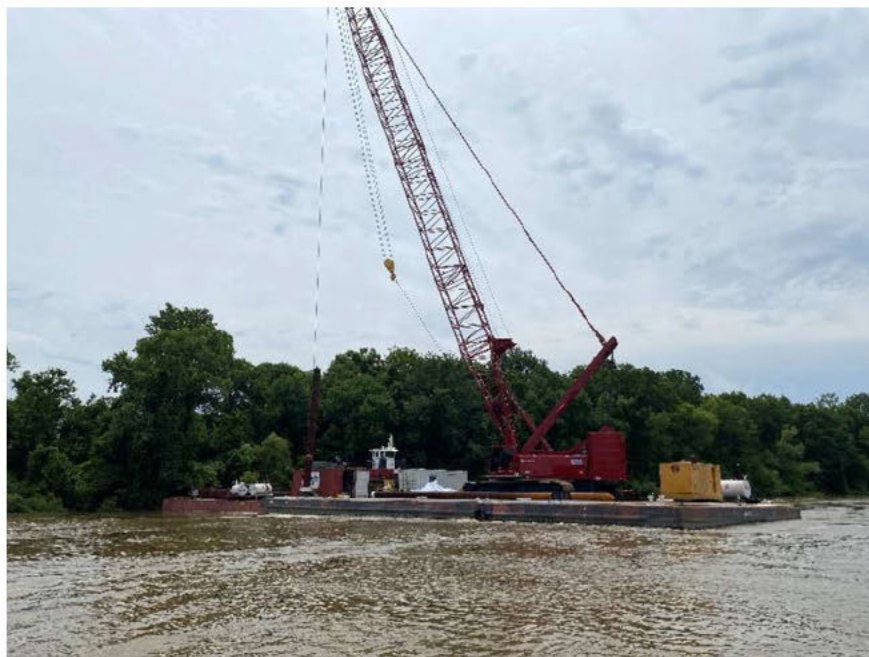
Figure 2. Crane barge and Flexifloat along the east bank. (June 16, 2023/Sector Mobile IO)

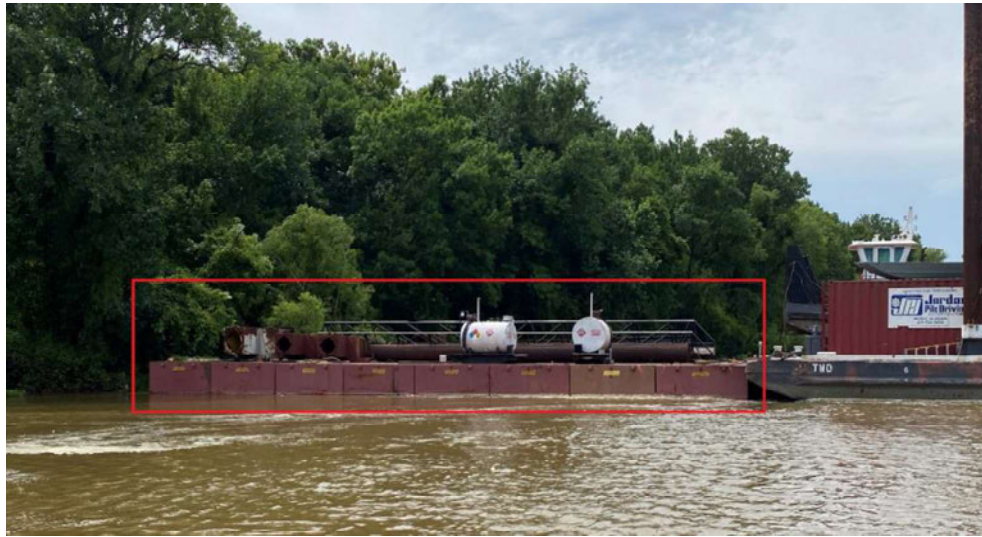
Figure 3. Flexifloat along the east bank. (June 16, 2023/Sector Mobile IO)

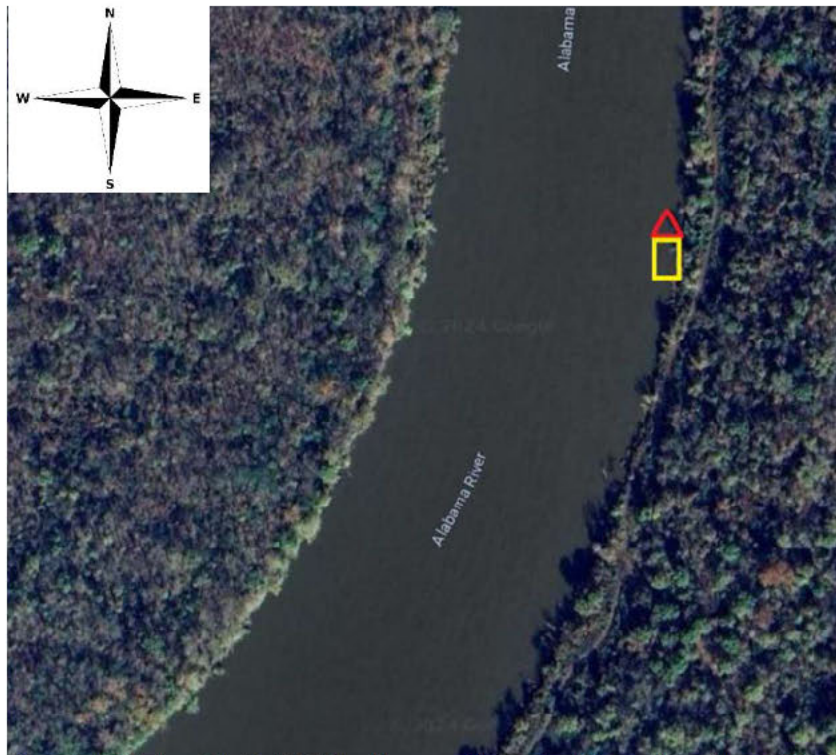
4.1.5. The following morning, June 15, 2023, the vessel departed at 0800 to continue the southbound transit before eventually stopping at 1800 near MM 9. The LITTLE G and accompanying barge pushed up against the east bank with the stern of the vessel on the north end and forward most part of the barge to the south. The forward spud was the only spud lowered at this time.

Figure 5. Aerial view of the LITTLE G and barge position on the Alabama River. (Google Maps)

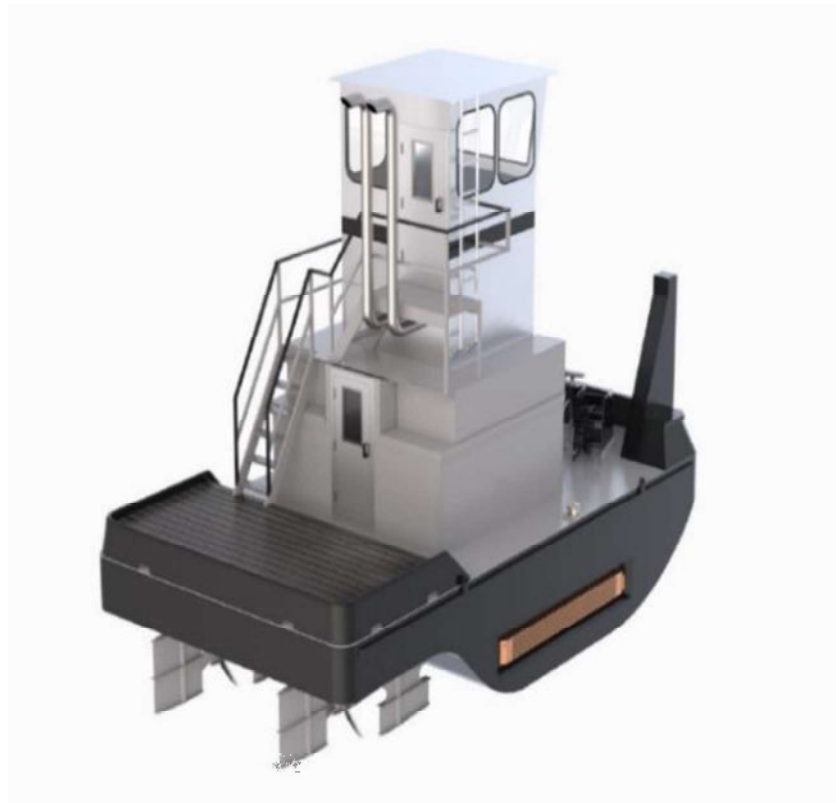
Figure 14. LITTLE G replica (MC Marine, LLC)

4.2.2. The uninspected Towing Vessel LITTLE G is less than 26' in length and not subject to inspection under 46 CFR Subchapter M – Inspected Towing Vessels. The vessel is subject to 46 CFR Subchapter C – Uninspected Vessels.
