UNITED STATES COAST GUARD

**REPORT OF THE DISTRICT FORMAL INVESTIGATION
INTO THE
SMALL PASSENGER VESSEL SPIRIT OF BOSTON (O.N.
954835) FIRE IN BOSTON HARBOR, BOSTON,
MASSACHUSETTS ON MARCH 24, 2023**

**FIRE ABOARD THE SMALL PASSENGER VESSEL SPIRIT OF BOSTON
(O.N. 954835) WHILE MOORED AT THE COMMONWEALTH WHARF IN
BOSTON HARBOR, MASSACHUSETTS ON MARCH 24, 2023**

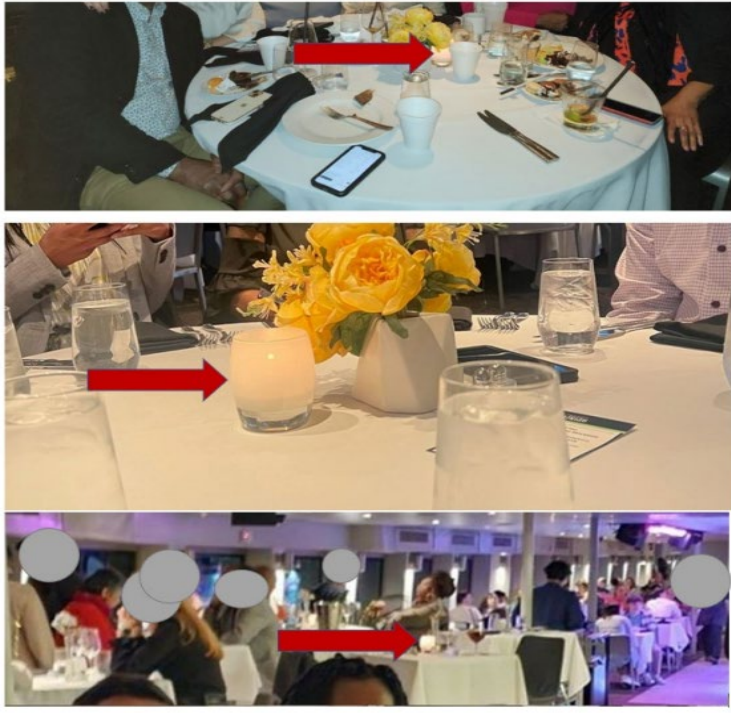
- 3.4. The paraffin candles, placed in a glass table sconce, had a wick and contained liquid paraffin fuel. A high school group populated the upper deck on the dinner cruise, thus, per company procedures for student charters, no paraffin candles were used on their tables. The paraffin candles on the main deck tables were contained in glass sconces. After the cruise, the hospitality staff would blow out the paraffin candles and, the next day, would determine which needed replacing based on the amount of the remaining fuel in the candle. All of the paraffin candles would be moved up to the second deck for later use.

Figure 6-Paraffin candles in glass table sconces in use on the main deck tables for the cruise prior to mooring at the dock at the end of the cruise. (Source: Passenger supplied photos)

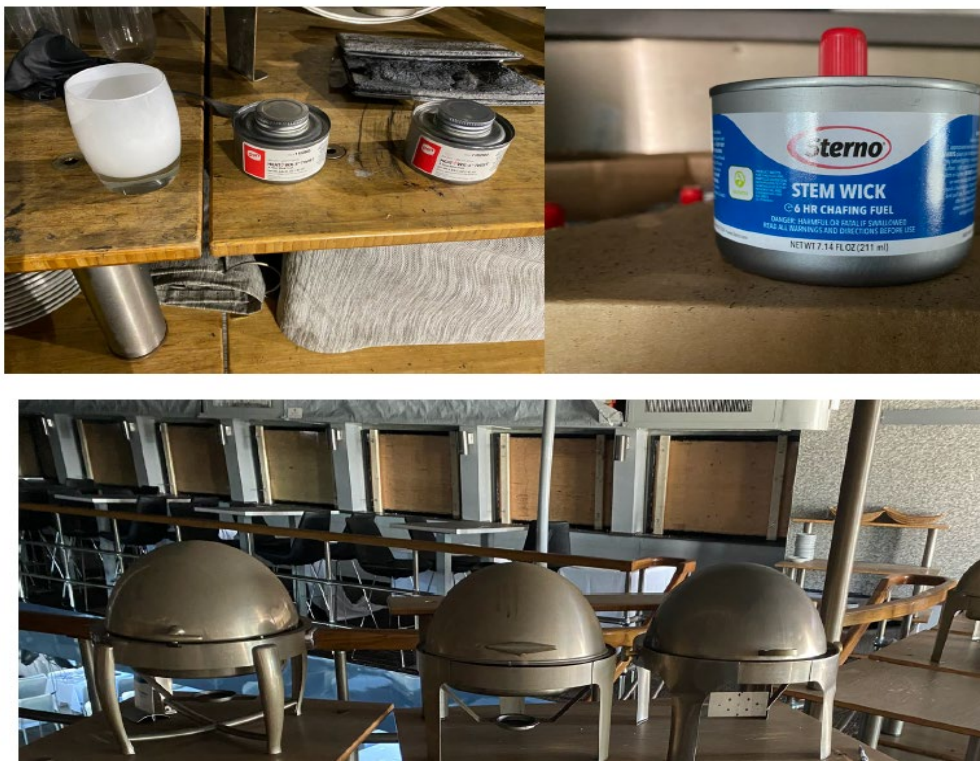
- 3.5. Fuel in canisters was used to heat food in chaffing dishes and to warm coffee in the main deck wait station area. Two types of canisters were used. One used a wick and the other had a cap. The stem wick fuel canisters were designed to burn for up to six hours. The other type of fuel canister can, the “Don” product, would provide four hours of fuel to heat the food.

Figure 7-Two types of chaffing dish fuel canisters in use on the *Spirit of Boston*. Top left: two 4 four-hour fuel cans to warm food. Top, right: one stem wick six-hour canister heating source. Bottom: examples of the buffet line chaffing dishes used on the vessel. (Source: USCG)

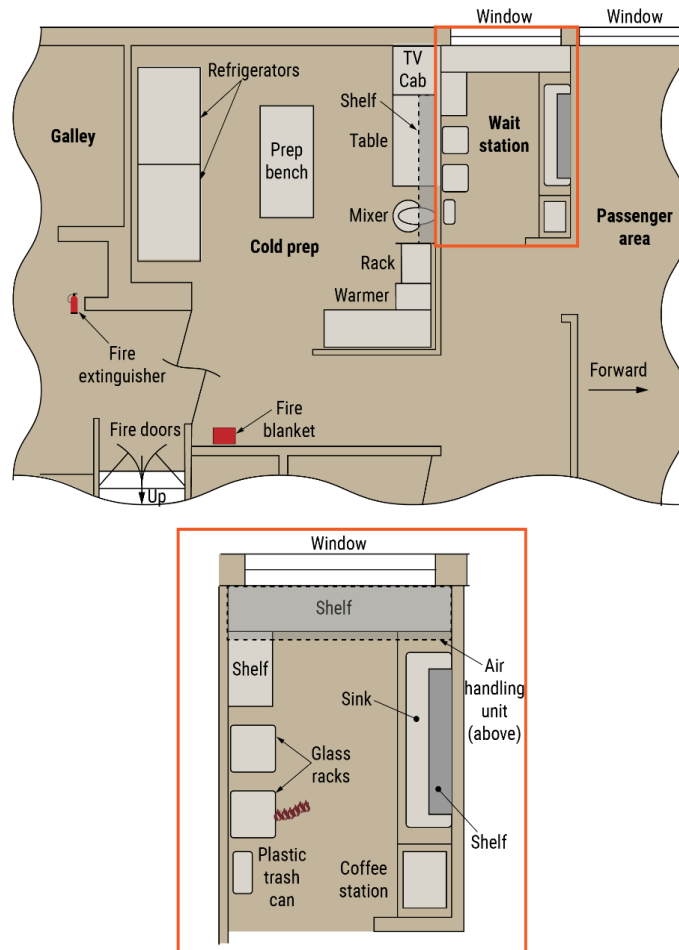
Figure 9-Overhead view of the *Spirit of Boston*'s cold prep area, galley, wait station, and passenger area, to include the location of the fire blanket and fire extinguisher. The closeup of the wait station depicts the area the initial fire was witnessed by the Associate Restaurant Manager. (Source: NTSB)

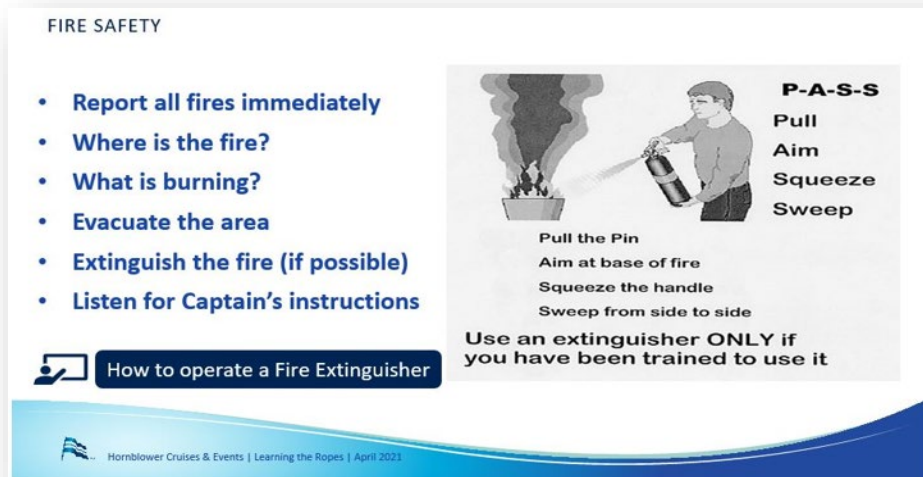
4.4.4.2. The orientation training is typically delivered in a presentation that includes several slides that cover such topics as fire safety, donning a life jacket, persons overboard, and security. The slide for fire safety is reproduced in Figure 16. There is no separate slide for marine crew versus hospitality staff, such as server's assistants and bartenders. Under the bullet point, "extinguish the fire" there is the notation ("if possible") and the slide also contains the verbiage, "use a fire extinguisher only if you have been trained to use it."

Figure 16- Slide for the fire safety portion of new hire orientation showing the expectations for employees in the case of a fire. There is a subset of this slide that provides for a demonstration on the use of a fire extinguisher. (Source: City Cruises)

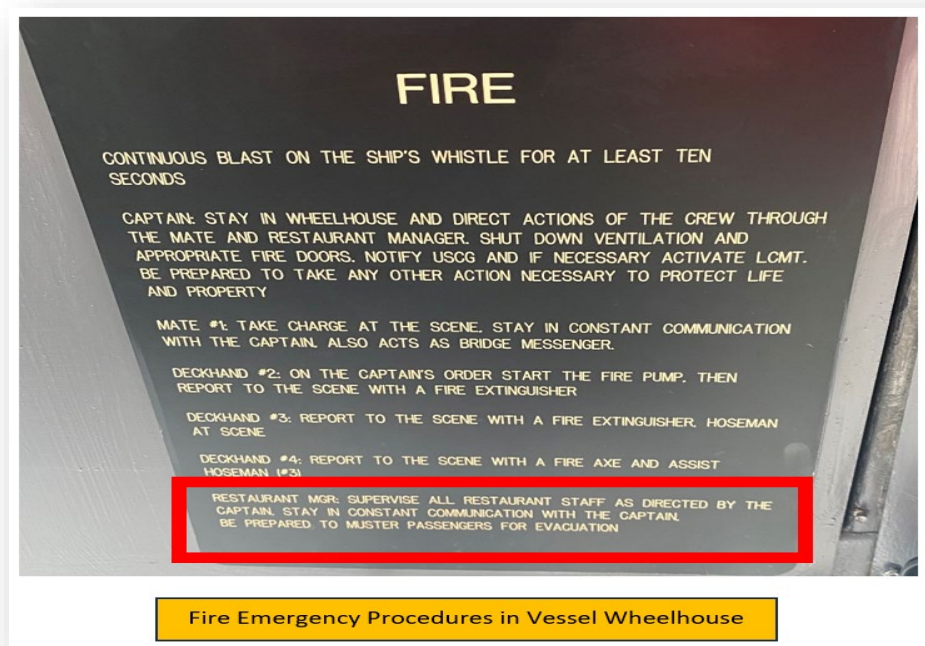
4.4.10.5. There are placards located in the wheelhouse, in direct view of the person operating the vessel. Figure 17 is the emergency fire procedure placard and it contains the steps to be followed in typical vessel emergencies.

Figure 17 - The procedures to be followed in the event of a fire. This placard is in direct view of the vessel operator in the wheelhouse. The red box outlines the Restaurant Manager duties to “SUPERVISE ALL RESTAURANT STAFF AS DIRECTED BY THE CAPTAIN. STAY IN CONSTANT COMMUNICATION WITH THE CAPTAIN. BE PREPARED TO MUSTER PASSENGERS FOR EVACUATION.” (Source: City Cruises)

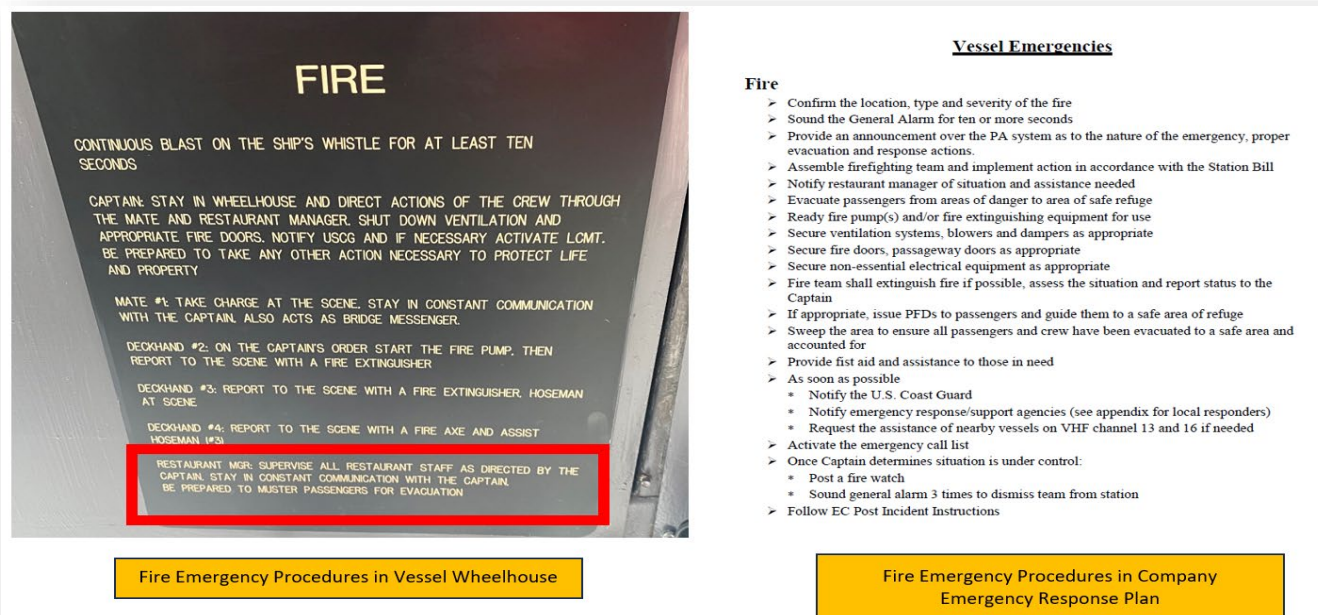
Figure 18 – **Left:** the procedures to be followed in the event of a fire. This placard is in direct view of the vessel operator in the wheelhouse. Note the duties of the Restaurant Manager in the red highlight box.

Right: the procedures that the crew was expected to follow during a fire event, from the “Vessel Emergencies” section of the company Emergency Response Plan, dated 2016 (Source: City Cruises)

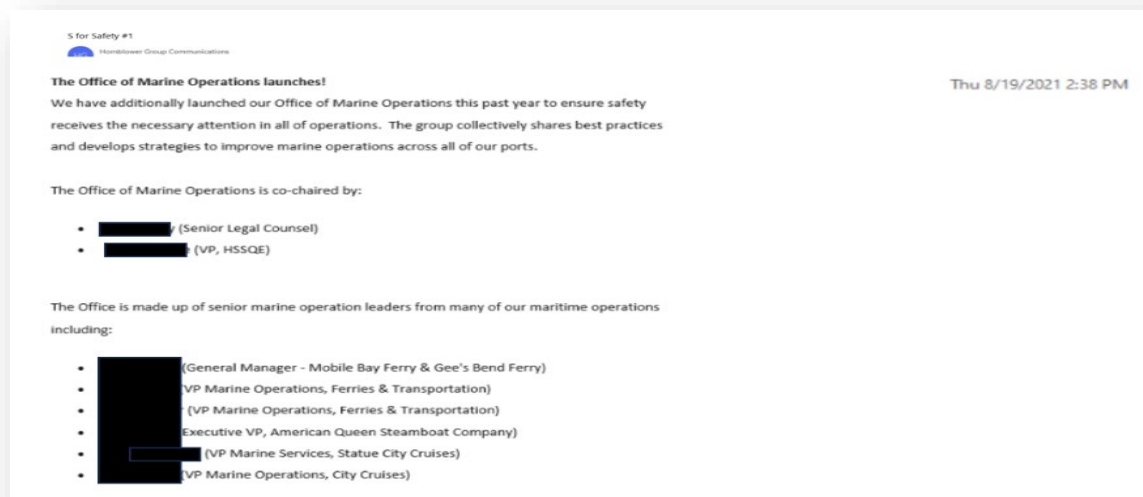
4.4.17.2. During the course of the investigation, no company employee or management personnel, mentioned the existence of this office.

Figure 20 - Portion of an email, dated August 19, 2021, launching Hornblower Office of Marine Operations, showing the lines of business represented in the team makeup. (Source: City Cruises)

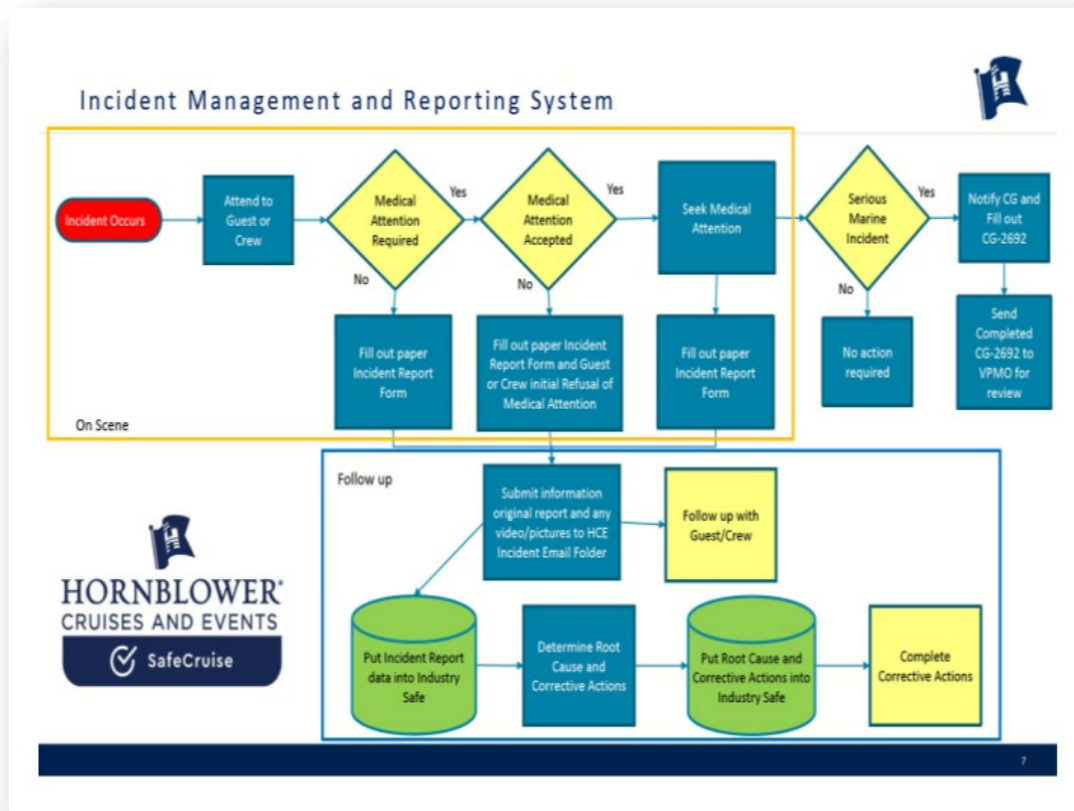
Figure 23 - Flow chart showing the steps company personnel are to follow after an incident had been identified. (Source: City Cruises)

4.4.19.9. The company provided the flow chart (Figure 23) outlining corrective actions. This flow chart is based on a request from the *Spirit of Norfolk* investigation as was discussed in the Formal Investigation Public Hearing. The flow chart does not appear to outline a follow-on process to place data into the company database for the report after a serious marine incident occurs. That data could be used to determine the root cause or corrective actions, input the root cause and corrective actions in Industry Safe, and then complete the corrective action process.
