REPORT OF THE INVESTIGATION
INTO THE
WAYMON BOYD (O.N. 261512) EXPLOSION,
FIRE, AND LOSS OF LIFE ON TULE LAKE
CHANNEL IN CORPUS CHRISTI, TX ON
AUGUST 21, 2020

16732/IIA # 7039383
19 December 2025

**EXPLOSION AND FIRE ON THE DREDGE VESSEL WAYMON BOYD (O.N. 261512)
RESULTING IN THE LOSS OF FIVE LIVES WHILE DREDGING ON TULE LAKE
CHANNEL NEAR CORPUS CHRISTI, TEXAS ON AUGUST 21, 2020**

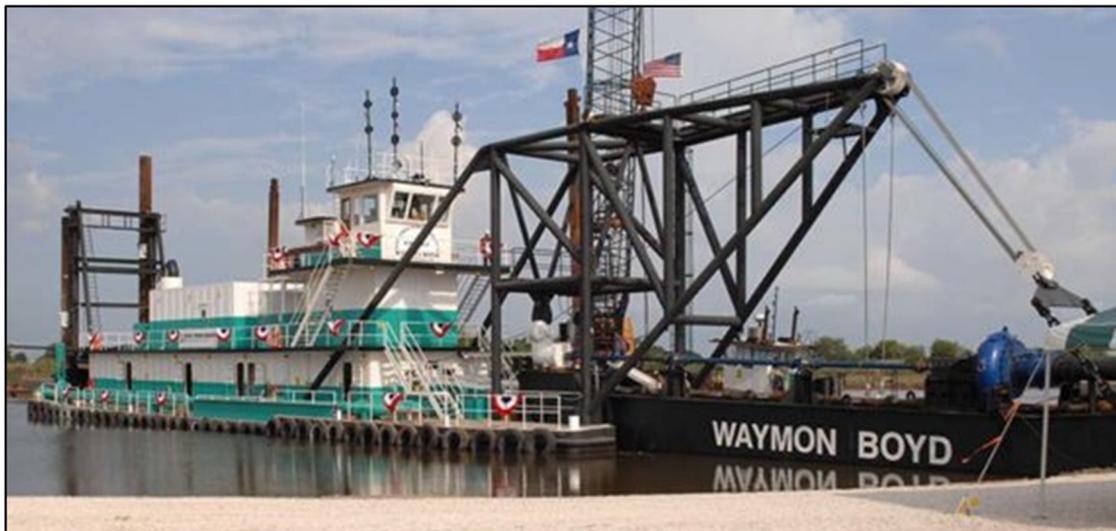
Figure 1. WAYMON BOYD prior to the incident, provided by Orion Marine Group.

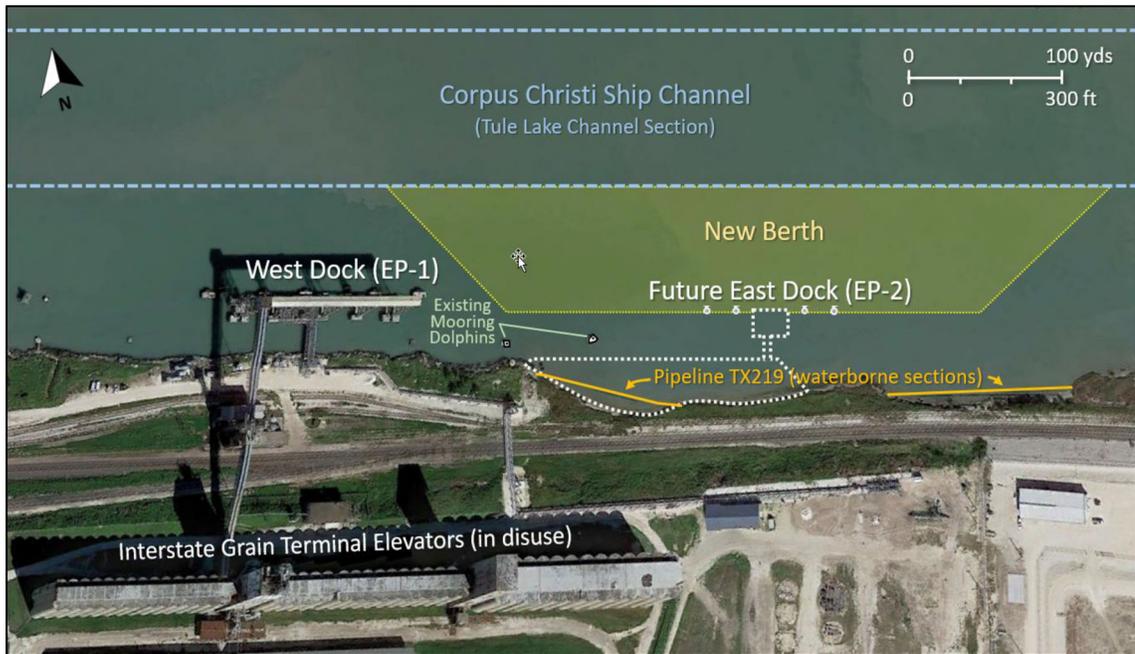
4.1.3. On August 19, 2020, the WAYMON BOYD was positioned to work between two of West Dock's mooring dolphins, which were included in the East Dock's dredge template. (See Figure 2)

Figure 2. EPIC Marine Terminal with Google Earth Background, taken from NTSB Nautical Operations, Human Performance, and System Safety Group Report

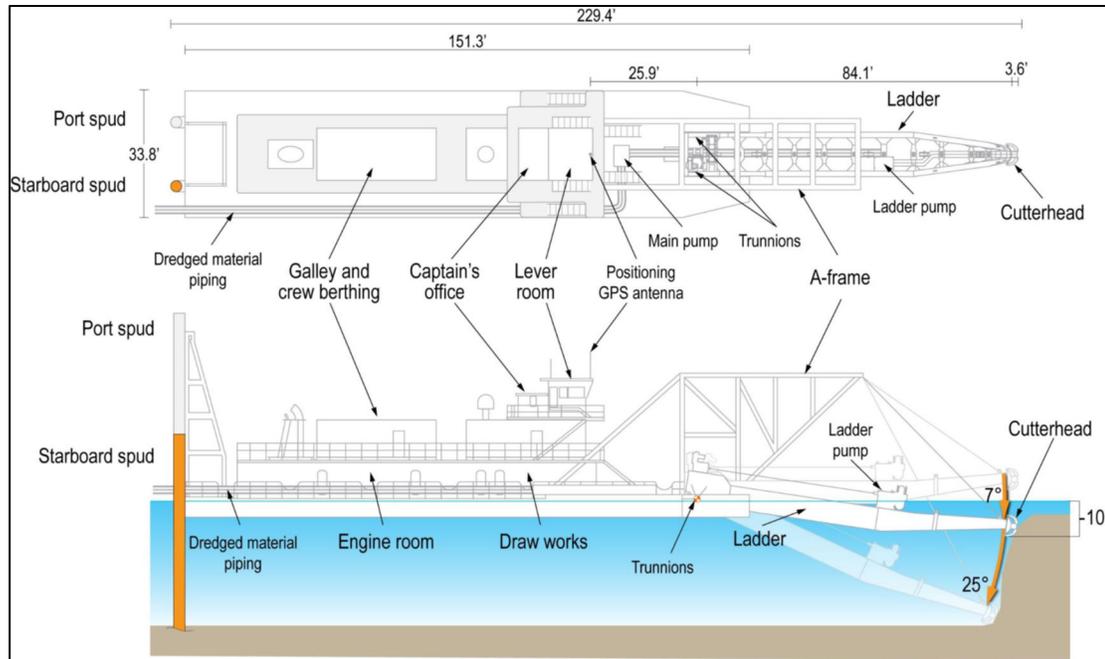
4.1.8. At 0700, the Dredge Captain woke up and left his room on the WAYMON BOYD, checked-in with the Day Leverman, and then went to the Captain's office, which was located just aft of the lever room. (See Figure 3)

Figure 3. WAYMON BOYD Schematic, taken from NTSB Nautical Operations, Human Performance, and System Safety Group Report.

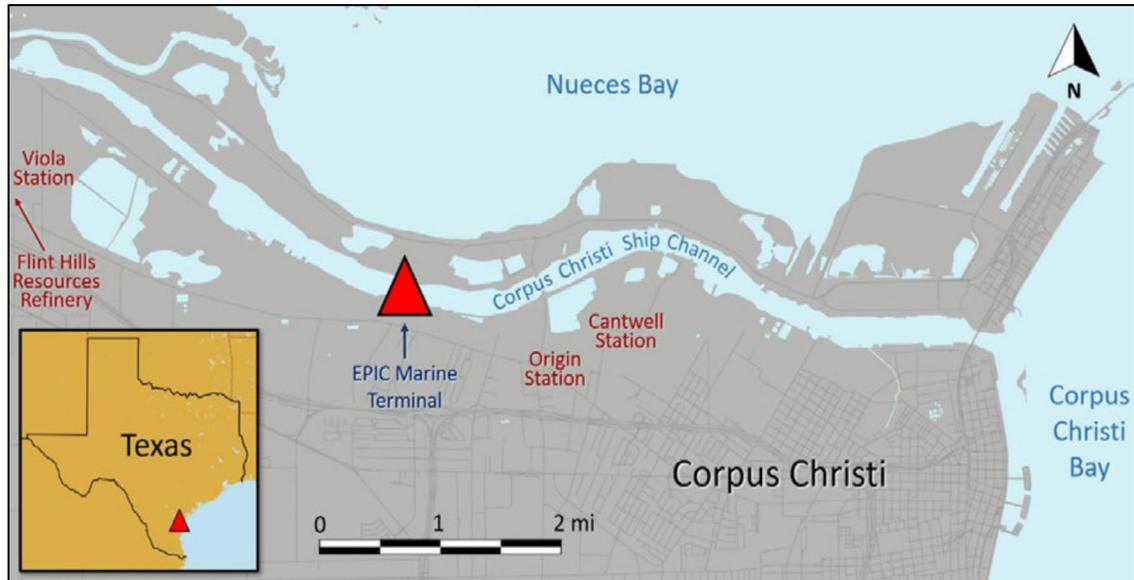
Figure 4. Location of accident with Google Map Background, taken from NTSB Nautical Operations, Human Performance, and System Safety Group Report.

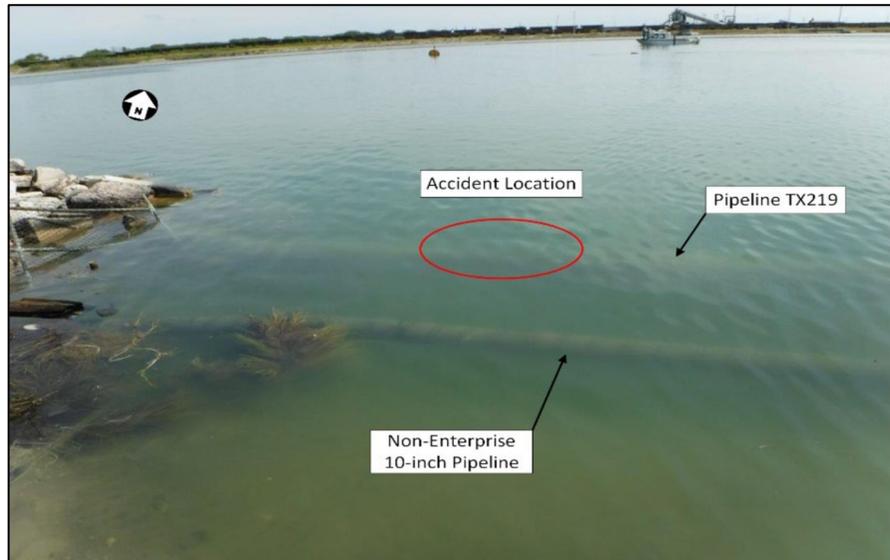
Figure 6. Approximate location of incident from NTSB Pipeline Operations Group Factual Report.

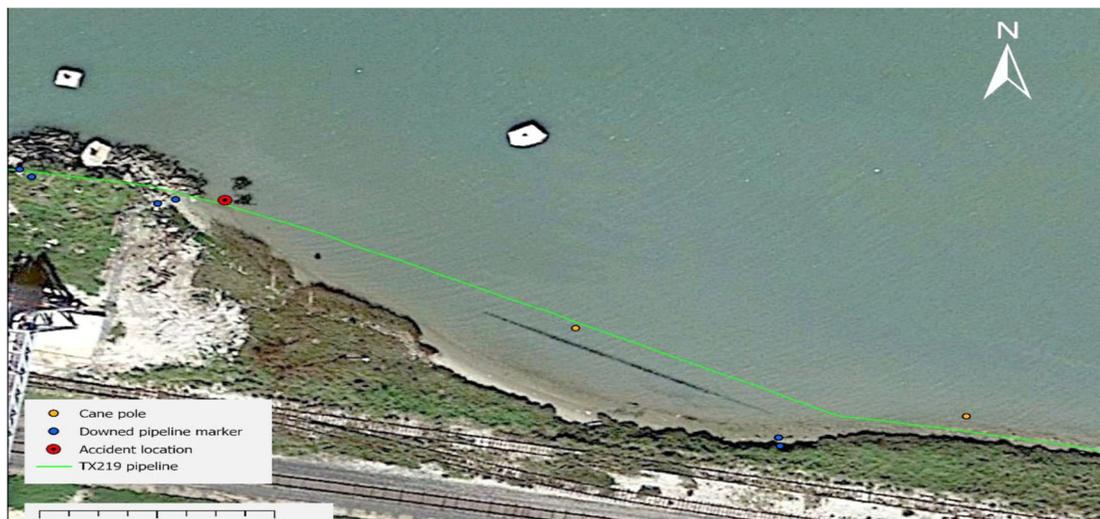
Figure 7. “Post-accident September 30, 2020, Enterprise Products pipeline TX219 KML, temporary and permanent pipeline marker survey locations, and accident location projected on Maxar Technologies, Google Earth imagery of January 31, 2020. Cane pole GPS 2289 was located between the 10-inch non-Enterprise pipeline, which is partially visible as a dark line parallel to pipeline TX219 (green line)”, taken from NTSB Pipeline Operations Group Factual Report

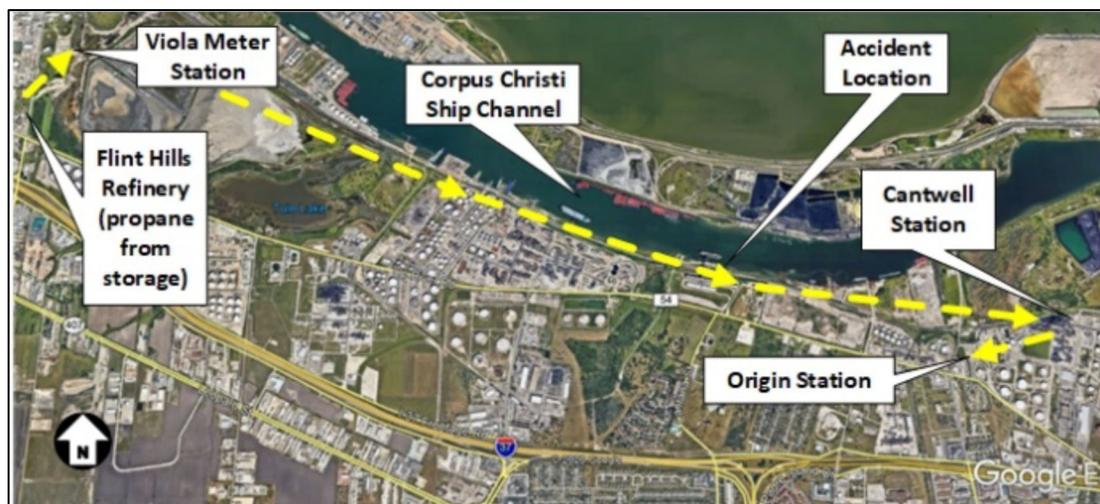
4.2.8. The pipeline did not flow continuously; rather, Flint Hills Refinery produced and stored propane and released it in batches to Enterprise Origin Station via TX219. Between Flint Hills and Enterprise Origin Station, the pipeline traveled through various stations. Product was introduced at Viola Meter Station and flowed east to Cantwell Station and then on to Origin Station.

Figure 8. General flow of Pipeline TX219, background image source Google Earth, taken from NTSB Pipeline Operations Group Factual Report.

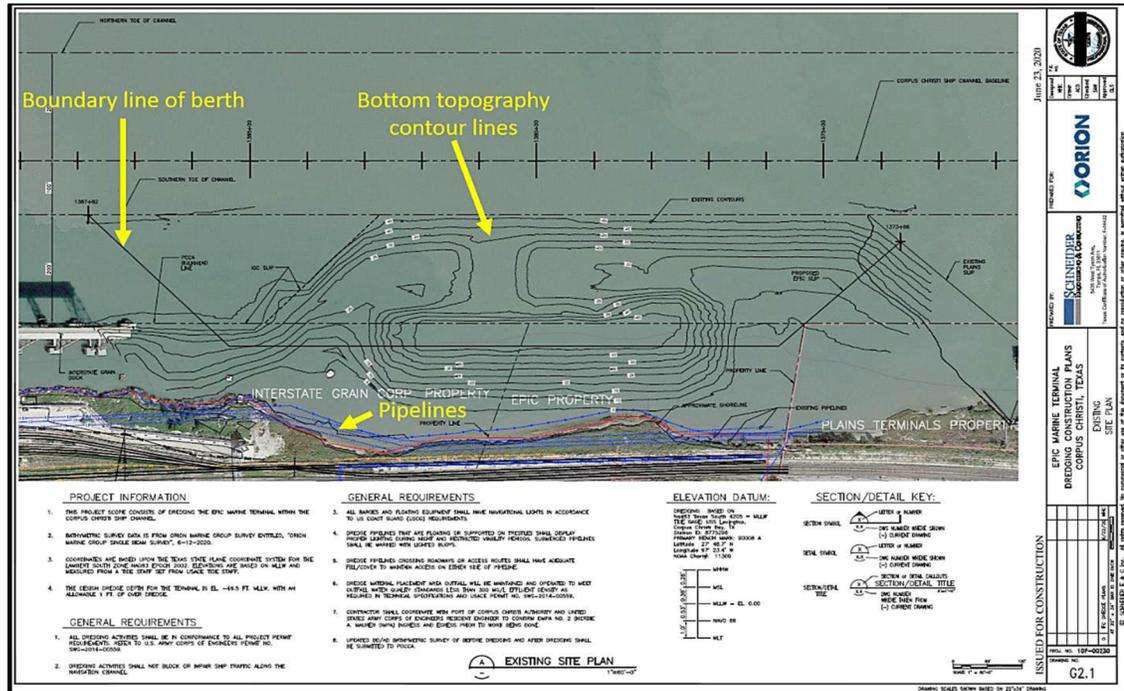
4.2.25. The design engineer was not concerned about the pipeline’s location, stating that the distance between the pipelines and the edge of the dredge template was “in the

neighborhood of 8-10 feet” at the closest point. The pipelines were considered outside the dredge template and not a concern.

Figure 11. Existing Site Plan from EPIC East Dock, annotated by NTSB Nautical Operations, Human Performance, and System Safety Group Report.

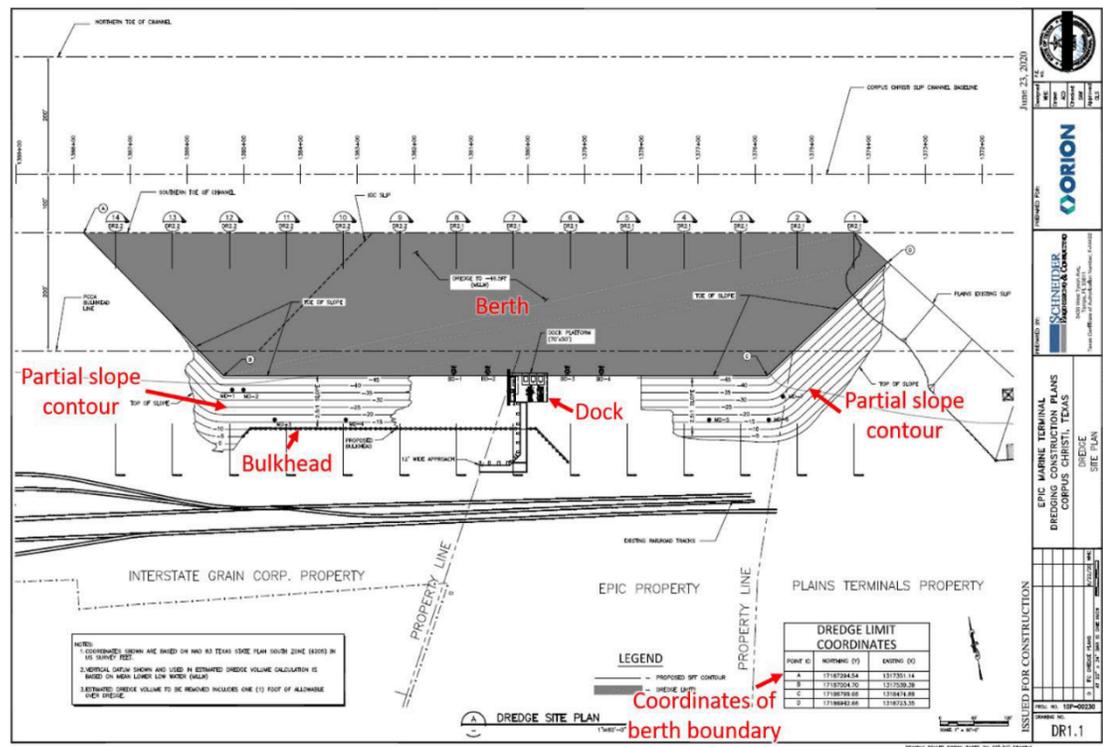
Figure 12. Dredge Site Plan from EPIC East Dock, annotated by NTSB Nautical Operations, Human Performance, and System Safety Group Report.

4.2.29. The Survey Superintendent included pipelines in the DREDGEPACK template if they were in the project area. He normally would be provided the coordinates of the pipeline from the Orion Project Manager and Orion Project Engineer to be included; he did not receive any for this project. During interviews, the Survey Superintendent stated he was aware of pipelines in the area, but he thought they were out of the way on the bank. The pipelines were not included for this template; in fact, he said they “were not considered at all.”

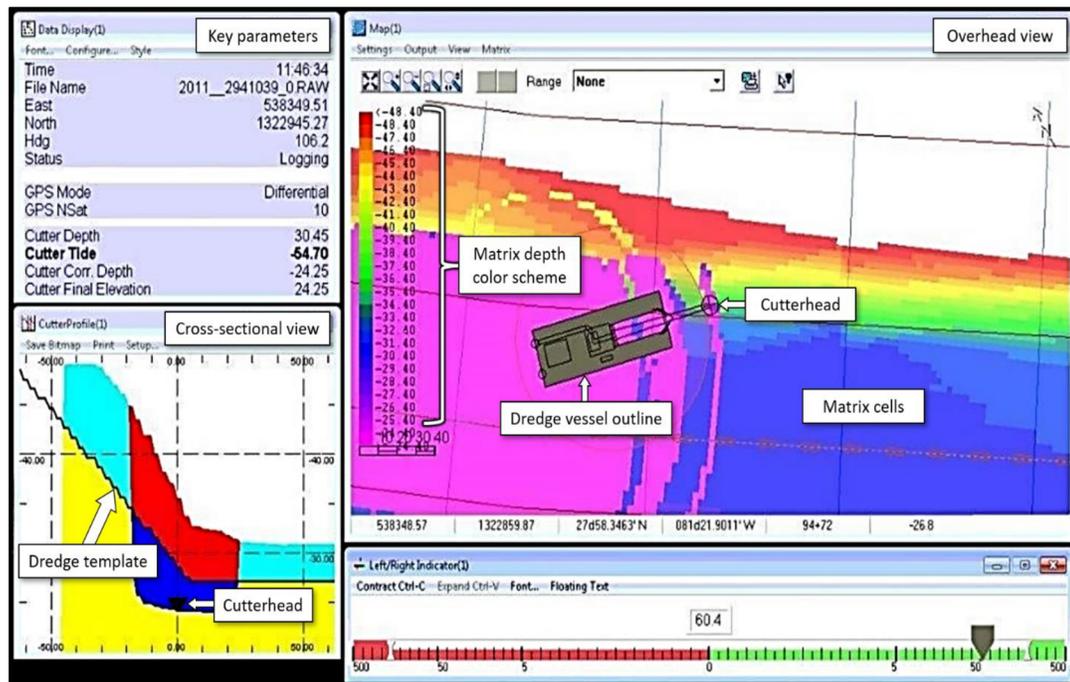
4.2.30. As he was digging, the Leverman looked at a DREDGEPACK display screen that showed the dredge template, where the cutterhead was positioned, and where he needed to dredge.

Figure 6. Sample DREDGEPACK Display, NOT related to this incident, taken from NTSB Nautical Operations, Human Performance, and System Safety Group Report.
