**REPORT OF THE INVESTIGATION
INTO THE
CLYDE S. VAN ENFKEVORT (O.N. 1232691) AND
ERIE TRADER (O.N. 1238380) ANCHOR STRIKE
WHICH DAMAGED SUBSURFACE TRANSMISSION
CABLES AND PIPELINES IN THE STRAITS OF
MACKINAC MICHIGAN ON 01 APRIL 2018**

SUBSURFACE PROPERTY DAMAGE INVOLVING THE ARTICULATED TUG CLYDE S. VANENKEVORT AND BARGE ERIE TRADER ON APRIL 1, 2018

**CLYDE S. VAN ENKEVORT (O.N. 1232691) and ERIE TRADER (O.N. 1238380) Anchor
Strike Which Damaged Subsurface Transmission Cables and Pipelines
In the Straits of Mackinac Michigan on 01 April 2018**

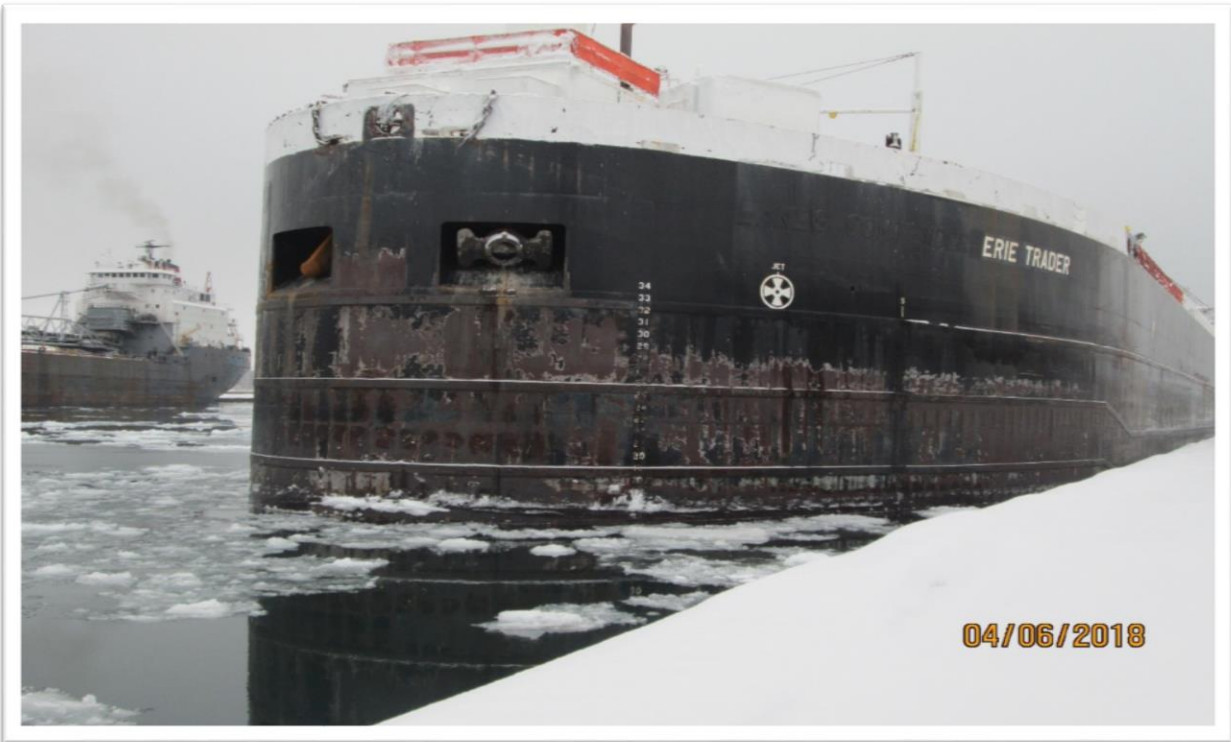
Figure 2-1 The barge ERIE TRADER on the South Pier St Marys River MI on 6 April 2018.

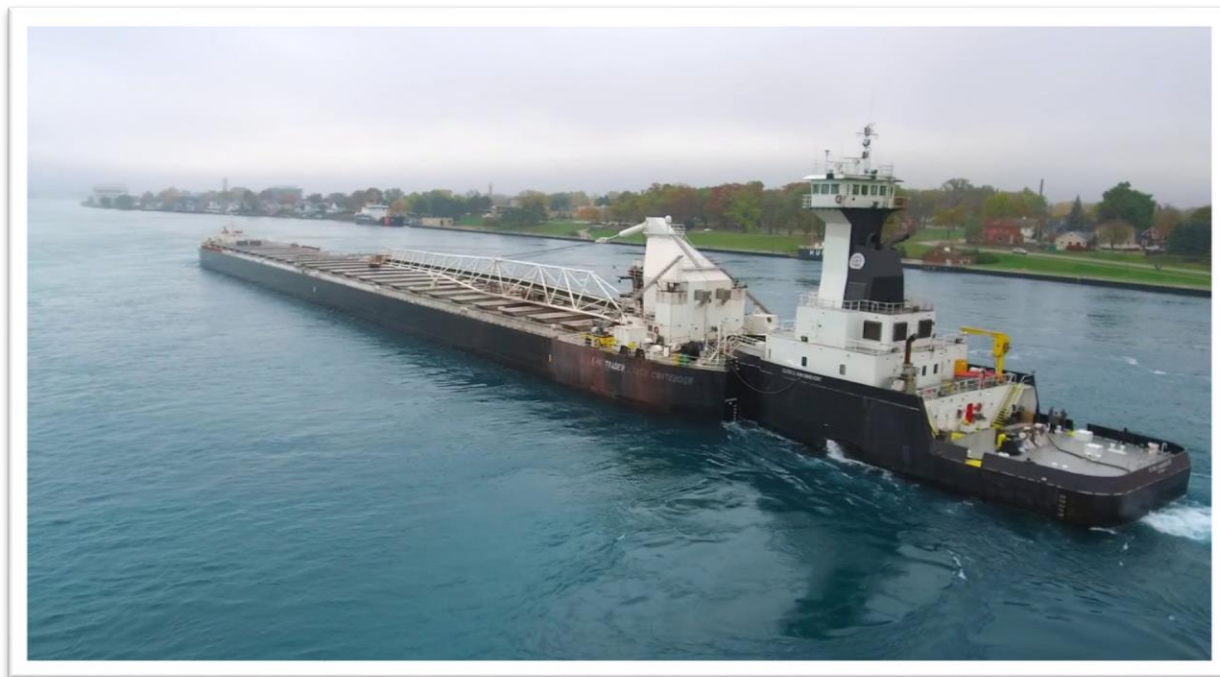
Figure 2-2 The towing vessel CLYDE S. VANENKEVORT and ERIE TRADER,(formerly the LAKES CONTENDER). Unknown time and location.

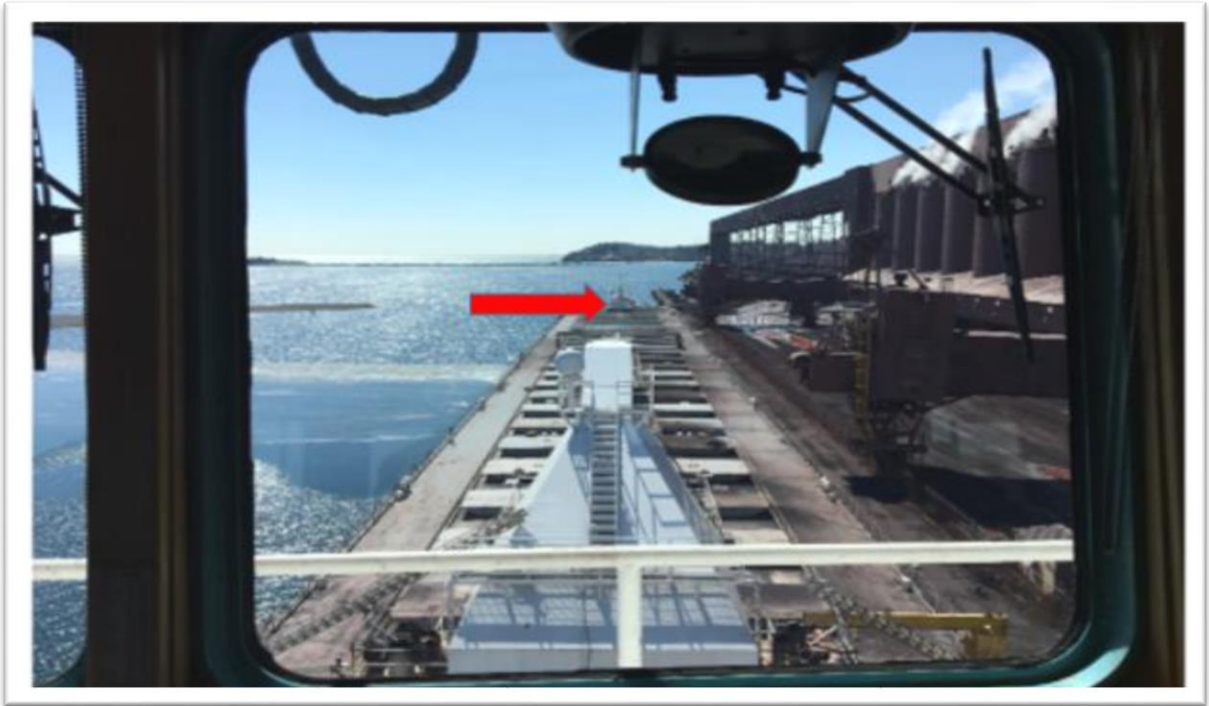
- 4.4 The ERIE TRADER is configured with the windlass, anchoring system, and associated tackle in an enclosed space on the bow main deck just above the forepeak. This space houses the windlass systems, associated controls, and tackle for both the port and starboard anchors. The windlass system (model: 2W26231-16-00) and associated parts were manufactured by Coastal Marine Equipment Inc. These systems are not visible while standing on the main deck of the barge, nor are they visible from the bridge of the CLYDE S. VAN ENKEVORT. There are no alarms or signals on the bridge or otherwise that verify the status of the anchors. The windlass space is approximately 845 feet from the bridge (see figure 4-1).

Figure 4-1 View from the bridge of the CLYDE S. VANENKEVORT to the main deck of the ERIE TRADER. The red arrow indicates the location of the windlass room.

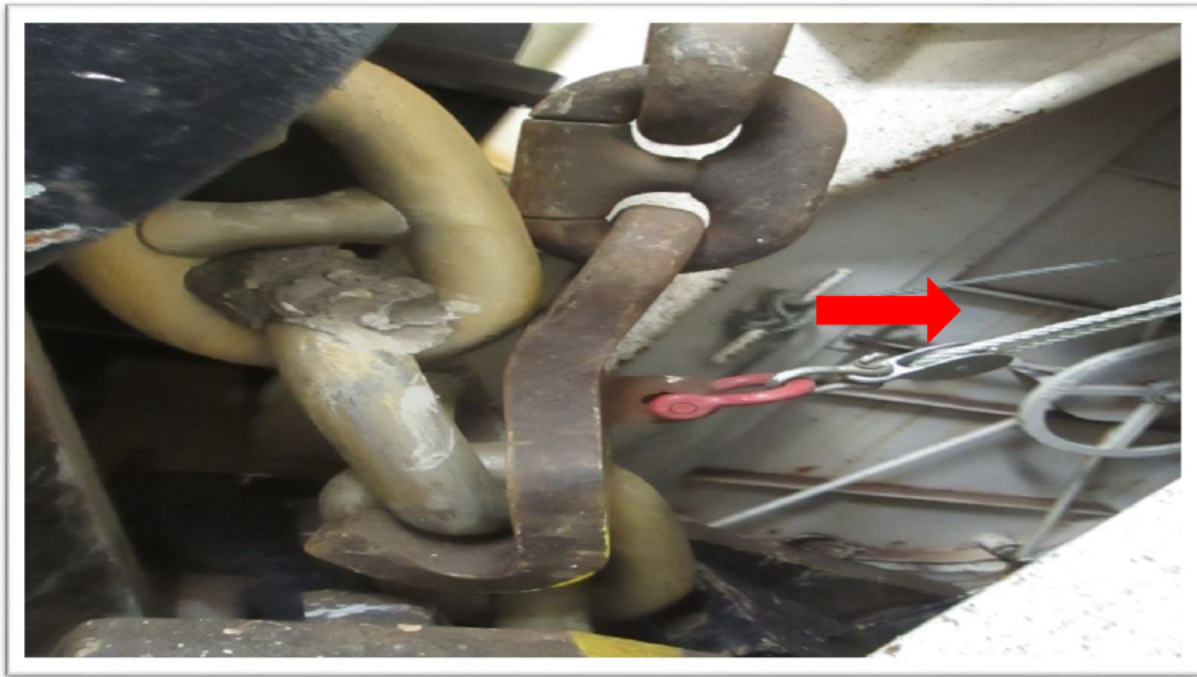
- 4.9 The barge ERIE TRADER is fitted with two stockless B-type anchors which weighed 12,000 pounds and are connected to a 2^{5/8} inch size chain. The brake holding capacity by design is 341,100 pounds. Each anchor chain is 6 shots (1 shot = 90 feet). The anchor was designed to have three mechanisms to protect against unintended release: the paw, the claw, and the brake (see figure 4-4). The claw and paw⁴ devices cannot be accessed from inside the windlass room. There is a separate space forward of the windlass room called the hawespipe locker that is accessed by a small hatch. In order to view the claw and paw the hawespipe locker hatch must be opened (see figure 4-3).

Figure 4-3 Inside view of the starboard hawespipe locker hatch. Red arrow indicates the hatch that provides access to the claw and paw. This image displays the hatch in the closed position.

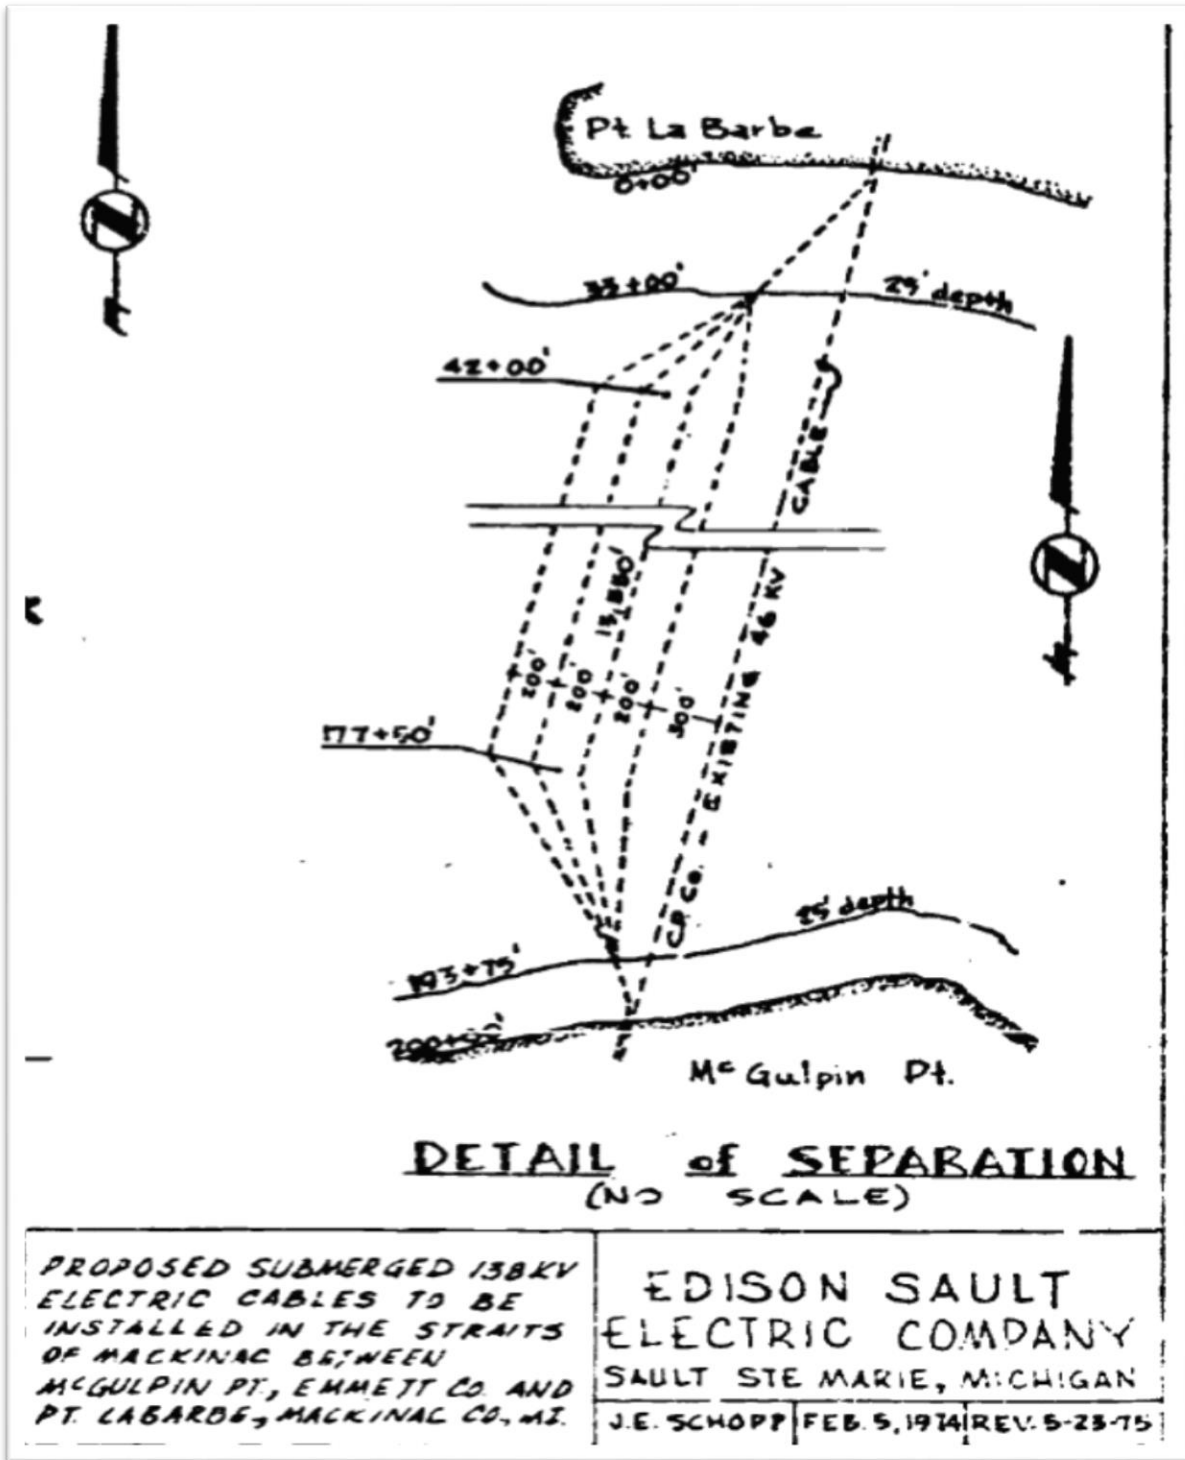
- 4.36 1 April 2018 1732- American Transmission Corporation (ATC) received a signal at their Systems Operations Center indicating that two protective relays connected to transmission cable circuits in the Straits of Mackinac had tripped offline less than a minute apart. American Transmission Company owns six underwater subsurface transmission cables that rest on the seabed in the Straits of Mackinac. These cables actively provide power to the upper peninsula of Michigan. The cables run between McGulpin Point, on the Lower Peninsula, to Pointe La Barbe, on the Upper Peninsula. The cables are spaced approximately 200 feet apart at depths of over 200 feet (see figures 4-8 and 4-9).

Figure 4-8 Diagram for the layout of ATC submerged cables west of the Mackinac Bridge. Image provided by U.S. Army Corps of Engineers. Cables originally owned by Edison Sault Electric Company..

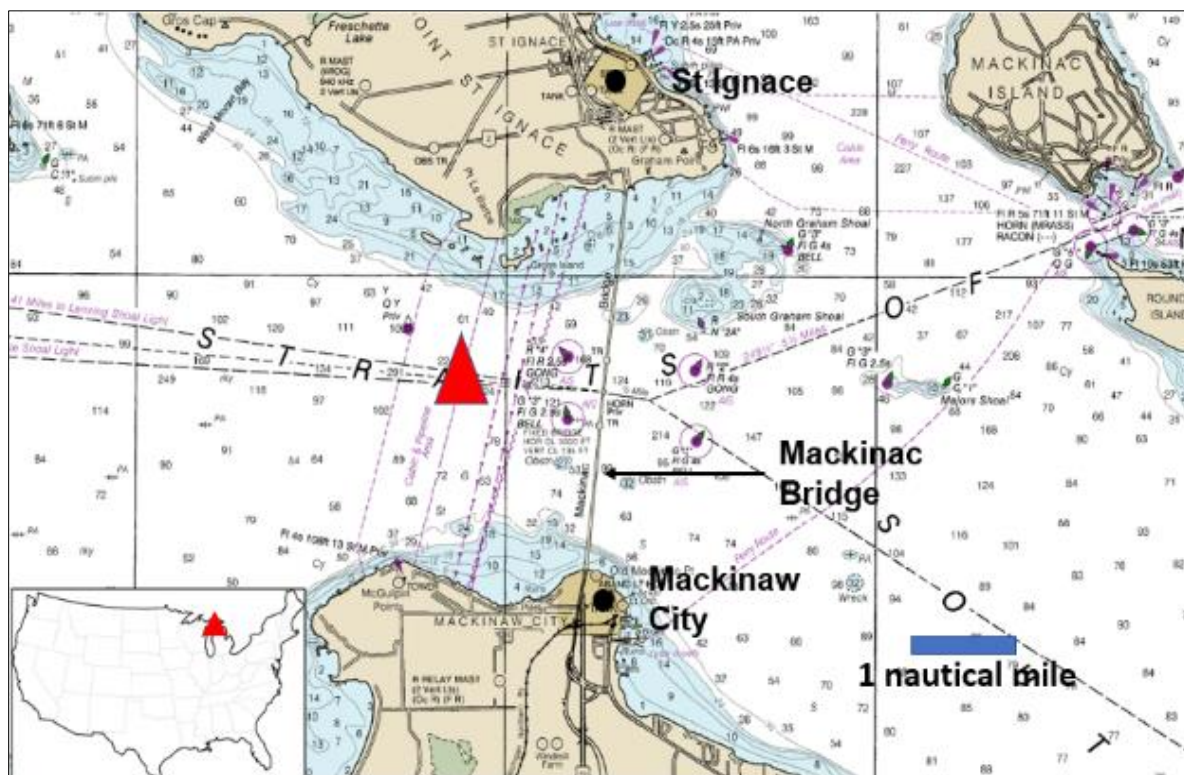
Figure 4- 9 Straits of Mackinac. Red area signifies the approximate location of the incident site (NOAA Chart 14881)

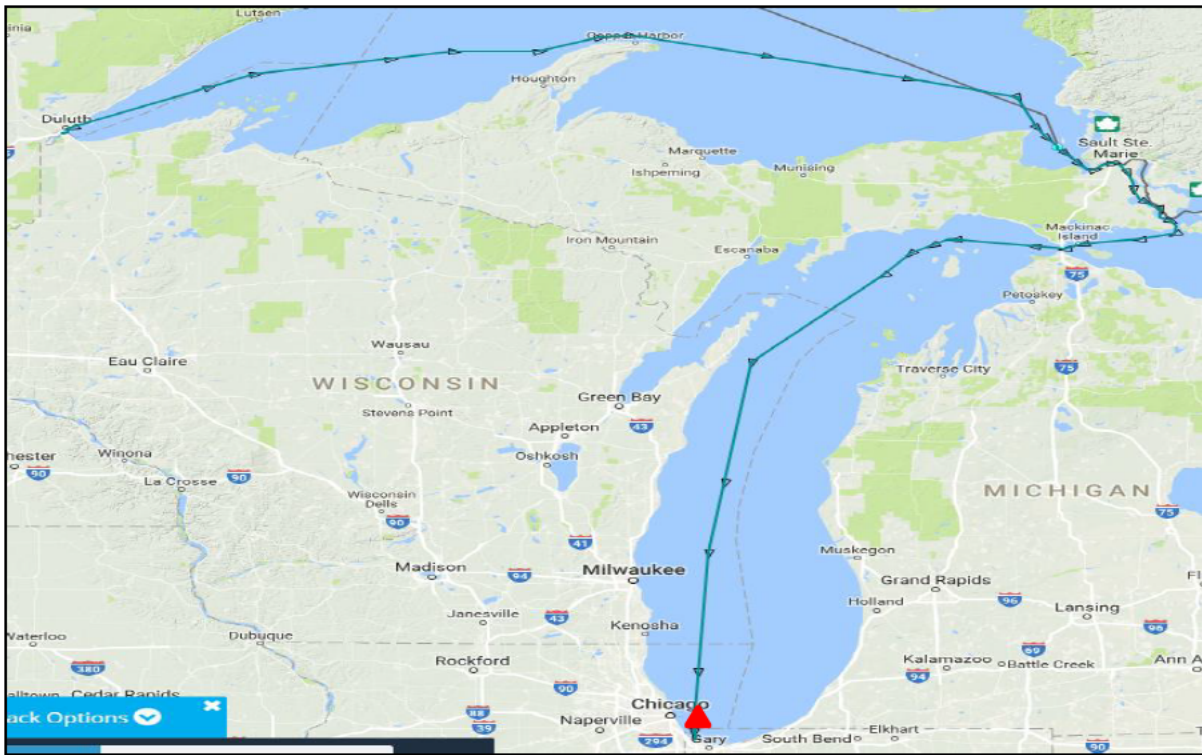
- 4.38 3 April 0020- While making preparations to enter Indiana Harbor, Mr. ██████ made his way to the bow of the ERIE TRADER to assume the Bow Watch. While walking to the bow he heard a noise that sounds to him like the vessel hitting ice. Upon realizing that there was no ice in the Indiana Harbor area, he investigated the noise. He peered over the starboard bow of the ERIE TRADER and discovered that the anchor was deployed. Mr. ██████ immediately notified bridge of the situation via hand held radio. Mr. ██████ the 2nd Mate, who was at the helm, took all pitch off the propellers and brought the vessel to a halt (see figure 4-10).

Figure 4-10 CLYDE S. VANENKEVORT AIS track line from Duluth, MN to Indiana Harbor, IN. AIS track line from 30 March 2018 through 3 April 2018. Image by Port and Waterways Safety System PAWSS. Red area signifies approximate location where the anchor was discovered to be deployed.
