**REPORT OF INVESTIGATION INTO THE  
CIRCUMSTANCES SURROUNDING THE PARASAILING  
ACCIDENT WITH LOSS OF LIFE AND INJURY ON THE**

**SMALL PASSENGER VESSEL M/V TURTLE  
(VI0776TC)**

**IN THE VICINITY OF ST THOMAS HARBOR, USVI  
ON NOVEMBER 15, 2011**

**INJURY AND LOSS OF LIFE ONBOARD THE PASSENGER VESSEL  
TURTLE WHILE CONDUCTING PARASAIL OPERATIONS  
IN THE VICINITY OF ST. THOMAS HARBOR, U.S. VIRGIN ISLANDS  
ON NOVEMBER 15, 2011**

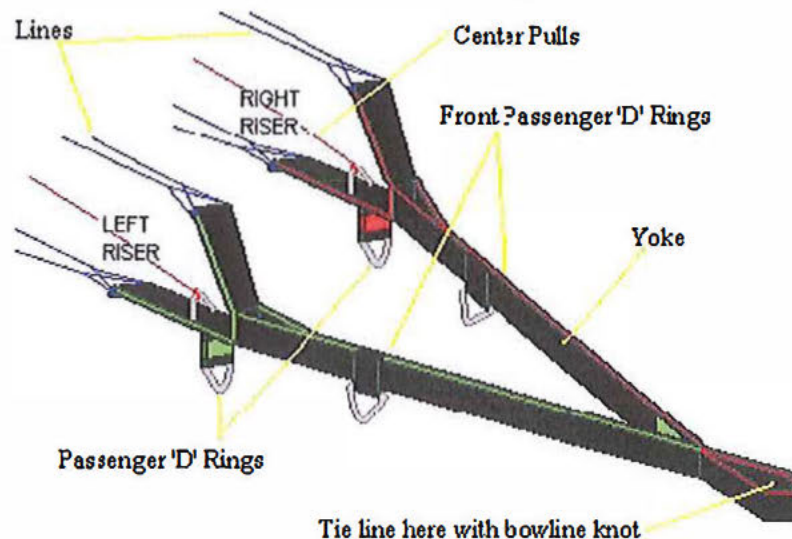
Figure 04. Graphic of a parasail harness

29. The passenger harnesses were both manufactured by Custom Chutes Inc. The passenger harnesses have two leg openings and a padded back rest and seat. Once placed on the passengers, they sit in the harness, with feet hanging below them, during flight. Both passenger harnesses were recovered after the incident. No equipment failure found.
