## REPORT OF INVESTIGATION INTO THE CIRCUMSTANCES SURROUNDING THE PARASAILING ACCIDENT WITH LOSS OF LIFE AND INJURY ON THE

SMALL PASSENGER VESSEL M/V X-TREME  
(O.N. 1153017)

IN THE VICINITY OF HONOLULU HARBOR HOTEL  
BUOY  
ON JANUARY 29, 2012

**INJURY AND LOSS OF LIFE ONBOARD THE PASSENGER VESSEL X-TREME  
WHILE CONDUCTING PARASAIL OPERATIONS IN HONOLULU HARBOR  
ENTRANCE NEAR LIGHTED BUOY "H" ON JANUARY 29, 2012**

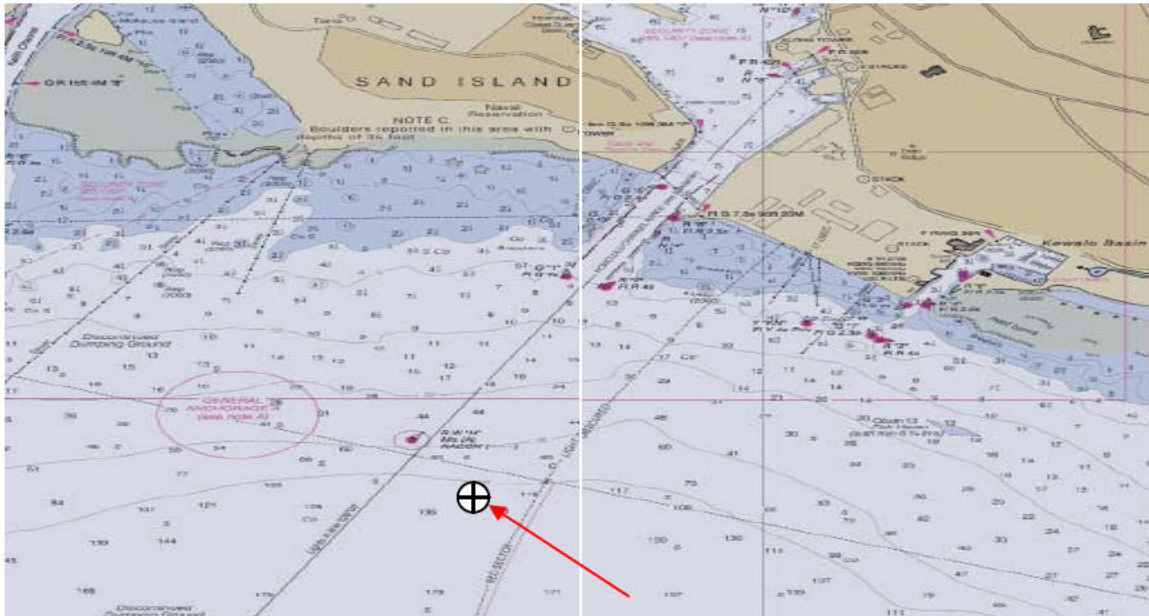
Figure 1: (Approximate location of the towline parting)

The incident happened in Mamala Bay, South East of Honolulu, Hawaii, near the “H” Buoy at the approximate location of 21° 16.789’ N, 157 ° 52.211’ W.

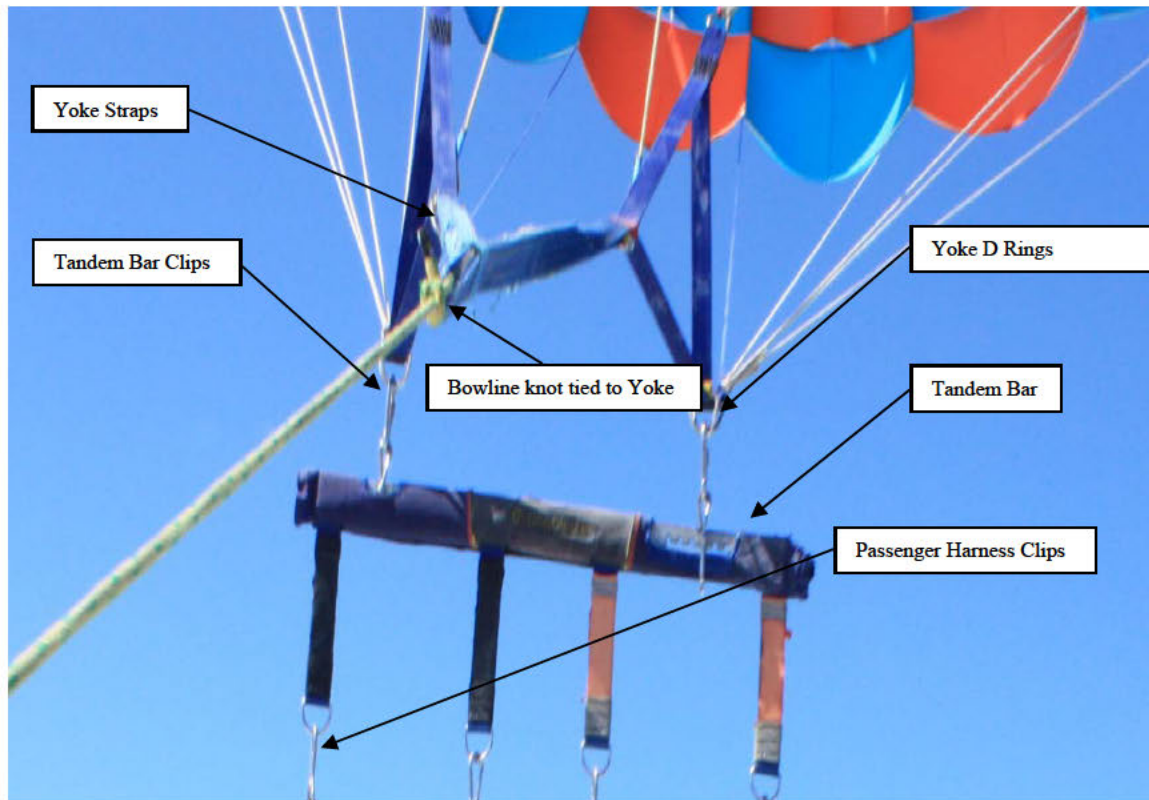
12. The parasail being used at the time of the incident was a Bird's Parasail Australia Trivent 34-foot parasail, manufactured in November 2009. The parasail was purchased through Bird's Parasail Australia and shipped on March 15, 2011. The parasail and all associated rigging sank in deep waters at approximately 21° 16.545' N, 157 ° 52.758' W in the vicinity of Honolulu Harbor H buoy and were not recovered.
13. The passenger bar was purchased from Custom Chutes Inc. The passenger bar hooks into the parasail yoke and the passenger harnesses clip into the bar straps, hanging below the bar during flight. The passenger bar was not recovered after it was cut away from the M/V X-TREME and sank in deep water. The majority of the towline spooled on the winch, passenger harnesses and the bitter end of the parted line was available for inspection.

Figure 4: Actual rigging used during the incident.

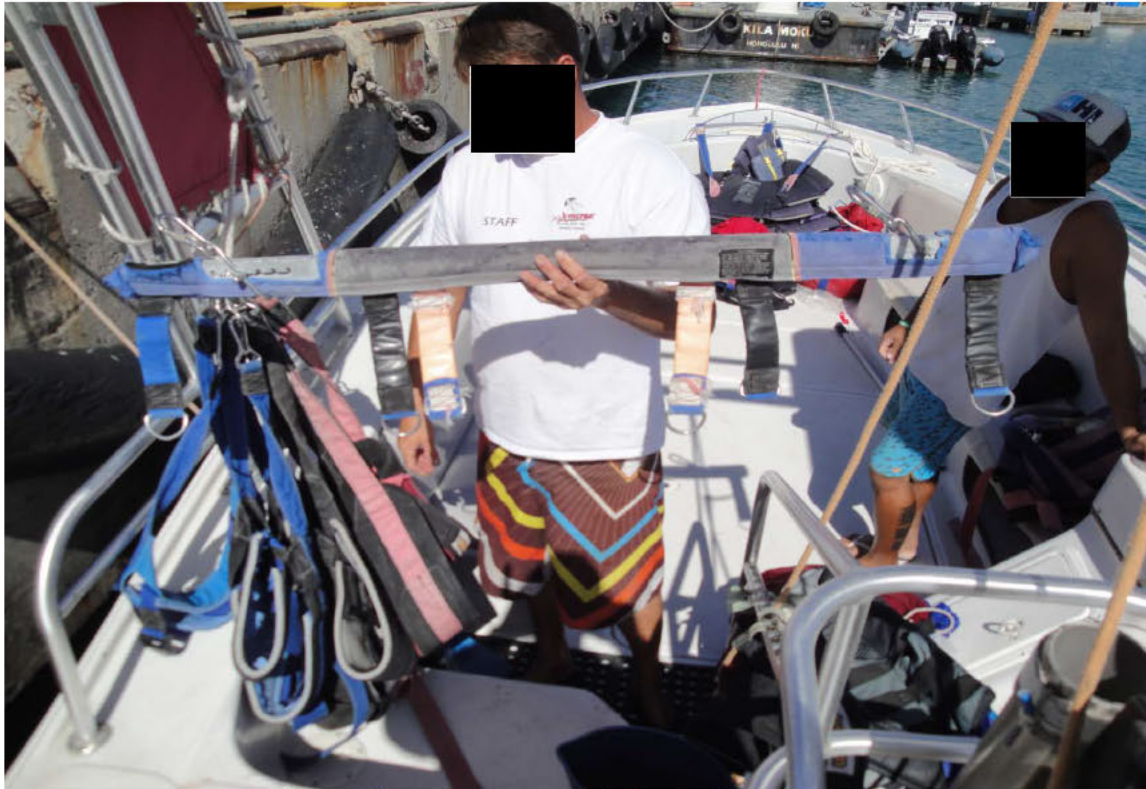
15. The passenger harnesses were both manufactured by Custom Chutes Inc. The passenger harnesses have two leg openings and a padded back rest and seat. When worn correctly, passengers sit in the harness, with feet hanging below them, during flight. Both passenger harnesses were recovered after the incident, with no equipment failures identified. However, investigators determined that the X-TREME crew attached the harnesses to the passenger bar with clip openings facing toward the stern of the boat. This way of attaching the clips creates the potential that, in the event of passengers being dragged backwards through the water, the resultant force of the water that is applied to the clips might open them.

Figure 6: Picture of M/V X-TREME triple bar similar to the tandem bar that was lost.

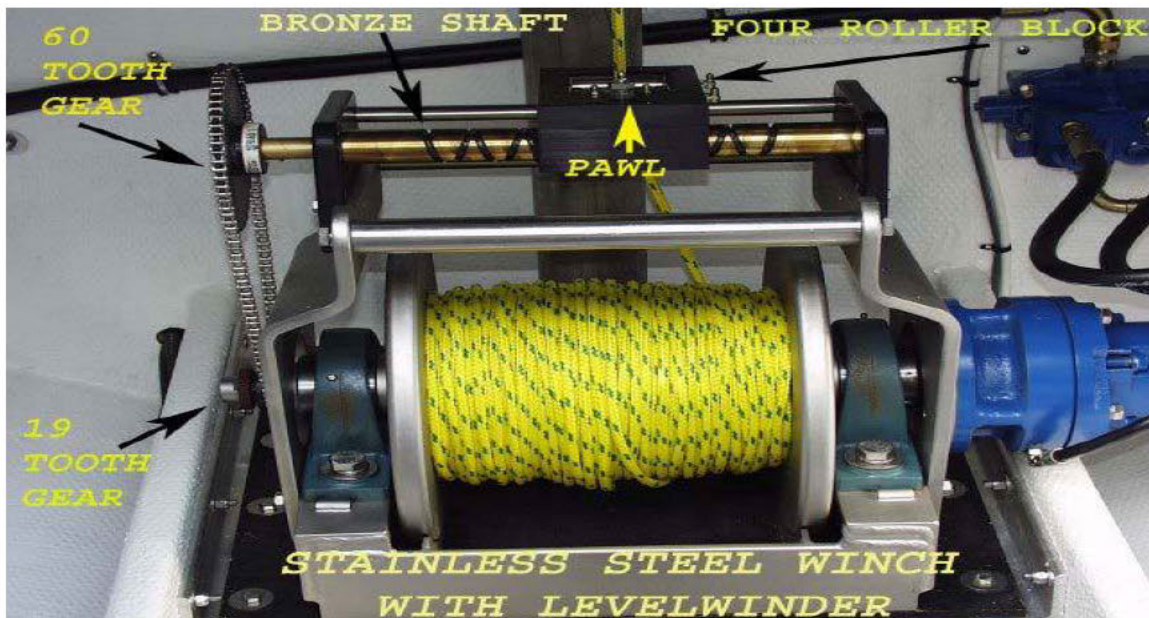
16. All parasailing machinery appeared to be operating properly. The M/V X-TREME parasailing winch drum was built by Mark I Industries and is made of heavy duty, stainless steel parts, equipped to handle 1,000 feet of 7/16-inch towline.

Figure 7: Picture of a winch similar to the winch onboard the M/V X-TREME.

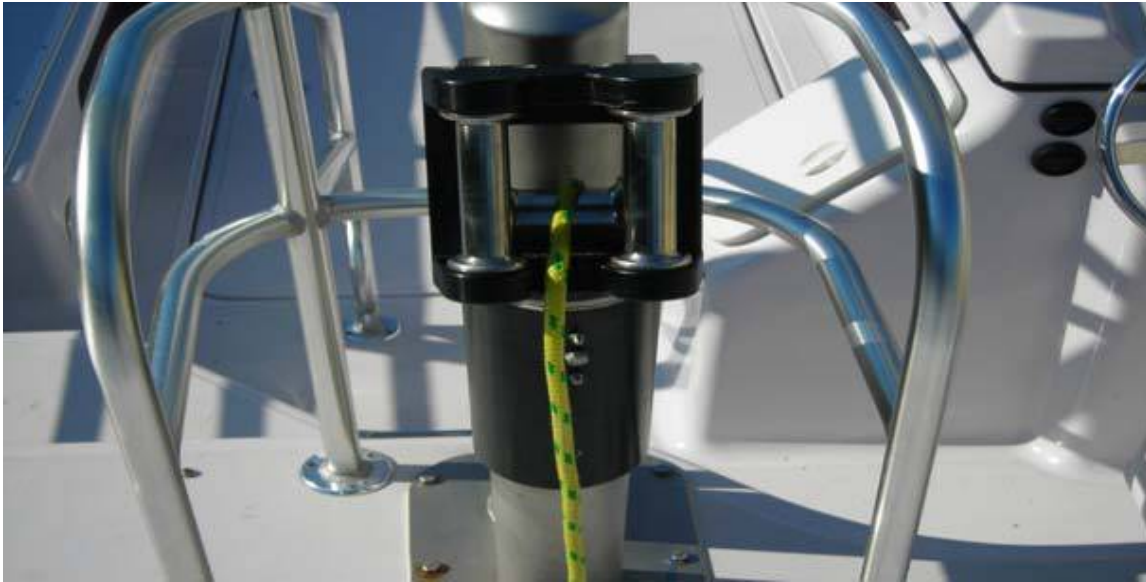
18. The onboard hydraulic winch system is fitted with a 3,000 pounds PSI relief setting. When this relief pressure is reached, hydraulics system will re-circulate fluid, preventing a hydraulic line failure, winch overload, or free spooling of the towline and freezing the movement of the towline until the pressure is within operating parameters.
19. A towline tri-roller head onboard the M/V X-TREME was mounted on the vessel's tow post. The tri-roller head consists of a two and a half inch diameter swivel mount, equipped with bearings, two vertical rollers on each side, one horizontal roller and a safety mechanism called a knot breaker at the bottom of the line guide. The roller is capable of swiveling from left to right at approximately 180 degrees as passengers are in flight.

Figure 9: Picture of a Tri-roller head similar to the tri-roller head onboard the M/V X-TREME.

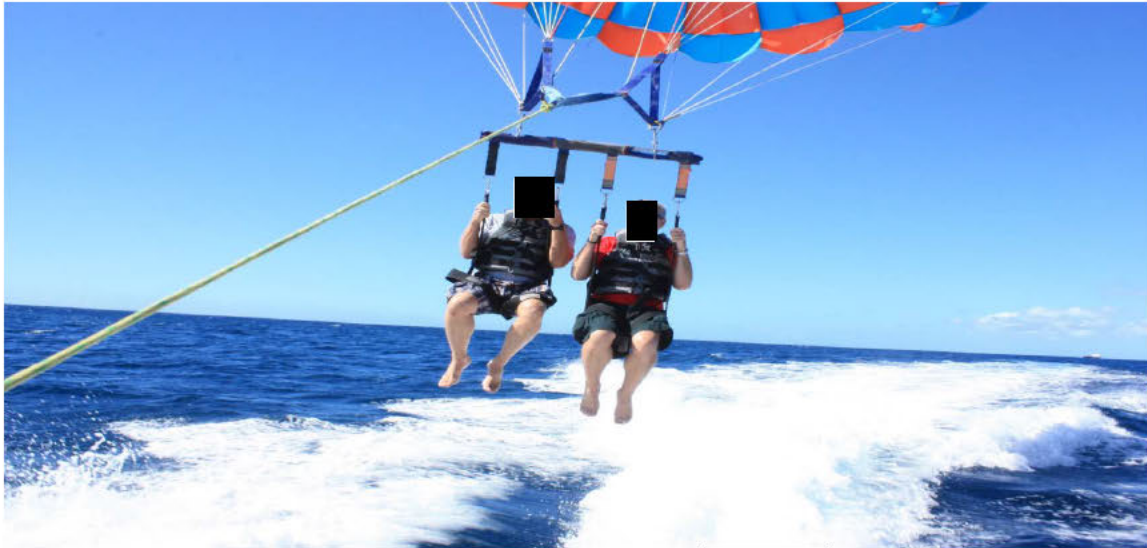
Figure 11: Picture of Mr. Banaszynski and Mr. [REDACTED] being launched.

Captain [REDACTED] launched Mr. Banaszynski and Mr. [REDACTED] without complication. Captain [REDACTED] paid out approximately 800 feet of line. Mr. Banaszynski and Mr. [REDACTED] reached a height of approximately 200 to 300 feet. While at the peak of their flight, passengers and Mr. [REDACTED] commented that the parasail was being buffeted by winds and the parasail was being rocked back and forth. During the retrieval leg of the flight Captain [REDACTED] stopped the vessel and winch and dipped the flyers' feet in the water. Photographs of the flight taken by the deckhand show wind chop and white caps in the vicinity of their operation. The winds were consistent with Beaufort scale rating of #5 moderate to fresh breezes with winds speed of 17 to 21 knots.
