UNITED STATES COAST GUARD

REPORT OF INVESTIGATION INTO THE CIRCUMSTANCES SURROUNDING THE INCIDENT INVOLVING A PARASAILING ACCIDENT ON THE

FL0238HY

**ONE MILE OFF HILLSBORO INLET,
POMPANO BEACH, FLORIDA ON 08/15/2012
WITH THE LOSS OF ONE LIFE**

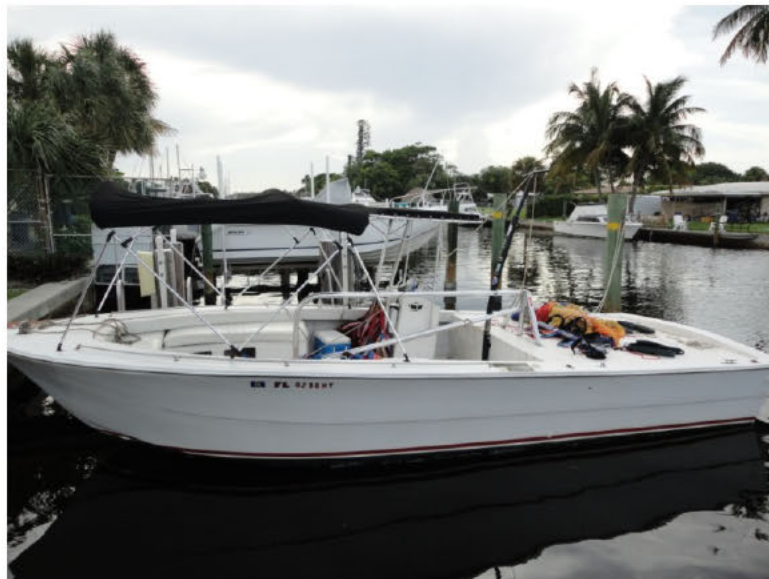
Figure 1 - FL0238HY immediately following casualty.

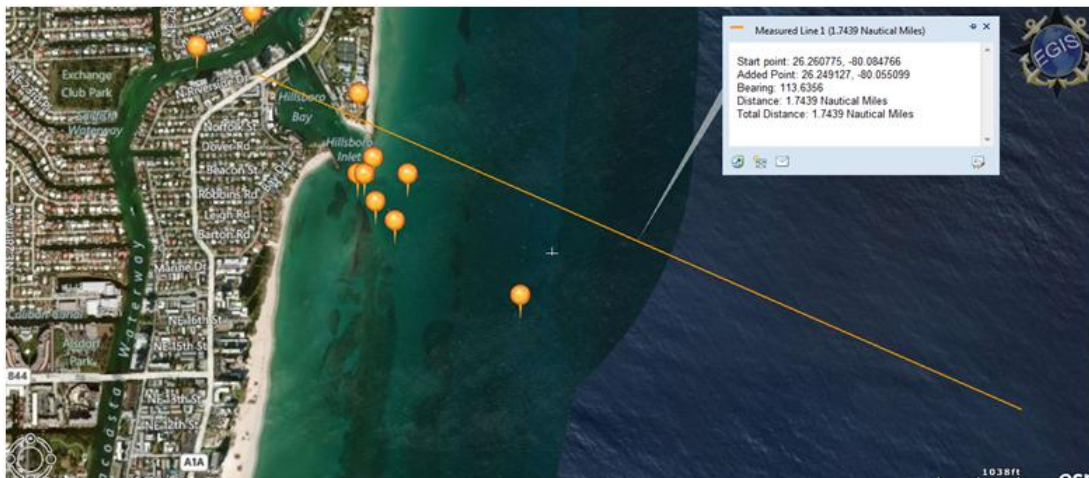
40. A line of position was established for the location of the casualty using the photograph in Figure 10. In this photograph of the moment the casualty occurred, the Hillsboro Lighthouse can be seen in the bottom-left corner of the photograph aligned with a multi-story building. The multi-story building is the Hillsboro Light Towers and using mapping software, it was determined that the casualty occurred ½ to 1 NM from shore on a bearing of 113 degrees true from the Hillsboro Lighthouse (Figure 2). The orange markers in Figure 2 indicate aids to navigation.

Figure 2 - Line of position for the location of the casualty.

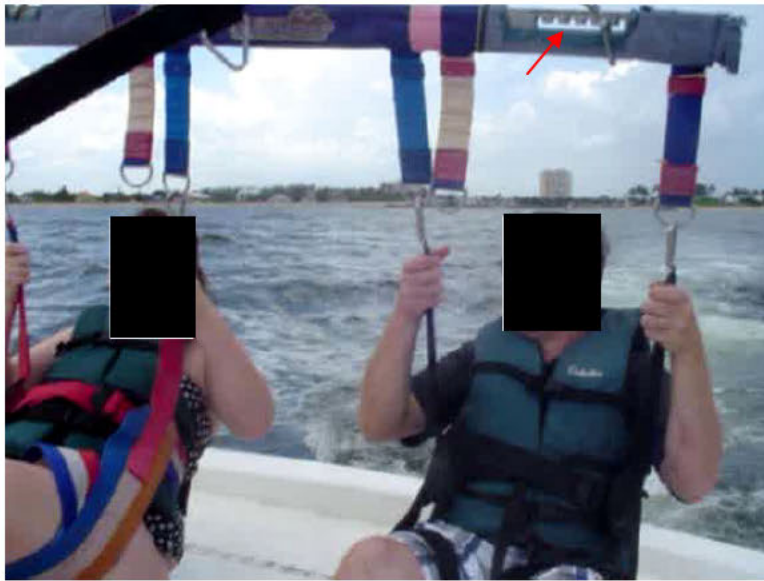
55. In relation to the vessel, Mrs. Miskell's harness was clipped to the hanging straps marked with blue blazing on the starboard side of the flight bar and Mr. ██████ harness was clipped to the corresponding hanging straps on the port side. The carabineer for the weight difference adjustment on the flight bar was in the second notch of the adjustor slot (see arrow in Figure 3).

Figure 3 - Passengers attached to the flight bar, just prior to launch.

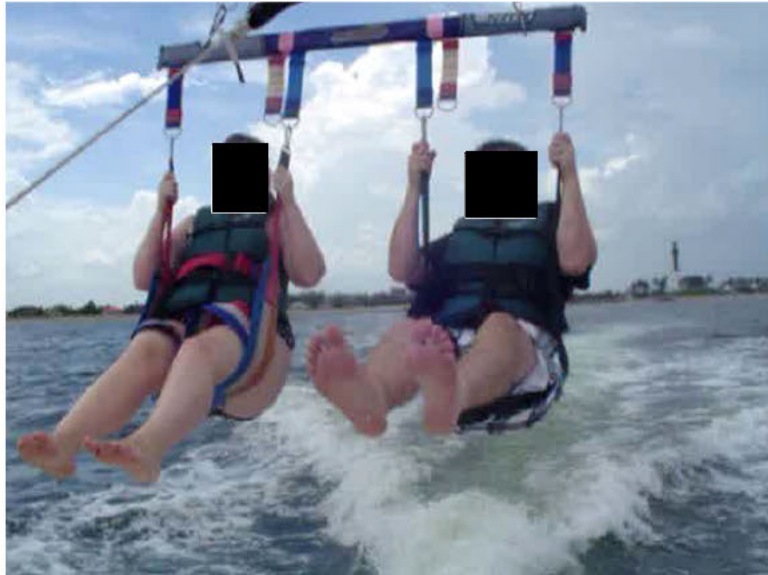
57. At 1500, the passengers began their parasail flight (Figure 5). The master put the FL0238HY on a southeasterly course into the wind. He accelerated the boat and began to let line out using the winch controls mounted on the right side of the helm.

Figure 5 - Passengers immediately after launch.

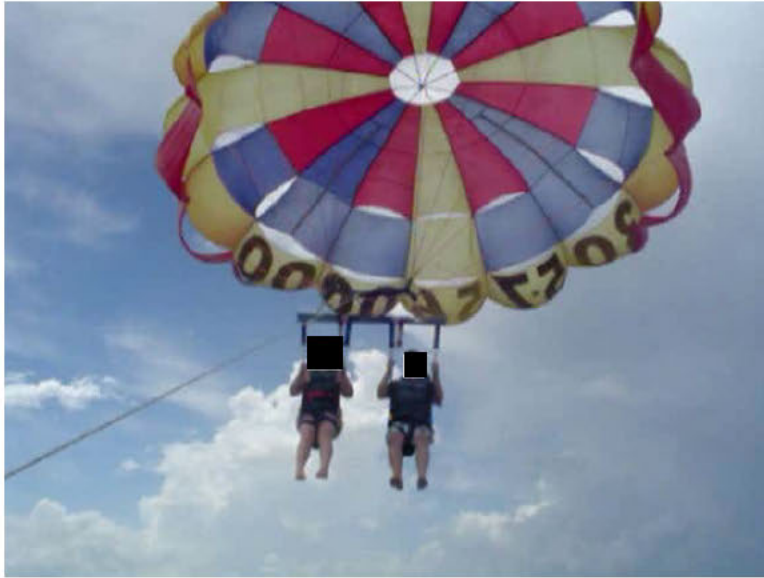
59. The master let out approximately 800' of towline (Figures 6, 7, 8 and 9). He stated that the winds were consistently out of the southeast at about 6 knots and that the sea state consisted of a "little chop".

Figure 6 – The parasail being let out.

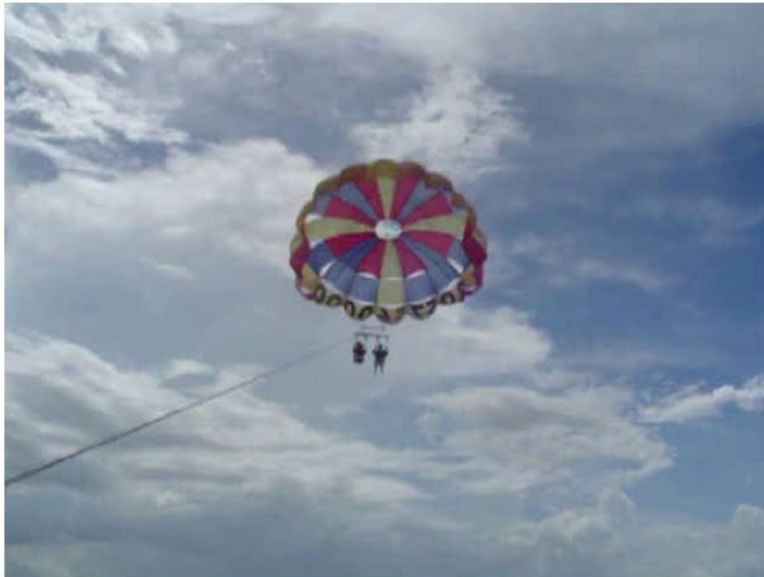
Figure 7 – The parasail being let out.

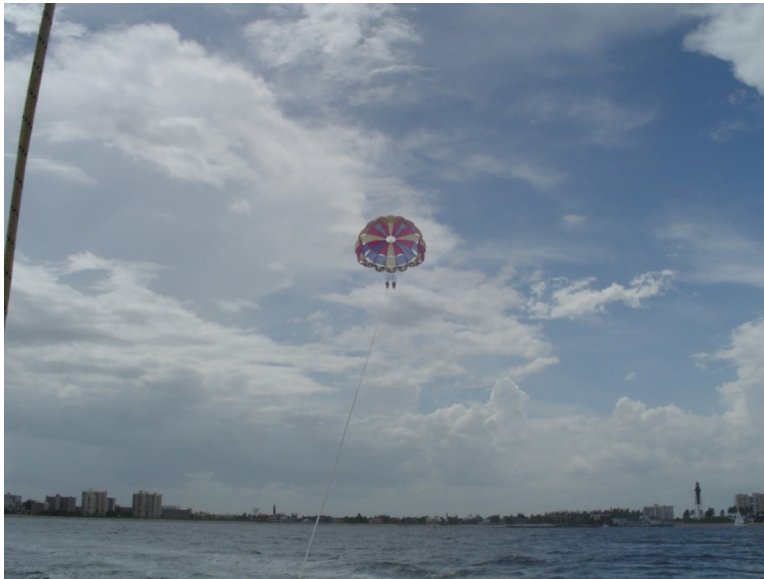
60. Once the two passengers were near their maximum height, the deckhand switched the camera to picture mode and captured 31 pictures of their flight (Figures 8 and 9).

Figure 8 – The parasail being let out.

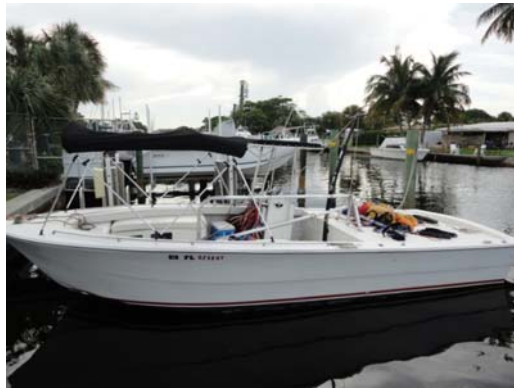
85. After the victim and her husband had been transported to the hospital, the FL0238HY was moved to the Broward Sheriff's Office facility at Alsdorf Park (Figure 11) where investigators examined the vessel and its equipment.

Figure 11 - FL0238HY at BSO office in Alsdorf Park.

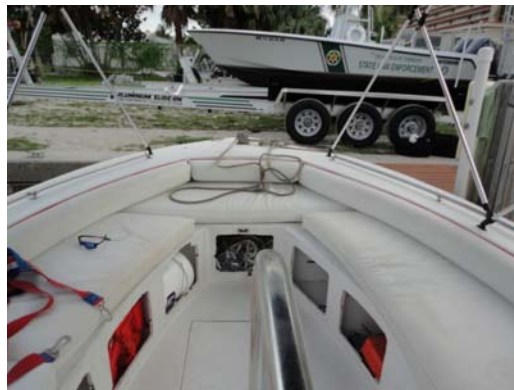
86. Figure 12 shows the FL0238HY and the equipment onboard from an amidships position looking forward.

Figure 12 - Bow of the FL0238HY.

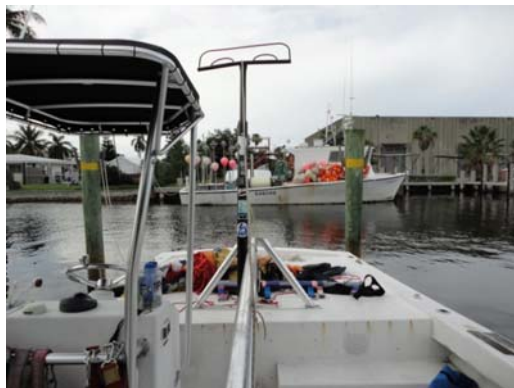
87. Figure 13 shows the FL0238HY and the equipment onboard from an amidships position looking aft.

Figure 13 - Stern of the FL0238HY.

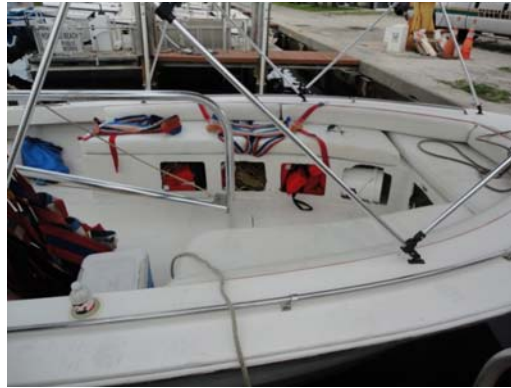
88. In the under-seat storage area on the port side of the FL0238HY, investigators found multiple Type 1 PFDs that were used for compliance with 46 C.F.R. Subchapter C. These PFDs were not being worn by the passengers at the time of the casualty (Figure 14).

Figure 14 - Inside view of FL0238HY.

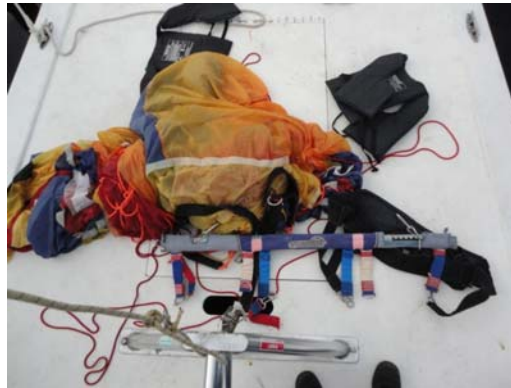
90. On the aft flight deck, investigators found the parasail and yoke attached to the towline, the two PFDs worn by the passengers during the flight, the flight bar, the remnants of the victim's harness, and the harness that the victim's husband had worn (Figure 16).

Figure 16 - Parasail equipment in use during the casualty on flight deck.

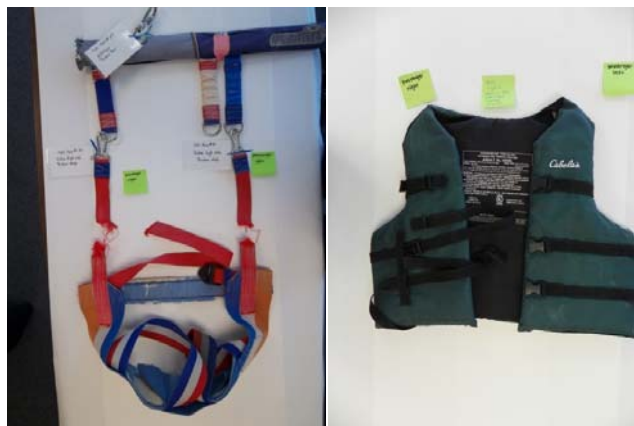
97. On August 21, 2012, investigators from Sector Miami, Sector St. Petersburg, and FWC conducted a detailed examination of the FL0238HY and the equipment onboard the vessel at the FWC's secure evidence bay in Port Everglades, Florida. All equipment was removed from the vessel, examined, photographed and cataloged (Figure 21). As lead agency, investigators from FWC seized all the parasail equipment from the vessel, tagged it with evidence control labels and entered it into their evidence control system. FWC also retained the FL0238HY itself.

Figure 21 - Evidence from the casualty was catalogued and photographed.

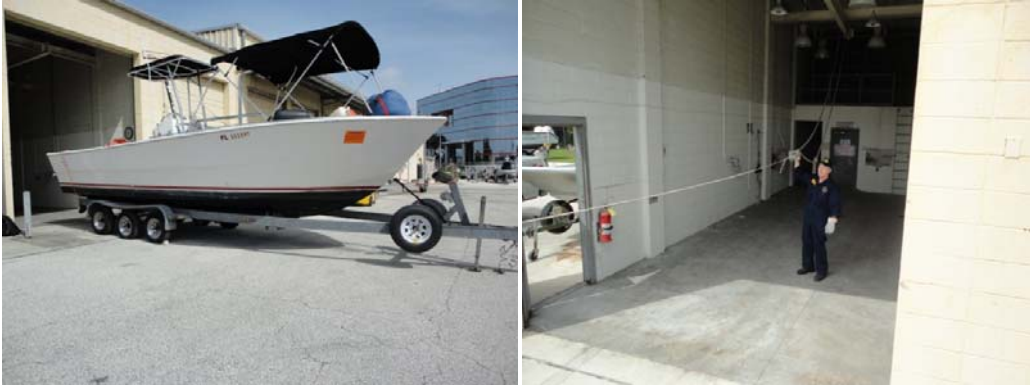
98. On August 31, 2012 the investigating agencies conducted operational pull tests of the parasail line winch (hereafter referred to as “winch”) onboard the FL0238HY (Figure 22).

Figure 22 - FL0238 removed from evidence bay for winch test, and the configuration of the test equipment.

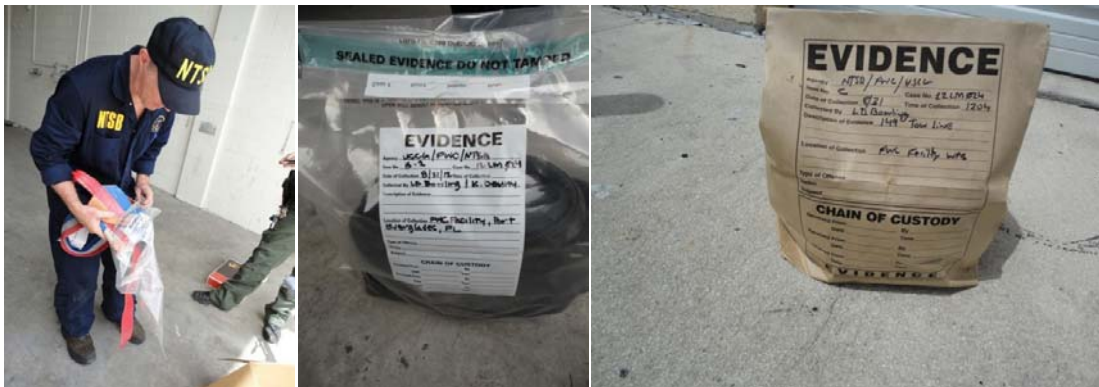
99. On August 31, 2012, at the completion of the winch tests, FWC transferred the victim’s harness, the second parasail passenger’s harness, the flight bar, and 149’2” of towline to the NTSB investigator for testing at the Office of Research and Engineering, Materials Laboratory Division in Washington, DC. The evidence was securely packaged and mailed to the NTSB laboratory on the same day (Figure 23).

Figure 23 - Evidence being transferred to NTSB.

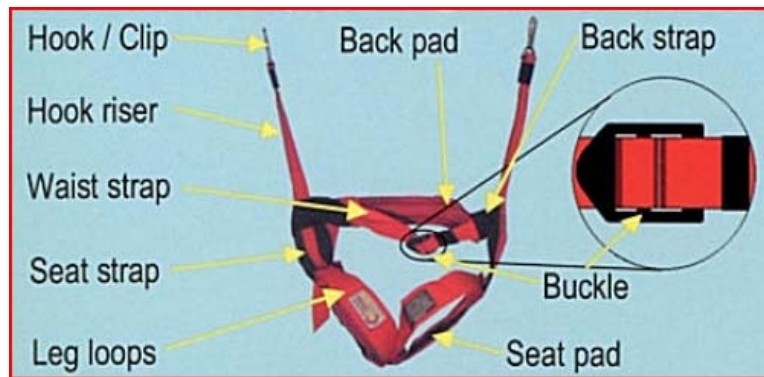
25. Figure 24 shows the components of a parasail harness.

Figure 24 - Harness components (courtesy of Custom Chutes, Inc.'s Product owners and maintenance manual).
