**REPORT OF INVESTIGATION INTO THE  
CIRCUMSTANCES SURROUNDING THE INCIDENT  
INVOLVING  
M/V WHY KNOT  
PERSONAL INJURY**

**ON 07/01/2013**

**MATERIAL FAILURE WITH PASSENGER INJURIES OCCURRING ON THE  
UNINSPECTED PASSENGER VESSEL WHY KNOT NEAR PANAMA CITY BEACH,  
FLORIDA ON JULY 01, 2013**

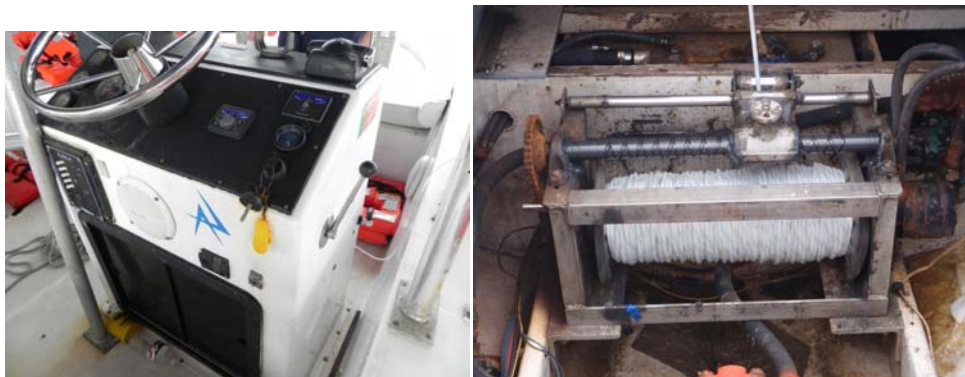
Vessel steering station with winch control

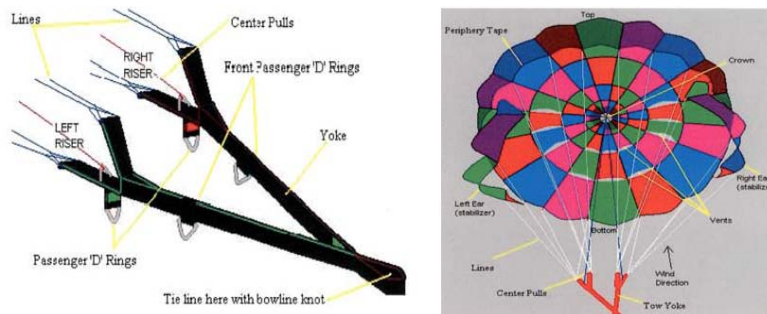
16. The yoke and riser assembly consists of three layers of two-inch polyester webbing connected to the parasail by 16, 7/32-inch polyester shroud lines. The parasail towline connects to the yoke with a bowline knot.

Parasail harness and assembly

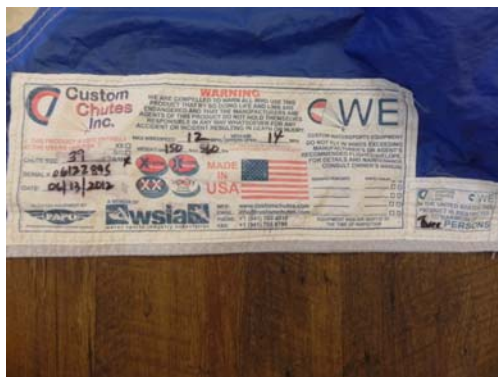
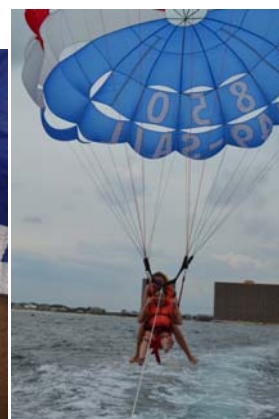
15. A Custom Chutes manufacturer's label affixed to the parasail canopy involved in the marine casualty identifies it as a 39-foot parasail. It was manufactured in June, 2012, serial number 06122895, and is designed to operate for a passenger weight load between 150 and 560 pounds and in winds not greater than 12 m.p.h. with air management zippers closed and 14 m.p.h. with air management zippers open.

Left: Label from the Custom Chute involved in the marine casualty.  
Right: Chute in use just prior to the casualty.

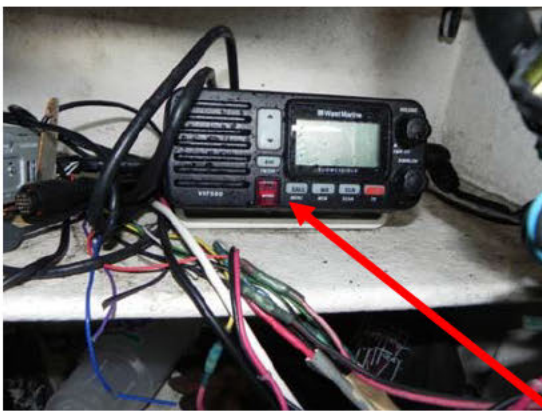
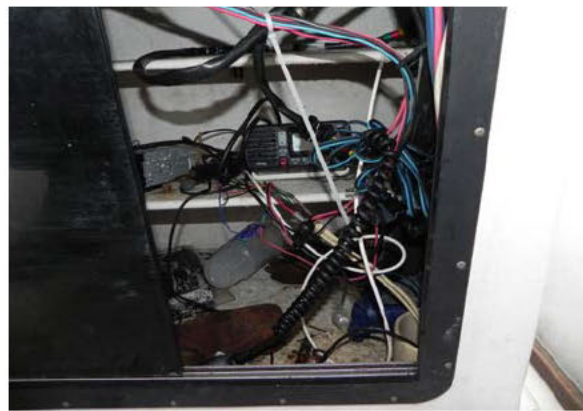
19. On 01 JUL 2013, the WHY KNOT was equipped with an operational VHF Marine Band Radio capable of receiving special weather broadcasts. The radio was energized and operational. However, Aquatic Adventures employees and parasail vessel operators relied on the use of handheld radio to collaborate on parasail operations and communicate weather conditions.

VHF Marine radio with weather channel, located in the steering console

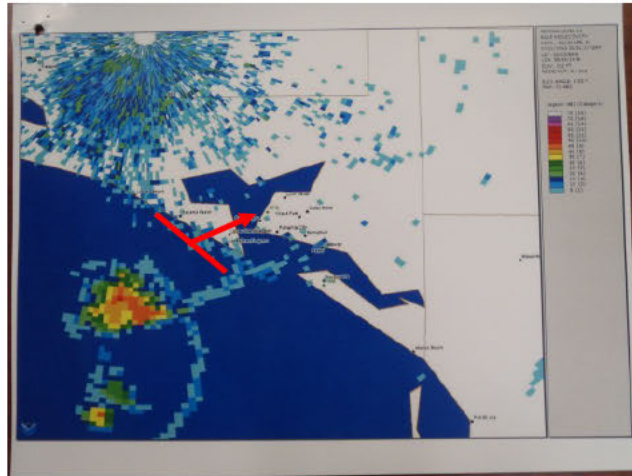
28. At 1531, weather radar images provided by NOAA show another storm cell located approximately 4 miles from the coastline moving North East towards the Panama City Beach.

Weather picture obtained from NOAA National Climatic Data Center for 1531 on 01 JUL 2013

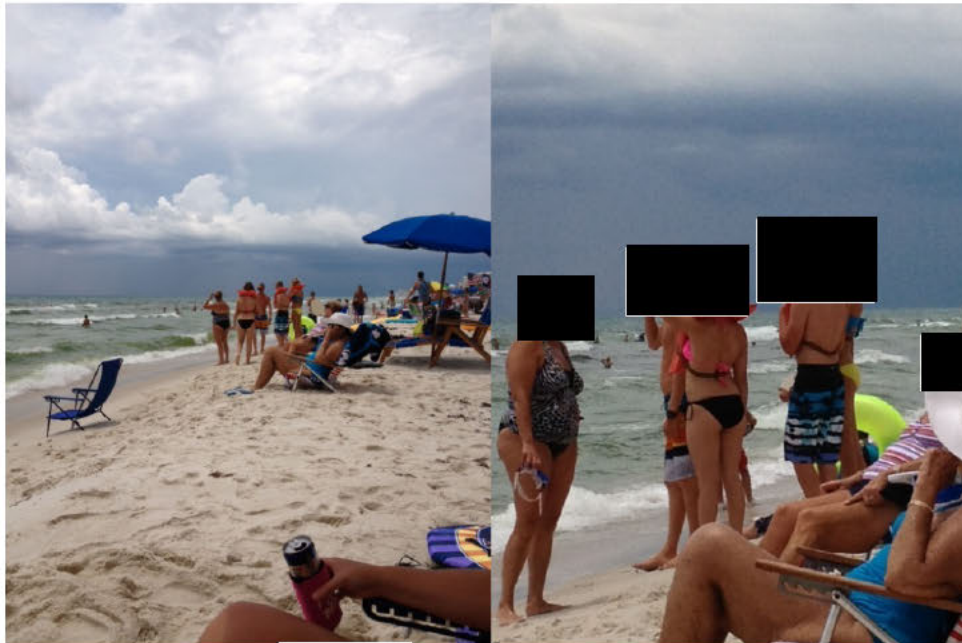
29. At 1525, Mr. [REDACTED] took photos prior to passengers [REDACTED] and [REDACTED] leaving the beach. Dark clouds from the storm cell moving in offshore are clearly visible from the beach where the passengers awaited to board the parasail vessel.

Photos taken by [REDACTED] prior to passengers leaving the beach.

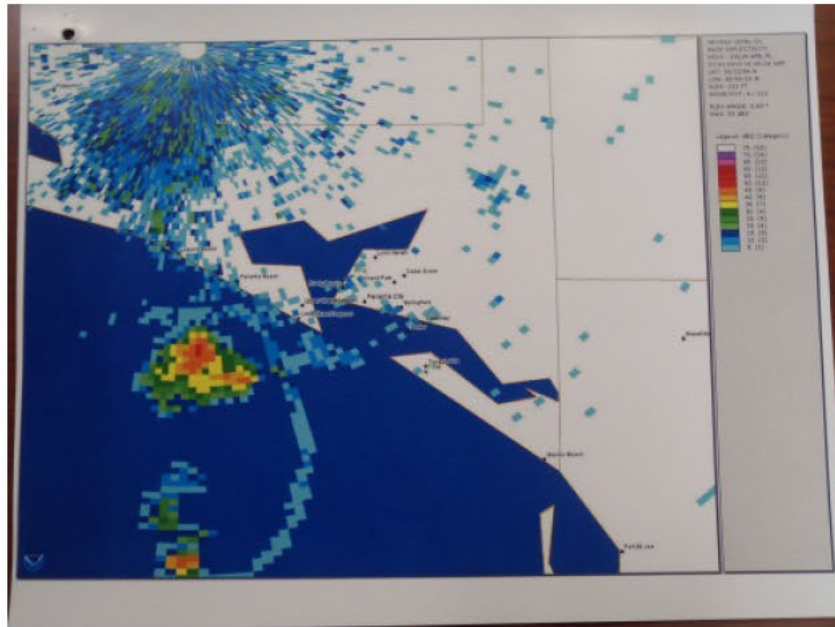
33. At a 1545, NOAA weather radar shows the storm moving closer to Panama City.

Weather picture obtained from NOAA National Climatic Data Center for 1545 on July 1, 2013

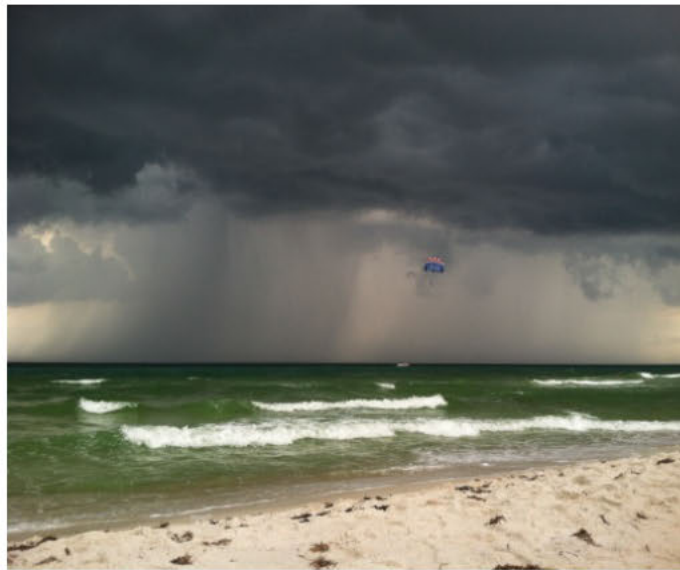
31. At approximately 1550, Photo Taken by [REDACTED], a bystander on the beach, shows the parasail afloat with the storm front moving into the WHY KNOT's operational area.

[REDACTED] and [REDACTED] aloft at approximately 1550. Photo taken from the beach.

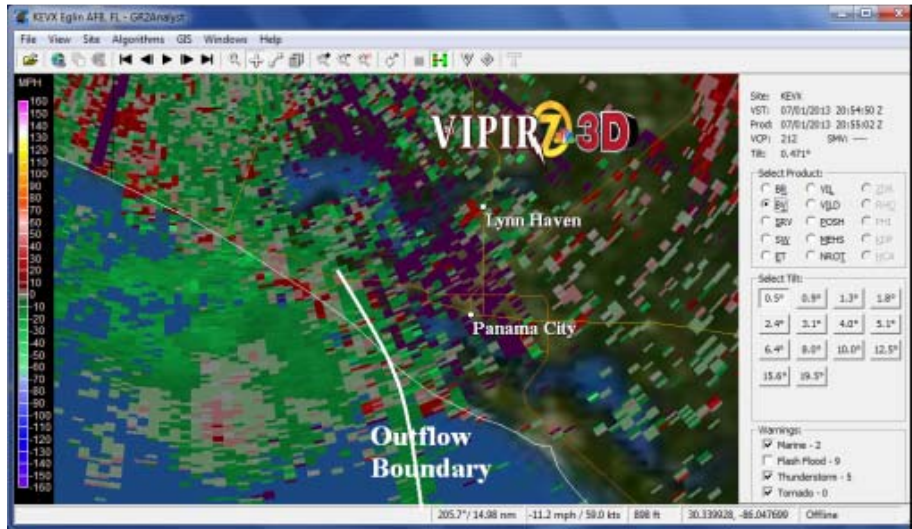
33. At 1555, weather radar images obtained from WJHG News Panama City clearly show the “Outflow Boundary” in the immediate vicinity of the WHY KNOT. An outflow boundary, also known as a gust front, is a storm-scale boundary separating thunderstorm-cooled air (outflow) from the surrounding air. This results in a direction shift of the wind, decrease in ambient temperature, and an increase of barometric pressure.

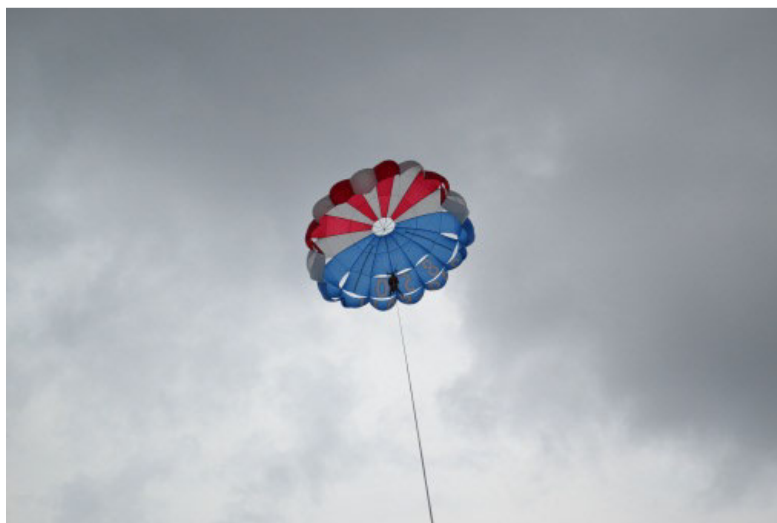
Photo of [REDACTED] and [REDACTED] directly overhead of WHY KNOT

34. At approximately 1555, immediately after taking the photo showing the parasail directly overhead, the prevailing weather conditions overcame the winch’s ability to reel in the parasail. The WHY KNOT subsequently lost all forward momentum and the combination of the increased strain on the parasail due to the increased wind pulled WHY KNOT stern first toward the beach.

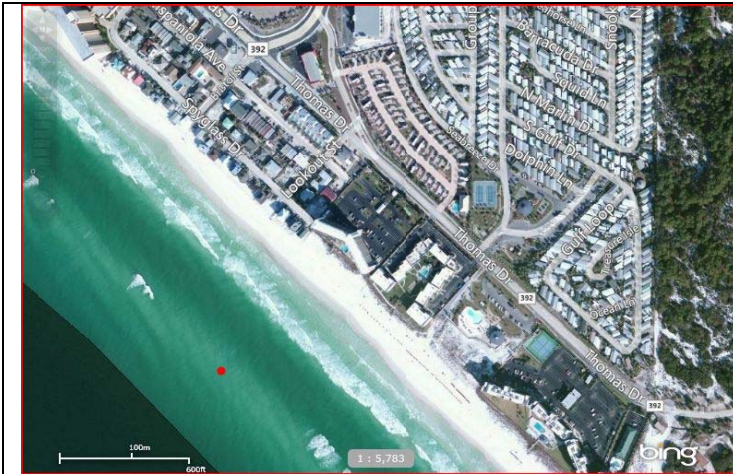
35. As the WHY KNOT began to cross the outer sandbar (approximately 900-1200 feet from the beach), Captain [REDACTED] directed crewmember [REDACTED] to go forward on the vessel and toss the anchor off the vessel's bow to arrest the momentum toward the beach. Once the anchor set, Captain [REDACTED] continued to increase RPM's on the engine to try to get more power to the winch to reel in the passengers for several minutes.

Location of parasail vessel anchored on sandbar  
Approximately 1.25 miles West of St Andrews Pass,  
Panama City Beach, Florida.

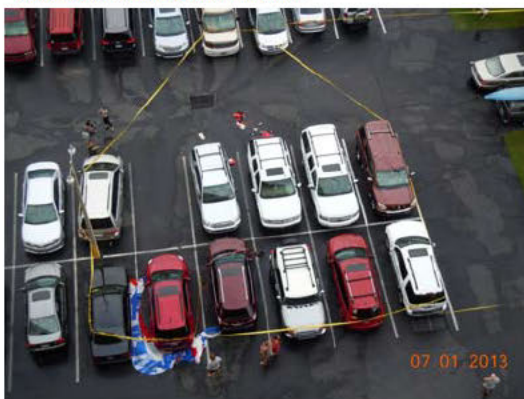
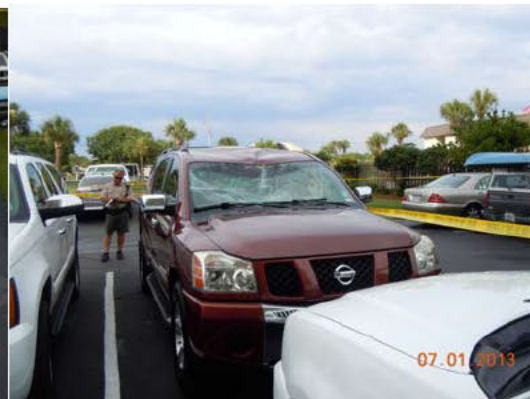
North side parking lot where parasail and passengers landed

Automobile where ██████████ and ██████████ landed

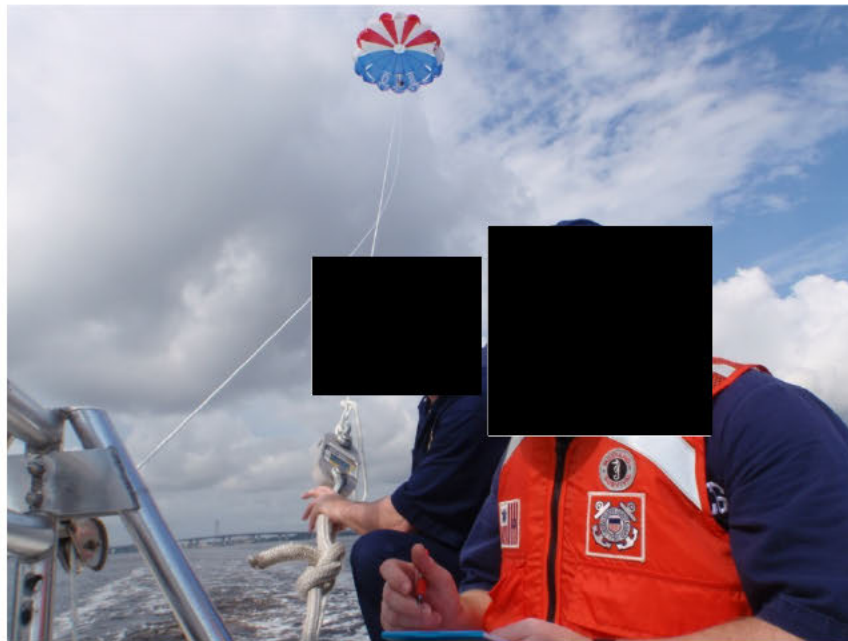
To examine the “typical” forces applied to the towline and winch in favorable weather conditions, on 13 JUL 2013, investigators also conducted underway test of force applied to the towline utilizing the WHY KNOT and the parasail involved in the casualty. Comparing the results of this underway operational test to the results of the maximum static pull test, results clearly indicate the winch experienced only half the tensional or torque forces compared to the static pull testing. Therefore, the operational and wind conditions at the time of the marine casualty presented forces almost double the “typical” parasail operations in favorable conditions.

Underway testing of force applied to towline of WHY KNOT

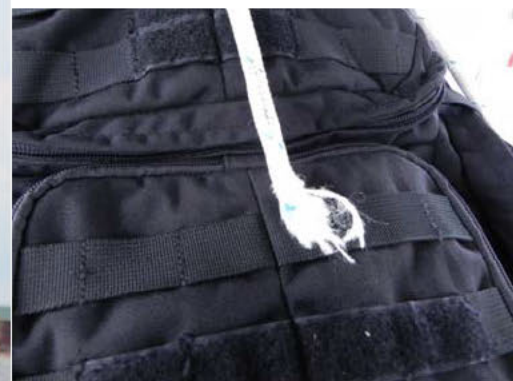
Line end still attached to the roll of line on the drum onboard the WHY KNOT

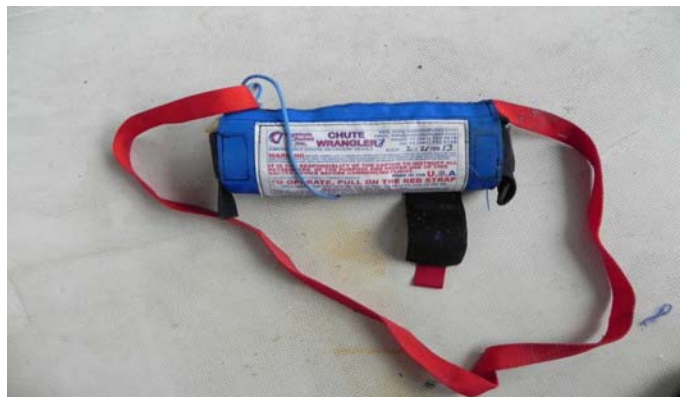
Included in the WHY KNOT's parasail equipment was a Chute Wrangler. Manufactured by Custom Chutes, Inc., the Chute Wrangler assists a parasail crew in the recovery of a parasail during times of an emergency, such as when a line breaks and the parasail falls into the water and may potentially drag the parasail riders. Fitted onto the rear riser of parasail, a passenger or crewmember can deploy the Chute Wrangler in the water to help bring a parasail to a slow stop, much like a sea anchor. Each parasail requires its own specific Wrangler deflation line appropriate for the various sizes of parasails. Investigators noticed the crew did not install the Chute Wrangler onto their parasail and found it tucked away in an onboard storage box. The crew indicated they did not use the Chute Wrangler because they did not have the correct size deflation line for their parasail.

WHY KNOT's Chute Wrangler.

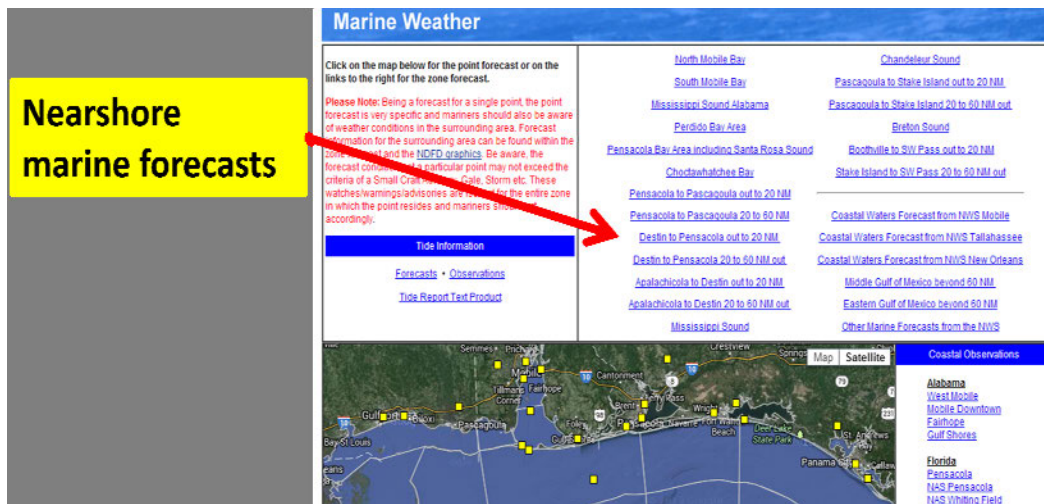
Screenshot of NWS Weather Forecast internet web page. Nearshore forecasts are found on the marine page found on the right.
