United States Coast Guard

Report of Investigation into the Circumstances Surrounding the CARIBBEAN FANTASY Fire, 2 Miles Northwest of San Juan, Puerto Rico; Subsequent Grounding and Evacuation of 511 Persons with 7 Minor Injuries on AUGUST 17, 2016

MISLE Activity Number: 5977513

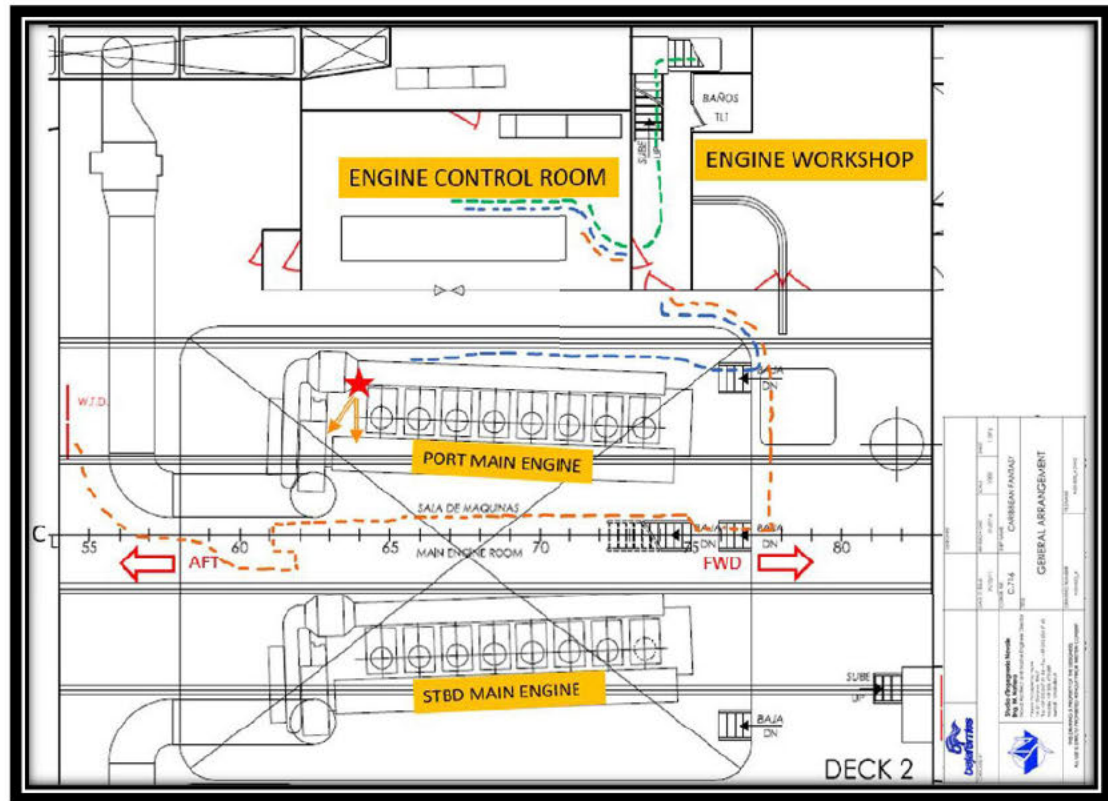
4.1.6. At 0723 the Chief Engineer reported the fuel leak to the bridge and took local control of the engine and reduced the pitch on the port main engine. He then left the ECR to return to the fuel leak which he discovered was now a fuel spray. The Chief Engineer observed the fuel spray ignite from contact with the exhaust manifold starting a fire. Both the Chief Engineer and Motorman, who were on the port side of the engine, returned to the ECR. When they returned to the ECR the Chief Engineer manually

activated the water-mist firefighting system, while the wiper, who was on the starboard side of the engine, evacuated the space via watertight door number 4 and 5 along the centerline of the vessel. This led through the auxiliary engine room immediately aft of the main engine room. He continued to evacuate via the stairs to garage B.

Figure 2; Engine room General Arrangement with fire location=*star* and egress routes of engine watch personnel. *Orange*=Wiper egress route; *Blue*=Motorman & Chief Engineer fuel spray investigation; *Green*=Motorman, Chief Engineer, and Third Engineer egress

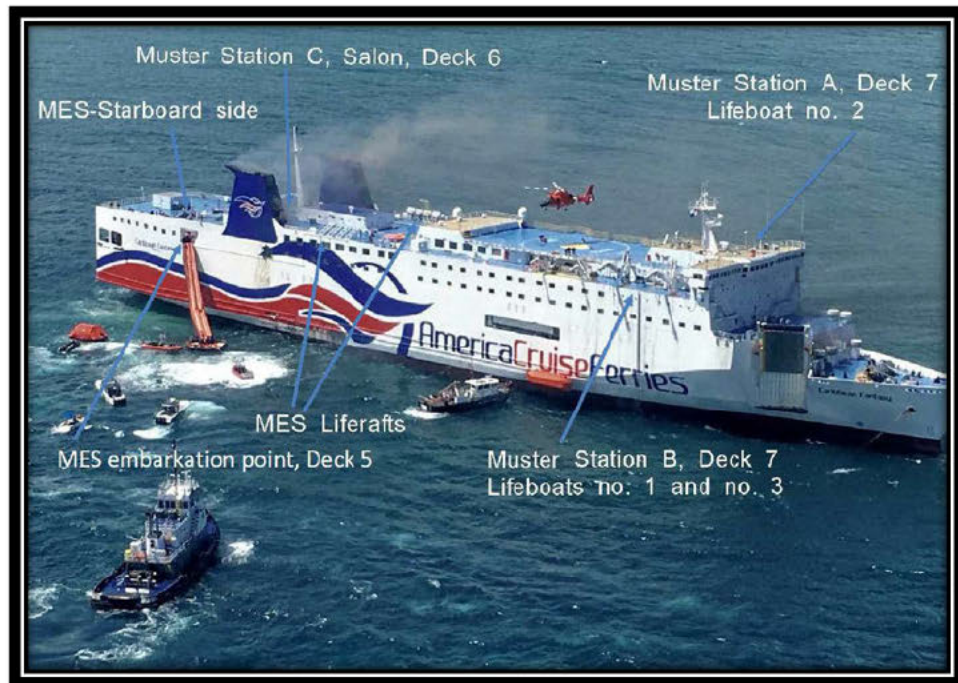
Figure 7; Photo during evacuation of CARIBBEAN FANTASY with Government, Commercial, and Recreational assistance.

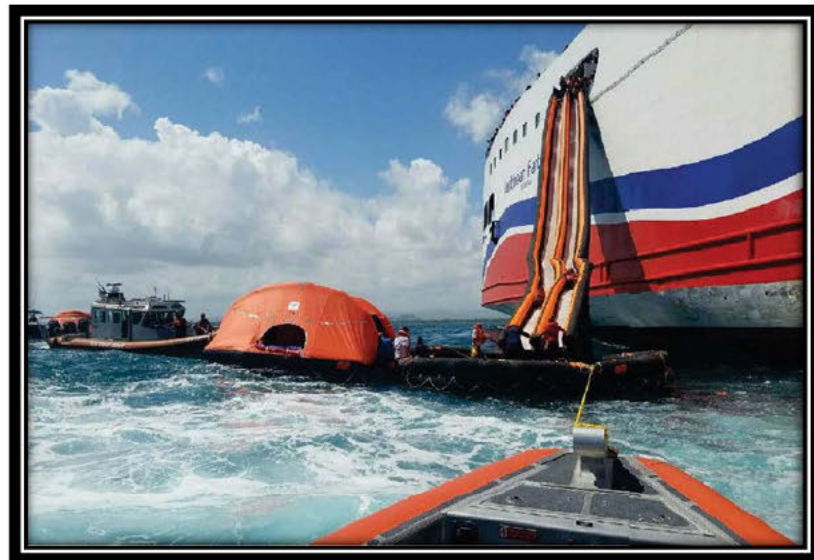
4.1.63. At 1009, a Coast Guard rescue boat attached a line to the starboard MES platform and pulled it forward to create a better slide angle. At 1010, the Master ordered the Staff Captain to proceed with sending the remaining passengers and crew down the slide.

Figure 10; Photo of CG response vessels assisting with moving liferafts and orienting the MES correctly during the evacuation.

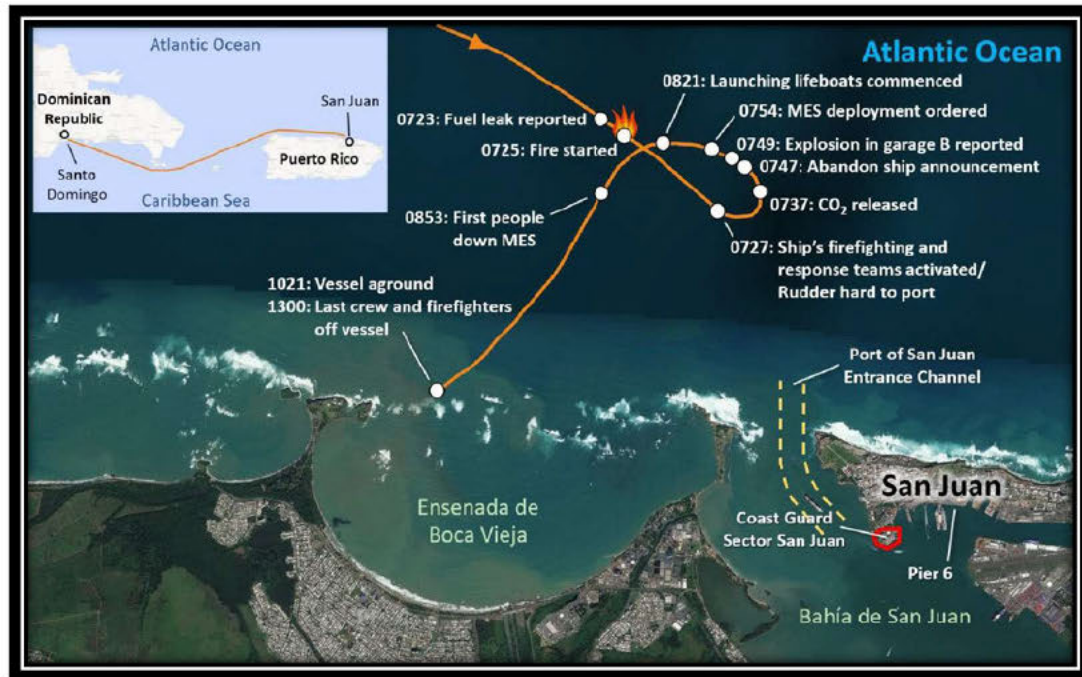
- 4.1.64. At 1012, the DIANE MORAN requested the CARIBBEAN FANTASY drop anchor.
- 4.1.65. At 1015, the Master ordered the anchor dropped and held six shackles in the water.
- 4.1.66. At 1021, the CARIBBEAN FANTASY grounded on sandy bottom.

Figure 11; GPS route and major events timeline.

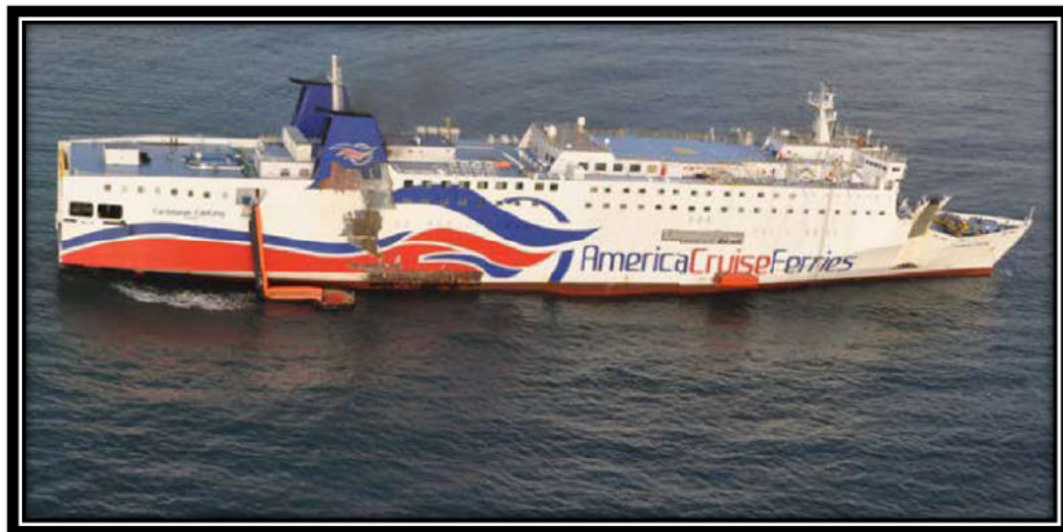
4.1.77. The CARIBBEAN FANTASY remained aground, on fire, until August 20 when it was towed into port and moored alongside pier 15 in San Juan Harbor. At 1600, the Coast Guard Captain of the Port (COTP) granted permission for the salvage company fire team to enter the main engine room to extinguish the fire. At 1800 the fire was reported extinguished.

Figure 12; Post Casualty photo of CARRIBEAN FANTASY post evacuation, grounded and anchored.

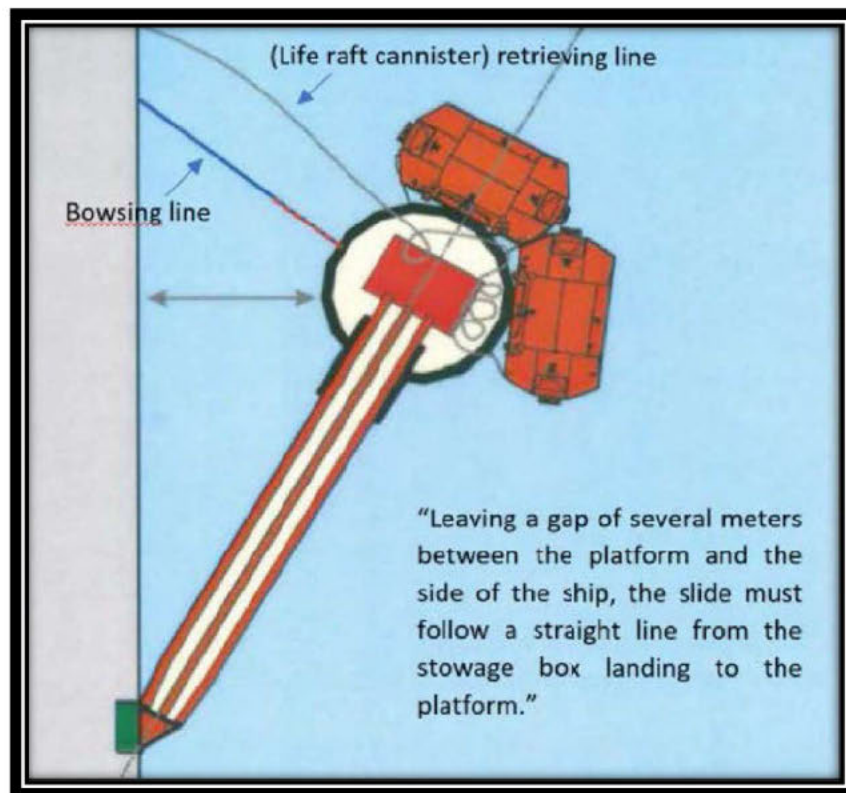
4.2.17. The port side MES did not adequately deploy, the Staff Captain added additional nitrogen to the slide and platform using the spare refill valve. This did not fix the orientation of the port MES slide and platform. The slide was too steep at the top and flat at the bottom. The bowsing line was not used to position the MES slide and platform. Even if functional, the Master decided that using the port side MES was a risk to passengers from smoke blowing toward the platform of the Port MES.

Figure 21; Viking Marine Evacuation System manual showing ideal orientation.
