REPORT OF INVESTIGATION
INTO THE
COMMERCIAL FISHING VESSEL (CFV)
COASTAL REIGN
Capsizing & Loss of Life

20 February 2021 16:37:00 PST

MISLE Activity Number: 7145693
MISLE Case Number: 1250976

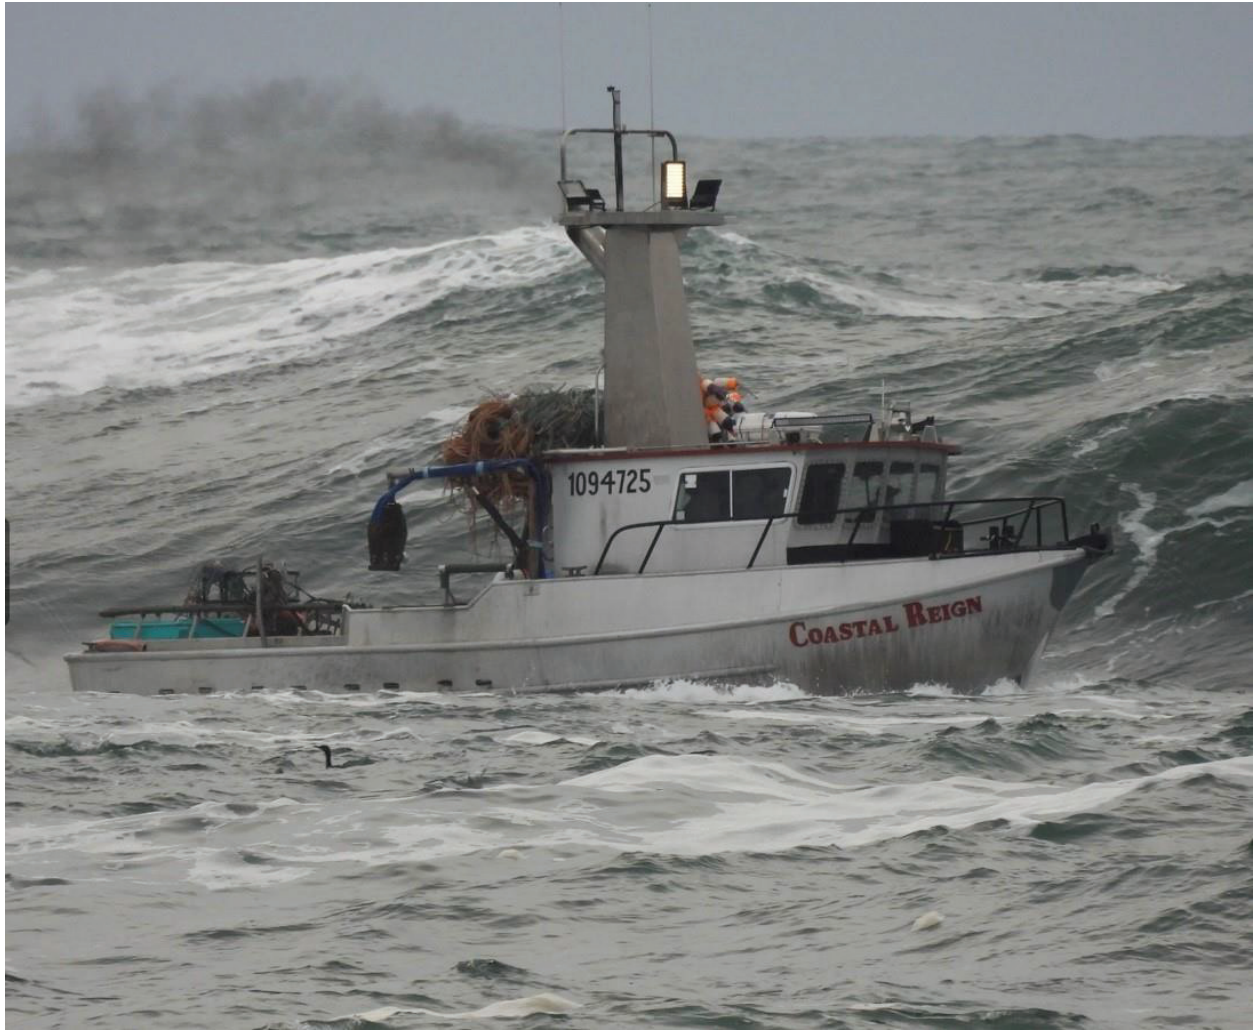
Photograph of COASTAL REIGN underway near Tillamook Bay Bar, Garibaldi, OR, February 20, 2021

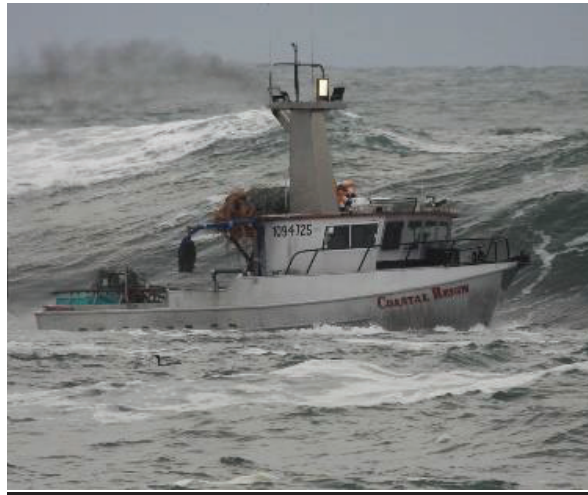
4.2 Video of COASTAL REIGN capsizing. (Press the “Ctrl” button and double click photo)

This hyperlinked photo will take the online reader to a composite movie with sound.

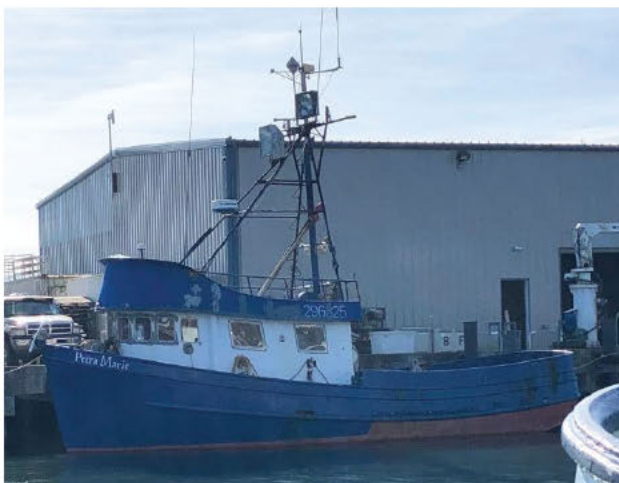
PETRA MARIE moored at the Garibaldi Marina. Date unknown.

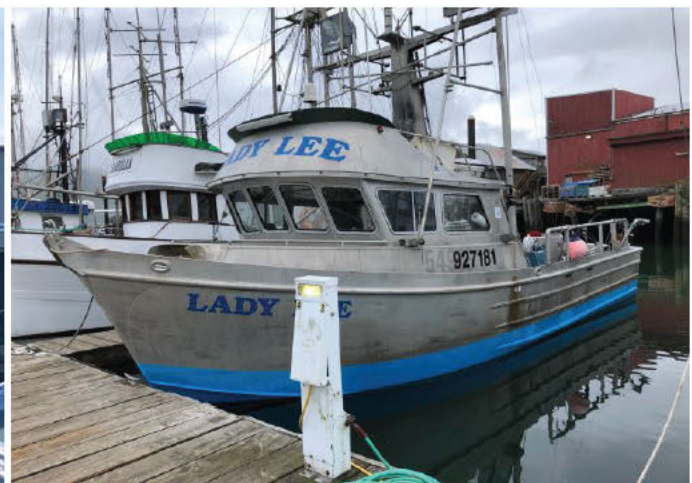
LADY LEE moored at the Garibaldi Marina. Date unknown.

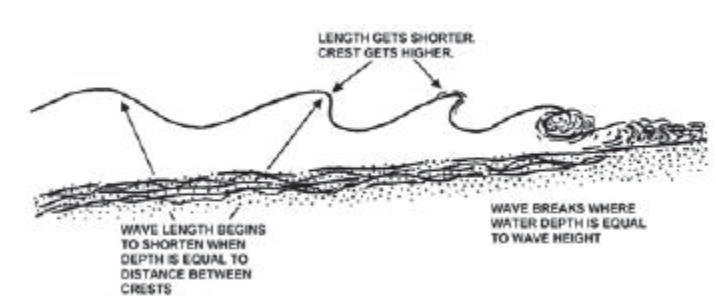
- 5.4 As deep-water waves approach the bar, they become organized by the effects of the contact with the bottom. As the depth of water decreases, the waves break and the crests tumble forward. They fall into the trough ahead usually as a mass of foaming white water. This forward momentum carries the broken water forward until the wave's last remaining energy becomes awash rushing up the beach or jetties. (USCG, 2003).

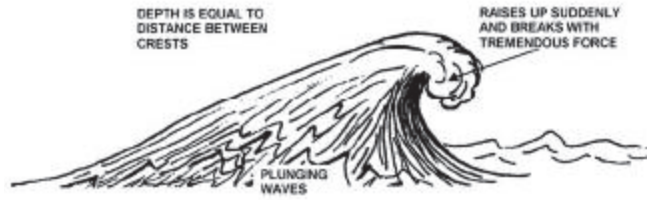
- 5.5 Plunging waves are breaking waves that result when there is a sudden lack of water ahead of the wave, such as in a steep rise of the ocean floor like the seaward edge of a bar or shoal. As a wave steepens, its momentum will cause it to fall forward or curl. This momentum gives the curl of breakers tremendous force. Waves can travel at up to 35 knots (40 mph), and very few boats can outrun a wave of that speed (note: an average fully loaded crab boat only makes approximately 6 to 10 knots). One cubic yard of seawater weighs almost a ton. A 20-foot breaker can drop 1,500 tons of water on a boat, and exert a force of up to 6000 PSI. (USCG, 2003). These types of breaks are usually found on the outer edge of the bar where deep water meets shallow depths. These types of breaks are common and visibly mark the end of the submerged portion of the South Jetty.

5.5.1 Breaking waves cause aerated water on the subsurface jetty. As the wave breaks, it combines with air, creating whitewater on the face of the breaker. As the breaker moves across the bar, it leaves a trail of pale or white aerated water behind it which takes some time to dissipate. This air-water mix can create changes in a boat's handling ability. A boat's propeller will not create as much thrust when operating in heavily aerated water. Likewise, a boat's rudder will not direct the propeller force as effectively in aerated water. A boat's response will be greatly slowed and create poor acceleration, cavitation (excessive engine RPM for a given throttle), and poor turning performance. (USCG, 2003).

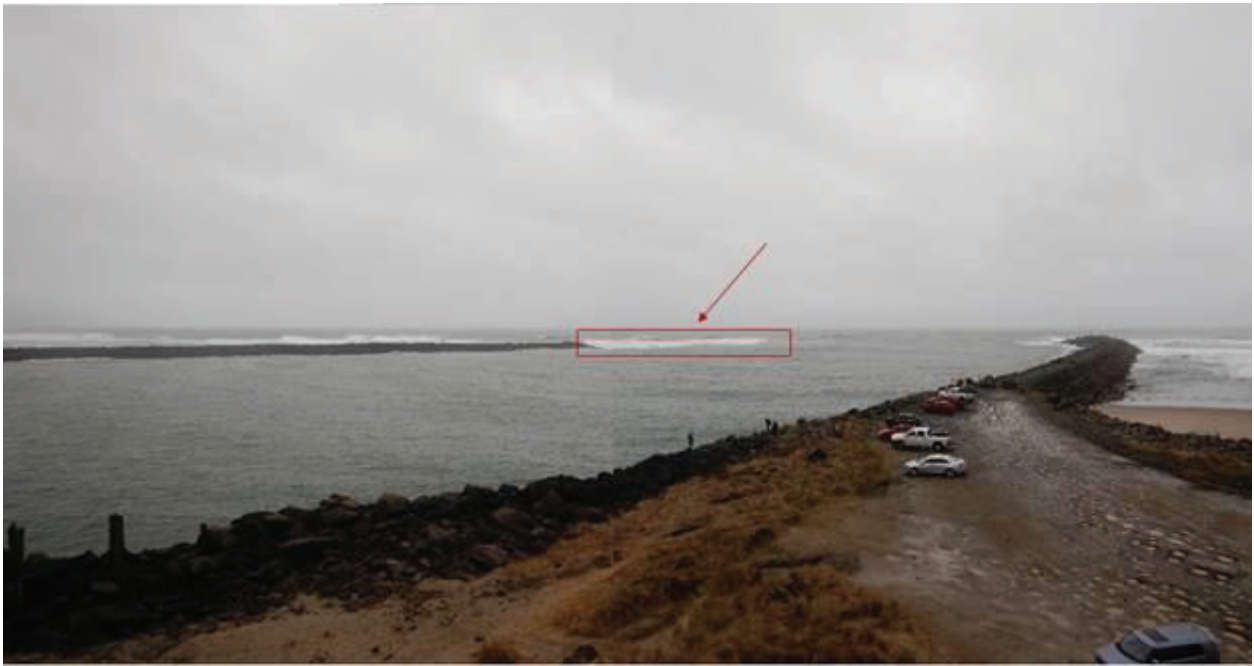
6.4.2 The operators of the CFV LADY LEE and the CFV PETRA MARIE stated that they saw the CFV COASTAL REIGN transiting over the white aerated water trailing behind the breaking waves over the top of the submerged jetty. The white aerated water has the capacity to change the vessel's handling ability as the propeller creates less thrust and the rudder less effective resulting in the CFV COASTAL REIGN being unable to turn. The operator of the CFV LADY LEE stated that had the CFV COASTAL REIGN turned to port and taken the waves straight on, they may have lost the front windows, but they likely would not have capsized. Had the CFV COASTAL REIGN's maneuverability not been reduced by the aerated whitewater located above the submerged jetty, the operator of the CFV COASTAL REIGN may have been able to turn into the oncoming breaking waves and may not have capsized.

The Tillamook Bay Bar is considered one of the most dangerous bars on the Oregon Coast. Due to the extensive shoaling at the entrance caused by the severely damaged jetty system in place, vessels are unable to transit straight across the bar in the charted channel unless the sea state is calm. An approach through the Middle Grounds would allow operators to travel head into the direction of the waves. Shoaling at the entrance forces vessels to use the North Hole or the South Hole entrances to cross the bar. Operators must travel beam-to the direction of the waves for a period of time which places the vessel in an inherently dangerous condition. If the jetties were properly functioning, the increased velocity of the water as it passed through the channel may have prevented the shoaling from occurring at the entrance of the Tillamook Bay Bar. This would have made the crossing of the Tillamook Bay Bar less hazardous as the CFV COASTAL REIGN may have been able to cross the Tillamook Bay Bar head-into the direction of the waves, and would not have been beam-to the waves, and may not have capsized.
