UNITED STATES COAST GUARD

**REPORT OF THE INVESTIGATION
INTO THE
SINKING OF THE COMMERCIAL FISHING VESSEL
EMMY ROSE (O.N. 909149), APPROXIMATELY 27
NAUTICAL MILES NORTHEAST OF PROVINCETOWN,
MA, RESULTING IN THE LOSS OF FOUR LIVES ON
NOVEMBER 23, 2020**

MISLEACTIVITY NUMBER: 7100250

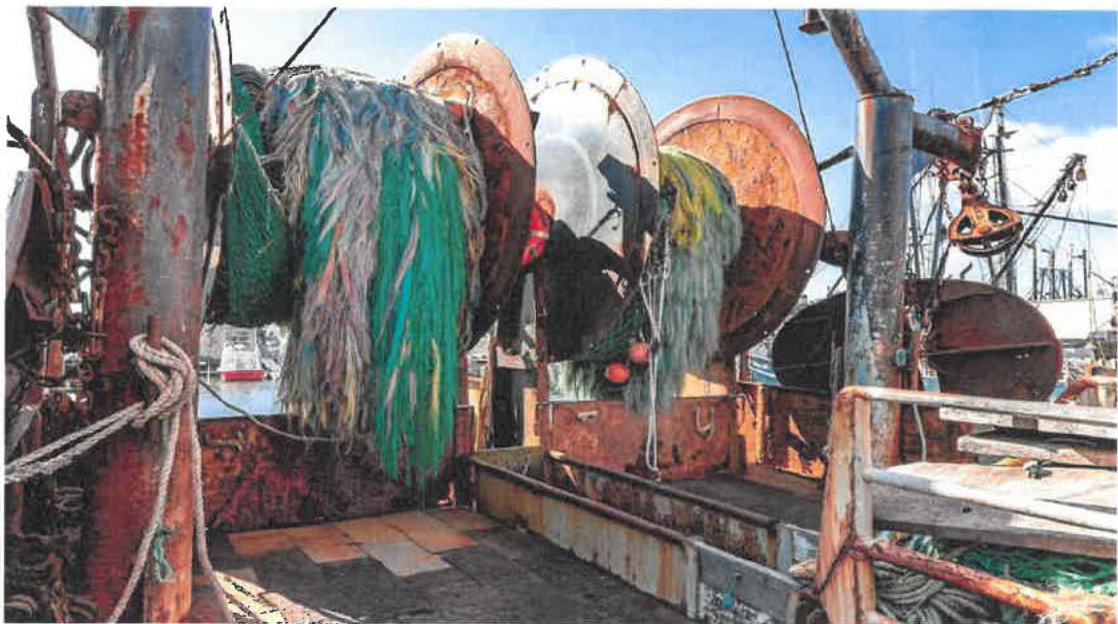
Figure 16: EMMY ROSE trawl net reels. Image courtesy of Atlantic Brokerage, 2019.

4.6.2. The port and starboard walkways were closed, forming stowage areas and the overhead was extended aft on the cargo deck area forming a sheltered area for the trawl winches. Aft on the work deck are port and starboard pillar style gallows. The structure is braced aft and supports the twin hydraulic net reels, which are suspended over port and starboard net ramps built into the vessel's transom. Sometime after 2001 modifications were made to the vessel's twin hydraulic net reels. It appears an additional 24" of reel was added to the vessel on each side.

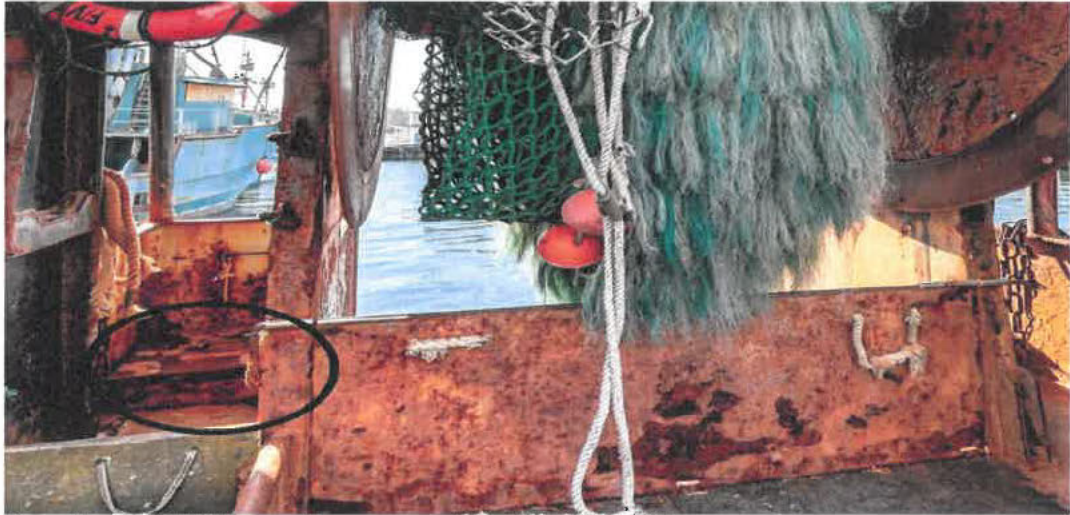
Figure 21: EMMY ROSE lazarette. Image courtesy of Atlantic Brokerage, 2019.

4.6.8. The lazarette is the furthest aft access which is accessed through a 6" high x 24" x 24" steel coaming located centerline aft and is fitted with a steel cap resting on the knife edge (not watertight). Within the lazarette are the hydraulic ram steering system, a high-water alarm, and a bilge suction from the engine room pumping system.

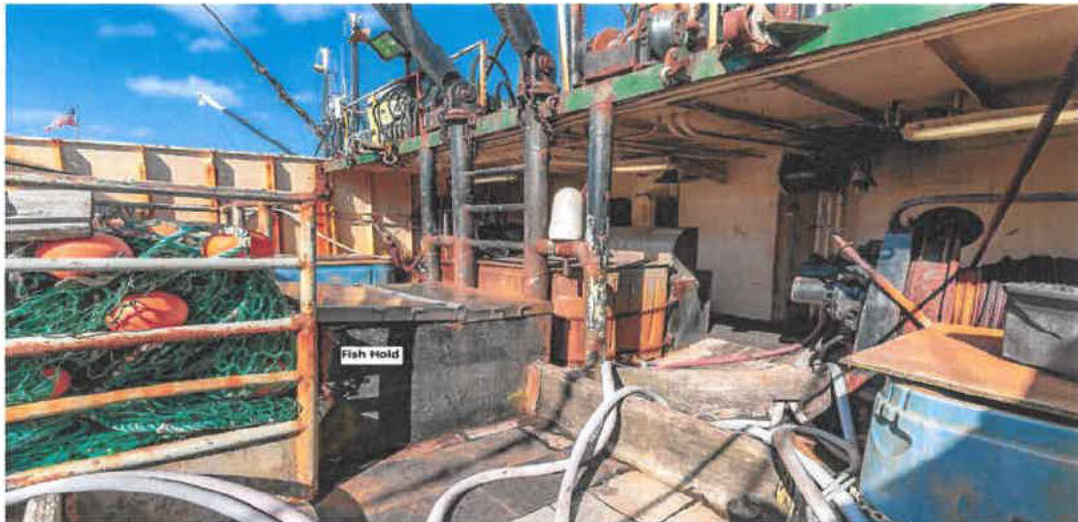
Figure 22: EMMY ROSE fish hold hatch. Image courtesy of Atlantic Brokerage, 2019.

4.6.9. The main hold is the fish hold which is located directly aft of the engine room, which can be accessed through a 32" high x 46" x 48" steel raised coaming. The hold is weathertight, secured with a two-piece stainless-steel cover, which is then covered with two wooden removable covers. The fish hold is subdivided into twelve individual two tiered pens. The stuffing box for the shaft through hull penetration is housed in the bilge of the fish hold. This area is fitted with a high-water alarm and bilge suctions from the engine room pumping system.

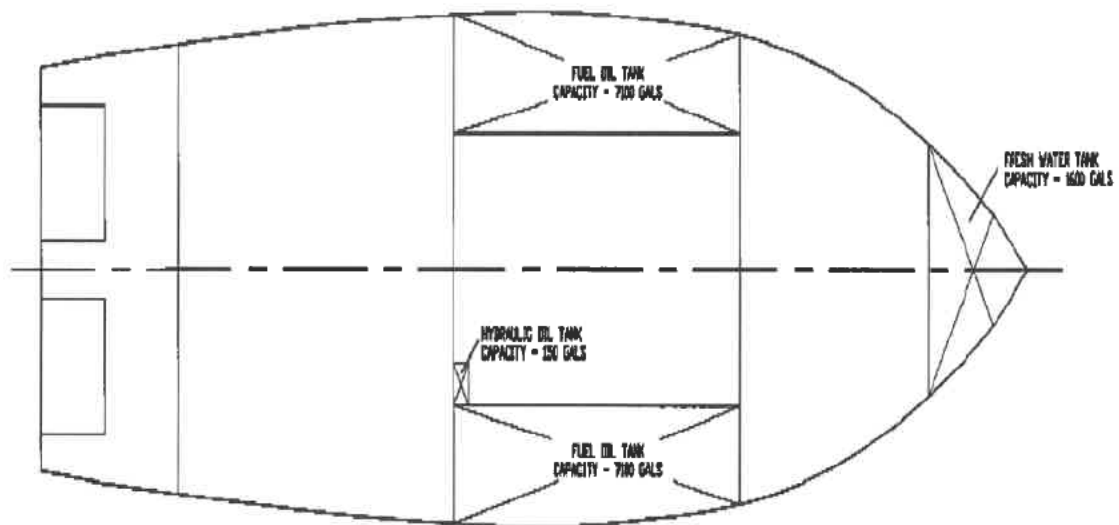
Figure 29: EMMY ROSE tank capacity plan. Image courtesy of Thomas M. Farrell Naval Architects, 2002.

4.6.14. The EMMY ROSE fuel storage consists of port and starboard wing tanks located in the engine room with a total capacity of 15,000 gallons. Each tank is filled and vented from the main deck level. The fuel system is fitted with hard piping and flexible rubber hoses with all equipment provided with Racor filter separator units. There is a fuel transfer pump located on the starboard fuel tank that was estimated to pump 26 gallons per minute. The transfer pump was used to transfer fuel between the tanks for both fuel supply and to control the vessel's list. The main engine is typically supplied from the starboard side tank and returns to the port tank.

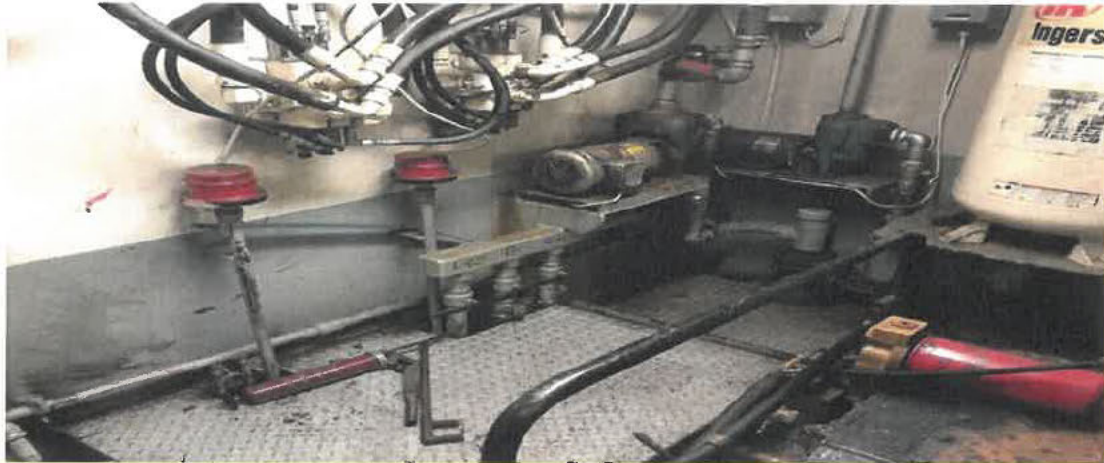
Figure 30: EMMY ROSE bilge manifold system. Image courtesy of Marine Safety Consultants.

4.6.19. Main bilge pumping capacity is provided by three (3) Baldor 3HP electrically driven Flomax 2" bilge and washdown pumps. The bilge system is fitted with two (2), three-valve independent manifolds. The port manifold is pressurized with two pumps and the starboard manifold with one pump. The bilge manifold was labeled in Portuguese.

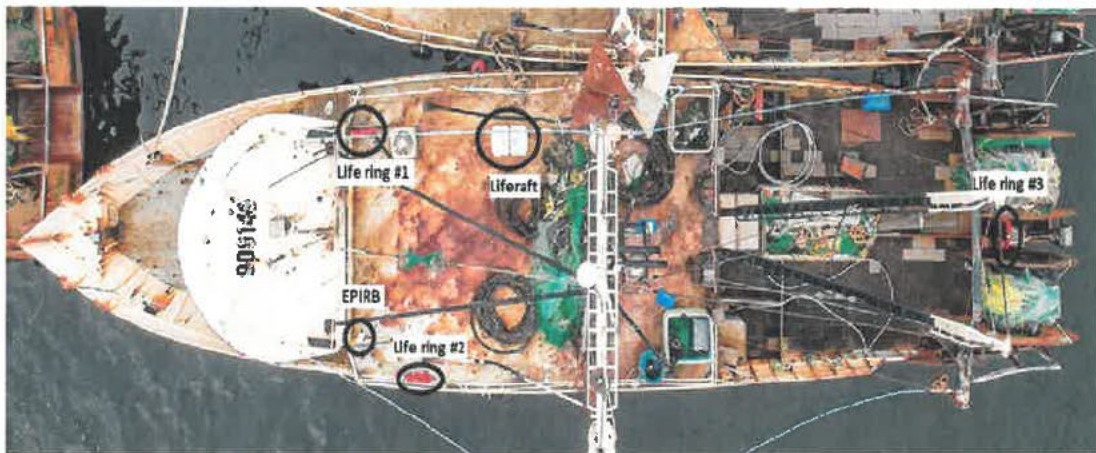
Figure 31: EMMY ROSE on deck lifesaving equipment. Image courtesy of Atlantic Brokerage.

4.6.23. All recovered lifesaving equipment, life ring buoy, EPIRB and life raft were inspected post casualty and had functioned properly. Both the EPIRB and life raft were deployed hydrostatically, meaning that no crewmember deployed either device.

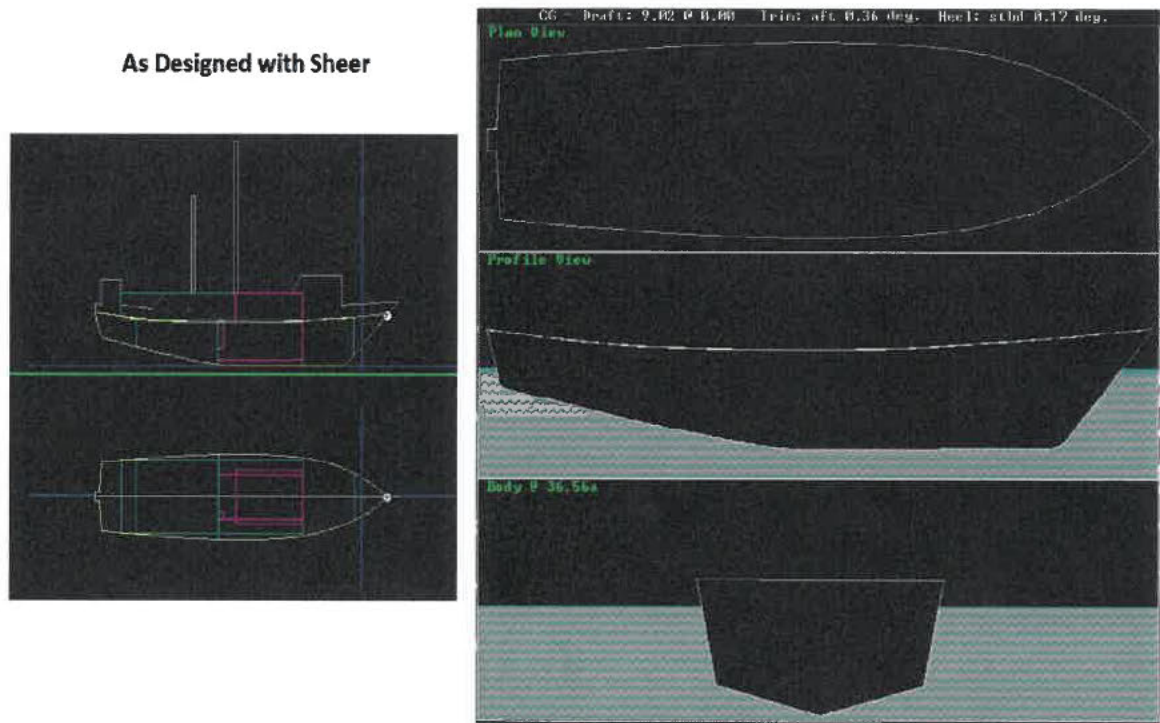
Figure 34: MSC recreation of EMMY ROSE as designed with sheer.

4.9.6. Based on the analysis, the vessel lacked sufficient stability in all load conditions, specifically at the time of incident, per the regulatory criteria in 46 CFR Subchapter C. The limiting criteria in all cases was 46 CFR 28.570 Intact Righting Energy. At the time of incident, the vessel failed by 20% or more in each failure of this criteria. The failure percentage exceeds any expected differences from the assumptions made in the analysis, therefore indicating the vessel lacked sufficient stability per the regulatory standards. Although failure of the criteria does not necessarily indicate capsizes, the likelihood is increased. Additionally, any off center loading or weight shifts that would cause a list would have reduced the vessel's stability further. This could be caused by large shifting weights on deck, shifting catch in the fish hold, or internal liquid transfers. The lack of sufficient drainage could also cause entrapment or pocketing of water on deck, producing a heeling moment and list.

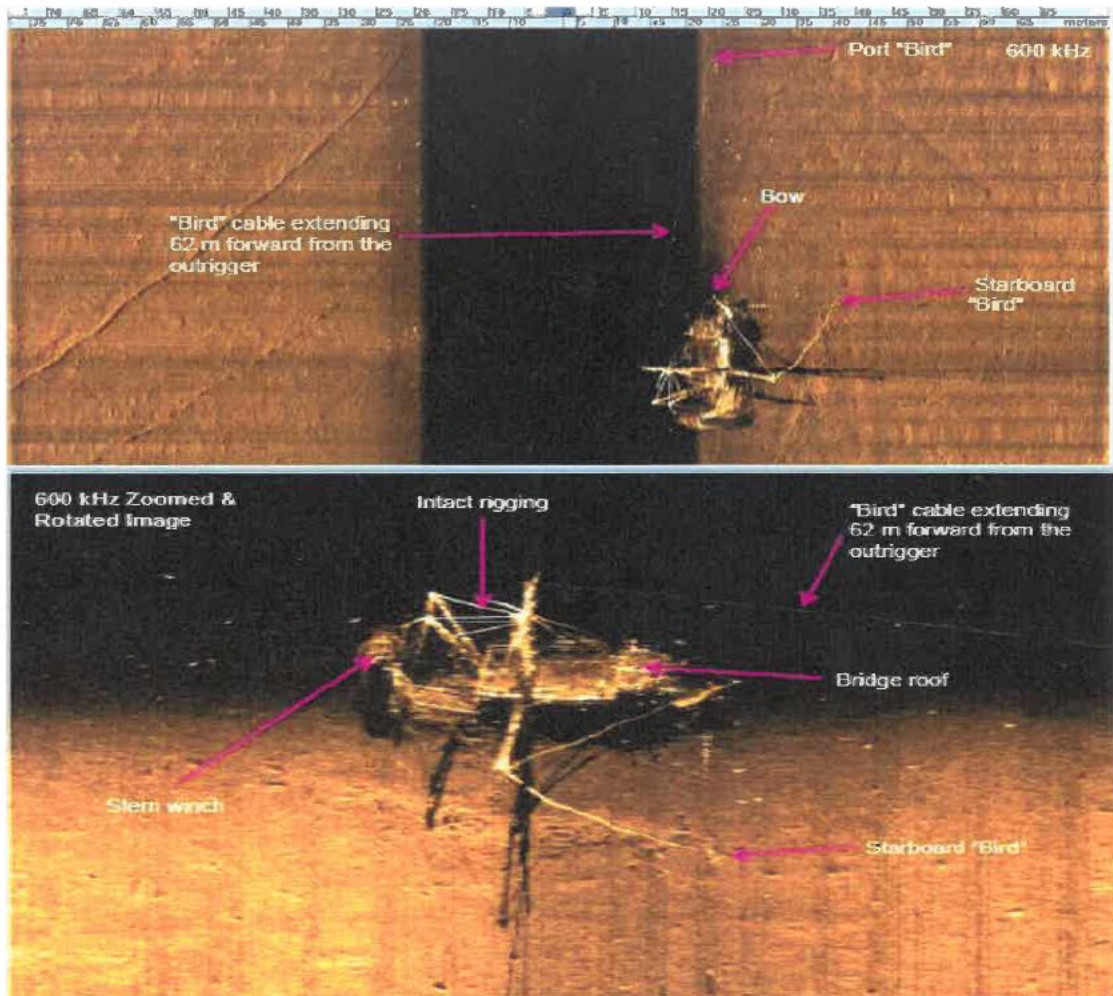
4.10.8. According to MIND Technologies, the EMMY ROSE is sitting upright on the seafloor with the bow oriented at 135° (southeast orientation) and the outriggers fully deployed. There is no apparent debris field on the seafloor close to the wreck. Additionally, there is no visible damage to EMMY ROSE evident as the mast, wire rigging, and superstructure features all appear intact. The ladders on both port and starboard outriggers are clearly visible in the sonar imagery. Figure 41 shows that the paravanes were deployed from the outriggers prior to the vessel sinking. A paravane system uses two wing-shaped weights (often called “birds”) that are dragged through the water on cables to assist with stability. The port paravane cable is taut whereas the starboard paravane cable appears to be slack. The position of the paravanes forward of the vessel bow indicates that the stern sunk to the seafloor before the bow at least just prior to the vessel making contact with the seafloor. All analysis in 4.10.8. and associated images was provided by MIND Technologies.

Figure 41: Prototype Klein 4K-SVY 600 kHz (75 m scan range) imagery of the EMMY ROSE with the towfish flown almost directly over the wreck. Image courtesy of Klein Technologies.

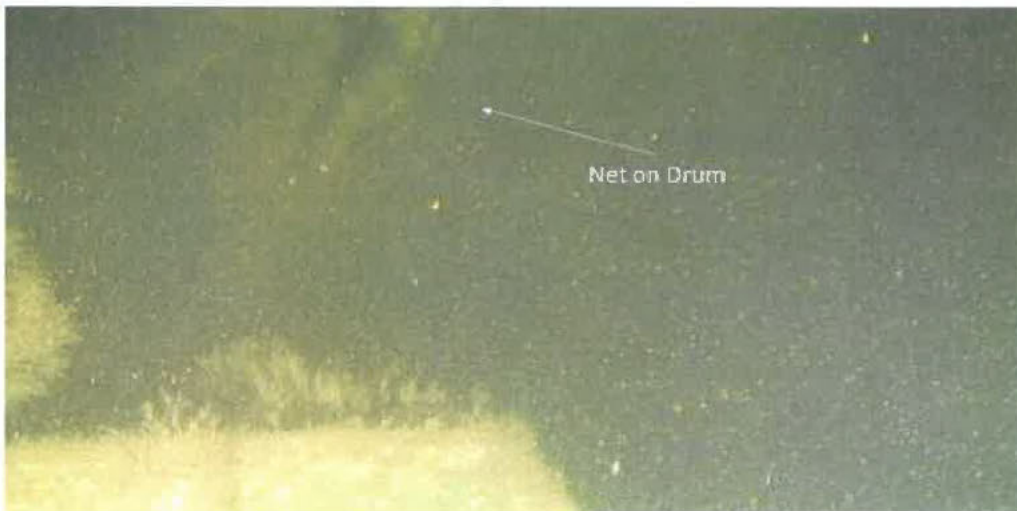
4.11.11. The ROV then returned to the stern and moved up the port stern bulwark and located the net on the drum.

Figure 50: Trawl net on stem drum of the EMMY ROSE. Image courtesy of WHOI, 2021.

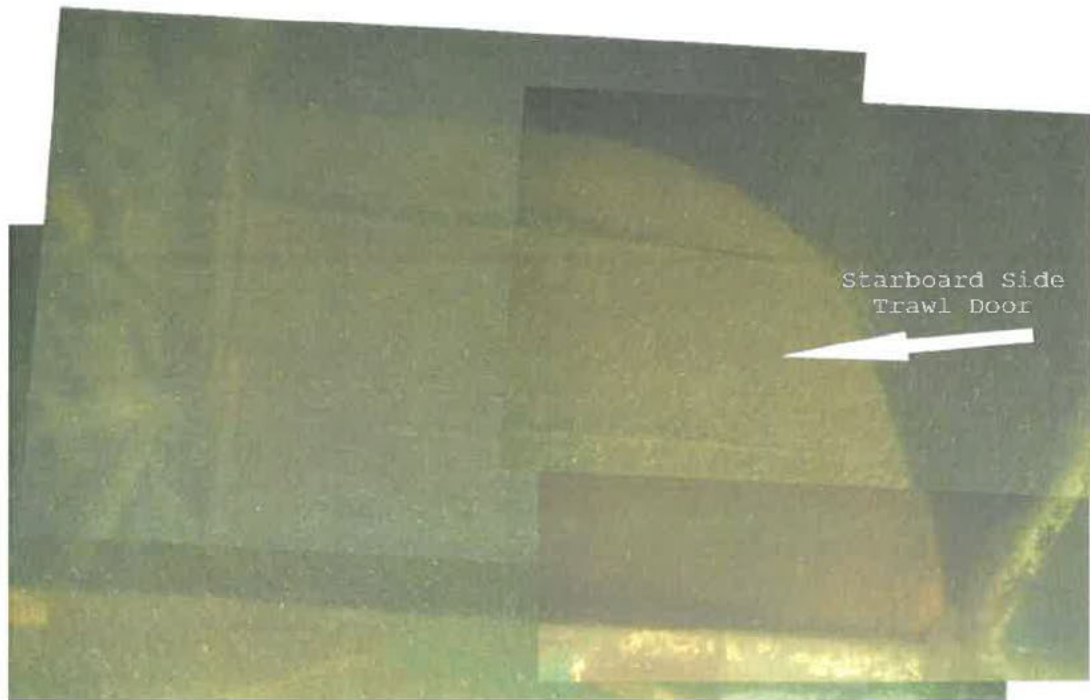
4.11.12. At approximately 2230, the team began the survey of the starboard side starting at the stern. Trawl chain was located hanging from starboard side near the stern. Following down the starboard side of the vessel, freeing port #1 and #2 (numbered from stern going forward) were found closed. The starboard side trawl door was found stowed.

Figure 53: Starboard side trawl door. Image courtesy of WHOI, 2021.

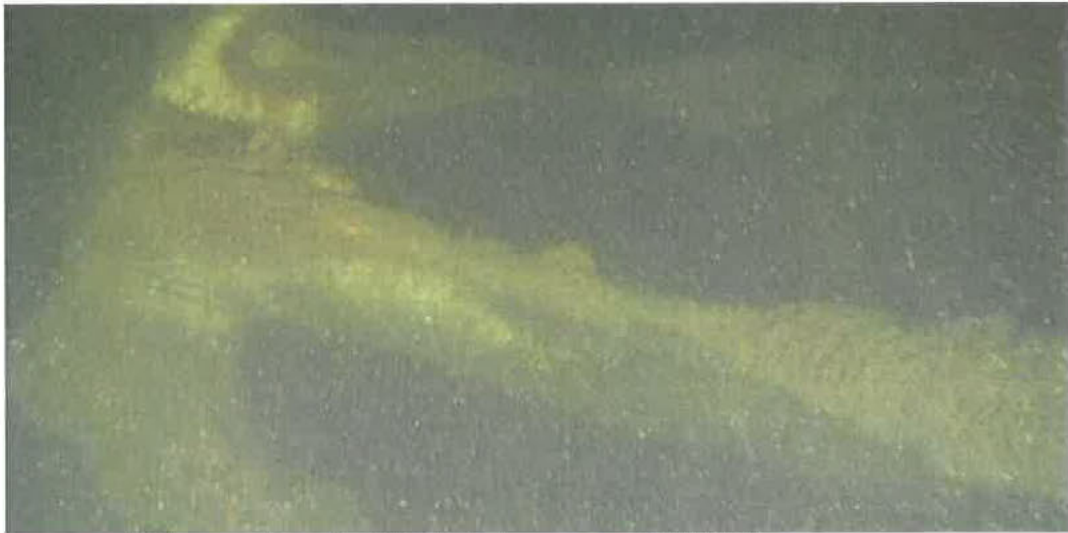
Figure 60: End of the port outrigger of the EMMY ROSE. Image courtesy of WHOI, 2021.

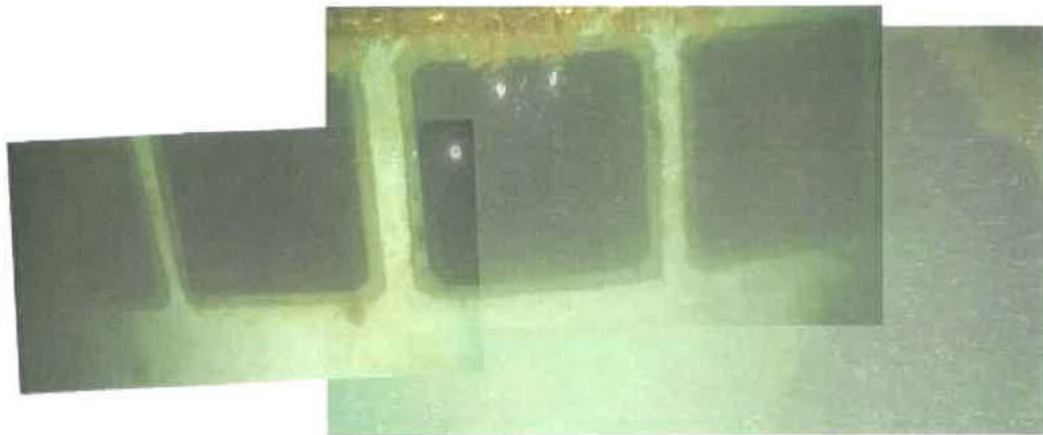
4.11.16. The ROV then visually inspected the bridge engine room vent and forward engine room/ auxiliary space hatch. The bridge doors and hatch were secure and all windows intact.

Figure 62: Pilothouse windows of the EMMY ROSE. Image courtesy of WHOI, 2021.

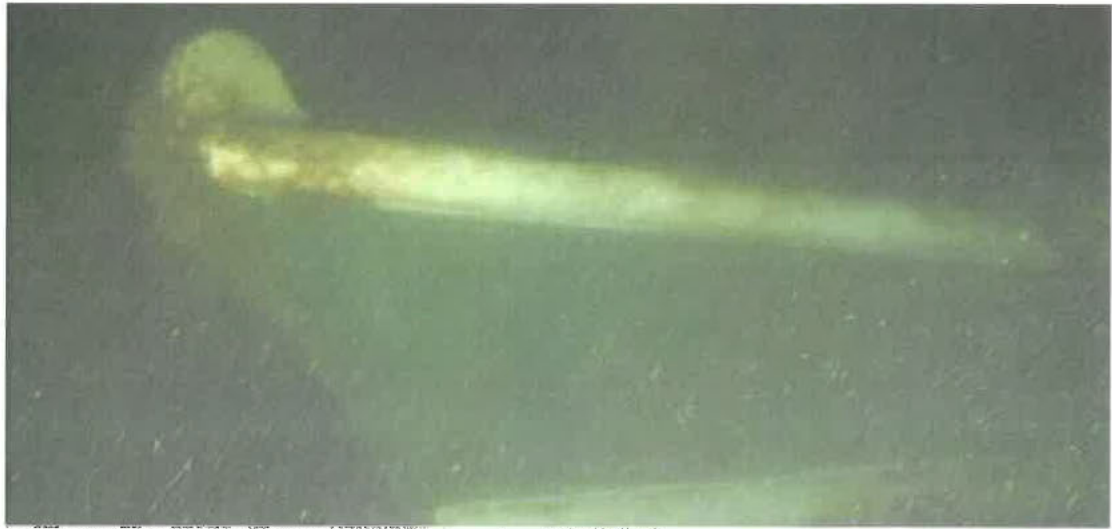
4.11.17. The ROV reversed away from the bridge and worked its way around the port side bow. Imagery showed the port bow intact and with no apparent damage.

Figure 63: Port side bow of the EMMY ROSE. Image courtesy of WHOI, 2021.

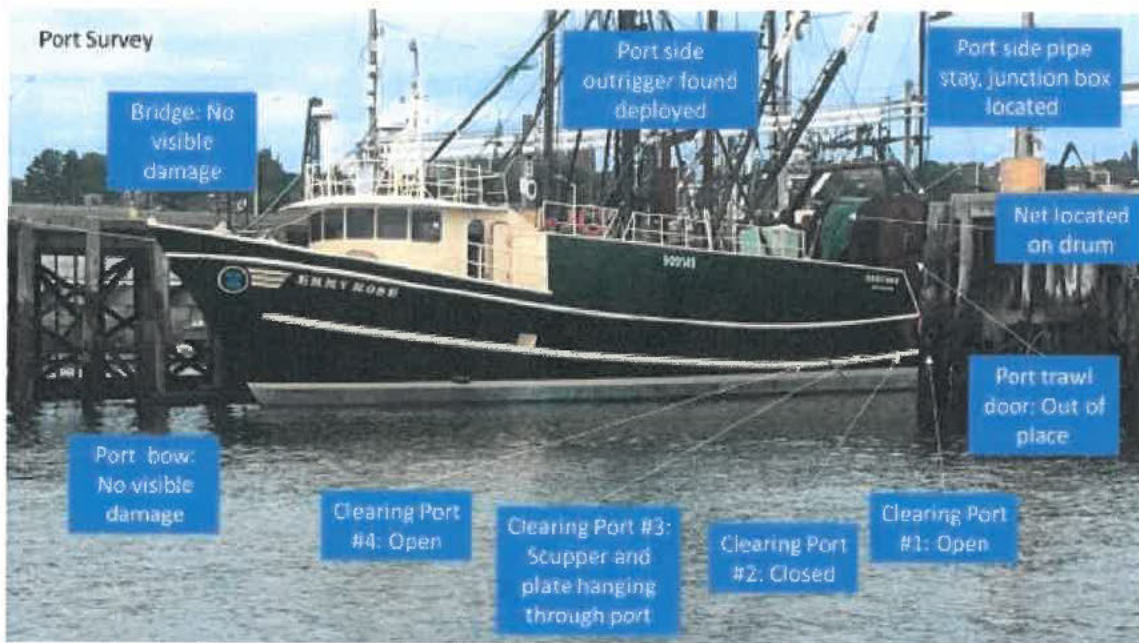
4.11.20. There is no visible damage to the vessel on the bow, port and starboard sides, stern, and the bridge where the ROV was able to inspect. The ROV could not image the starboard outrigger, stern doors, or stern deck hatches due to the risk of entanglement and maneuvering in the currents.

Figure 69: Port side ROV survey results of the EMMY ROSE. Image courtesy of WHOI, 2021.

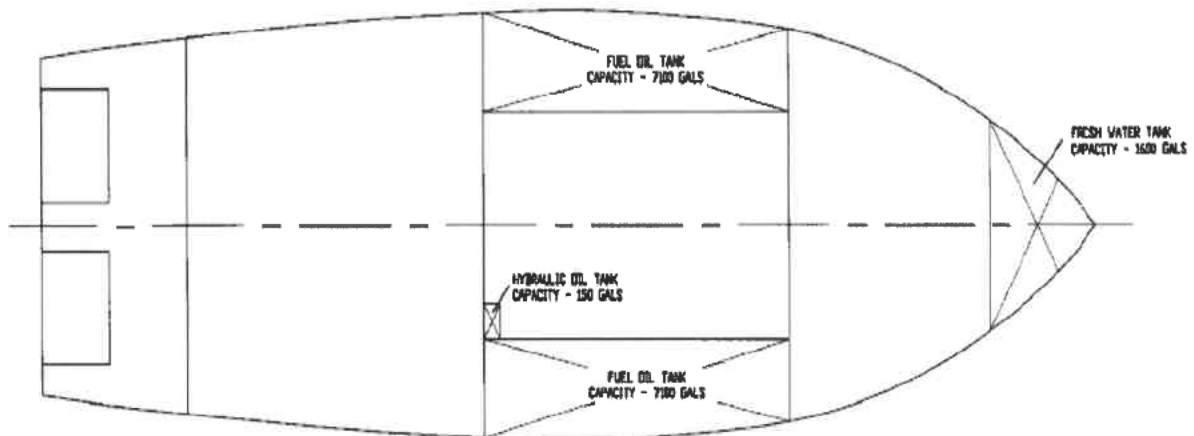
TANK CAPACITY PLAN

One source of weight that had the potential to put the vessel in an unrecoverable listed condition would be an excessive internal transfer of fuel. The EMMY ROSE was equipped with two fuel tanks, which were located in the engine room and used for service to the main diesel engine and generators. Each tank was located at the outermost part of the engine room and made the port and starboard hull bulkheads. Each tank had a capacity of 7,500 gallons, were cross connected, and were both capable of providing fuel to the main engine.

Figure 72: EMMY ROSE Fuel Tank layout. Image courtesy of Thomas M. Farrell Naval Architects, 2002.

Previous crewmembers stated that on two separate occasions, a transfer of fuel between the port and starboard tank caused the EMMY ROSE to list severely to starboard. These fuel transfers were unmonitored as the crewmembers who had both been asleep were awakened by a severe list in the vessels profile. Upon exiting the accommodation space to the aft deck, they witnessed the starboard side outrigger completely underwater with sea water coming over the top of the eight foot starboard bulwark rail, and the aft deck awash. On both occasions, the crewmembers went back into the accommodation space and found the Captain asleep in his bunk. Once awoken, the Captain proceeded to the engine room to transfer fuel back to the port tank, correcting the severe list.

In the two previous instances identified above, as the excessive amount of fuel was transferred transversely to the starboard tank, it negatively affected the vessels stability by shifting the vessel's center of gravity to the low (outboard) side. The EMMY ROSE laid over or "listed" about the angle of heel where the righting arm curve is zero. In this condition the vessel will not return to the upright condition due to the shift in the fuel's center of gravity, unless immediately corrected.

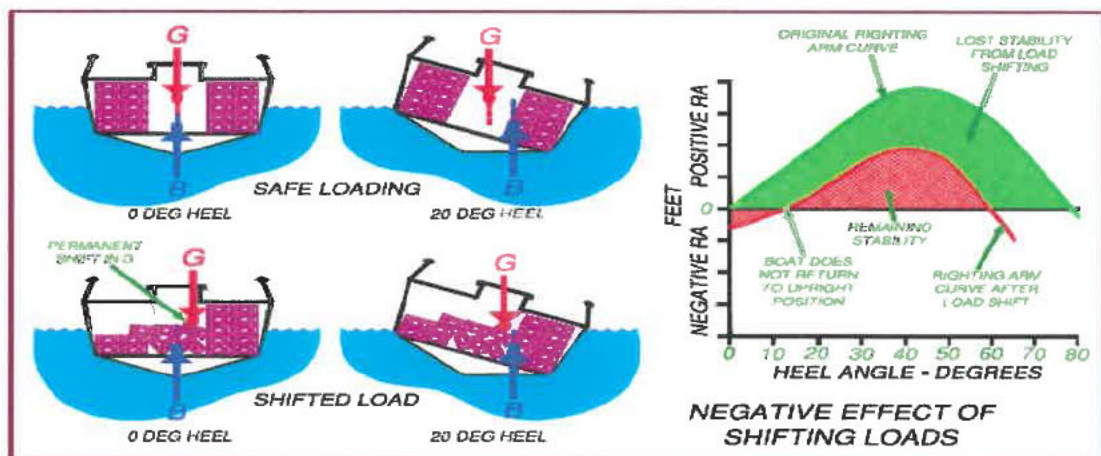
Figure 74: Negative effects of shifting loads. Image courtesy of "A Best Practices Guide to Vessel Stability- Second Edition", USCG.

A shifting of the vessel's catch within the fish hold is another possible cause for a vessel's stability to be affected. Although no collected evidence or witness testimony stated this as a likely possibility, it is still possible and would have had the same effect on the vessel's stability as the excessive fuel transfer.

In stability analysis, the total buoyancy forces, which are distributed over the part of the hull below the water, are mathematically combined into a single point called the center of buoyancy. This point is labeled "B" on stability model diagrams. When the shifting of a fishing vessel's catch or heavy fishing gear occurs during the voyage, its overall stability is reduced because the vessel's center of gravity "G" is shifted farther outboard because the catch has fallen to the lower outboard side. The vessel will not return to the upright condition due to the permanent shift in the catch's center of gravity. It lays over or "lists" about the angle of heel where the righting arm curve is zero.

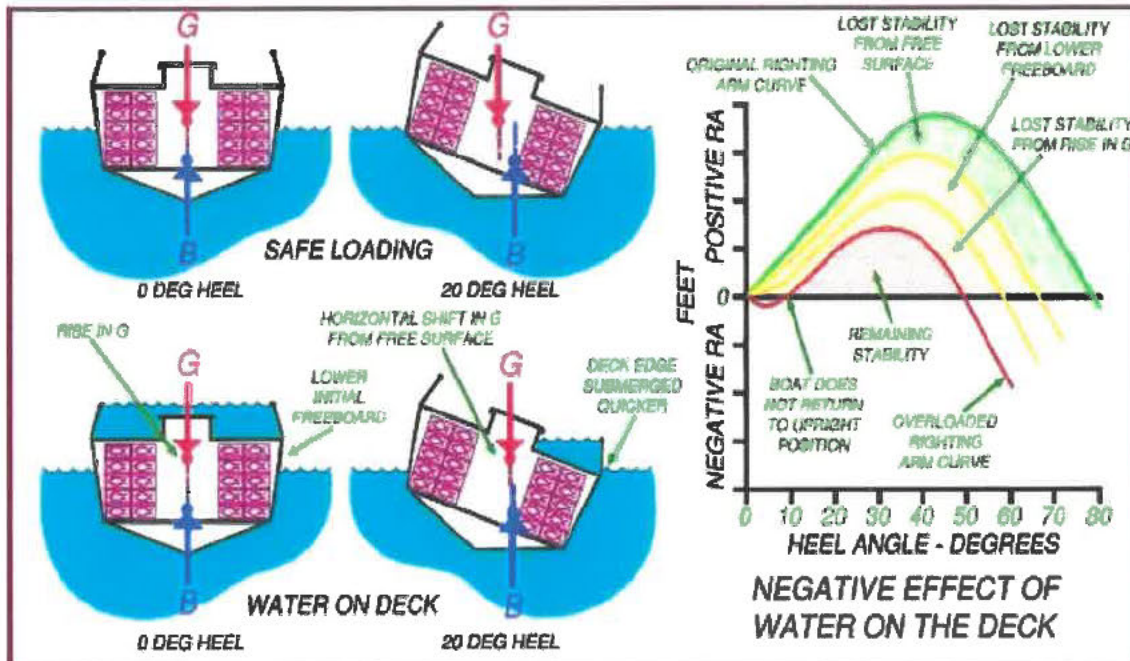
Figure 76: Negative Effect of Water on the Deck. Image courtesy of "A Best Practices Guide to Vessel Stability - Second Edition", USCG.

The center of gravity "G" is raised from the added weight of the trapped water high on the decks. The freeboard is reduced due to the added weight, which causes the deck edge to submerge at smaller heel angles. The effects of the trapped water on deck shifting reduce the righting arms. Because the trapped water on deck is located high on the vessel, the fishing vessel may not return to the upright equilibrium condition. Instead, it will lay over or "Roll" at the angle of heel where the new righting arm curve goes through zero.

Second, the wave alters the crucial shifting of the center of buoyancy "B" to create a capsizing condition. When the vessel is upright the center of buoyancy "B" shifts outboard due to the beam wave's shape to create a capsizing moment. And when the vessel heels over, which in previous examples creates a positive righting moment, a capsizing moment is still present because the beam wave's shape on the hull has prevented the center of buoyancy "B" from shifting outboard.

The added weight and the free surface effect on the deck would further reduce the stability of the EMMY ROSE's already listed profile. As the EMMY ROSE listed further to starboard, approaching the angle of capsizing, more and more water would continue to collect in the starboard aft pocket of the vessel, further exacerbating the situation. According to the MSC stability analysis for the EMMY ROSE, the vessel failed to meet the stability criteria while having water on deck and at $\frac{1}{2}$ and $\frac{1}{4}$ fuel differential, as would be the case determined by our analysis. Had the freeing ports onboard the EMMY ROSE been designed in compliance with regulations, the boarding waves would not have been able to swamp the deck of the vessel and any water on deck would have been able to run off through the hinged flaps fitted to the outside of the hull. Proper design and operation of the freeing ports would have reduced excess deck weight and free surface effect from sea water, increasing the EMMY ROSE's ability to maintain stability.

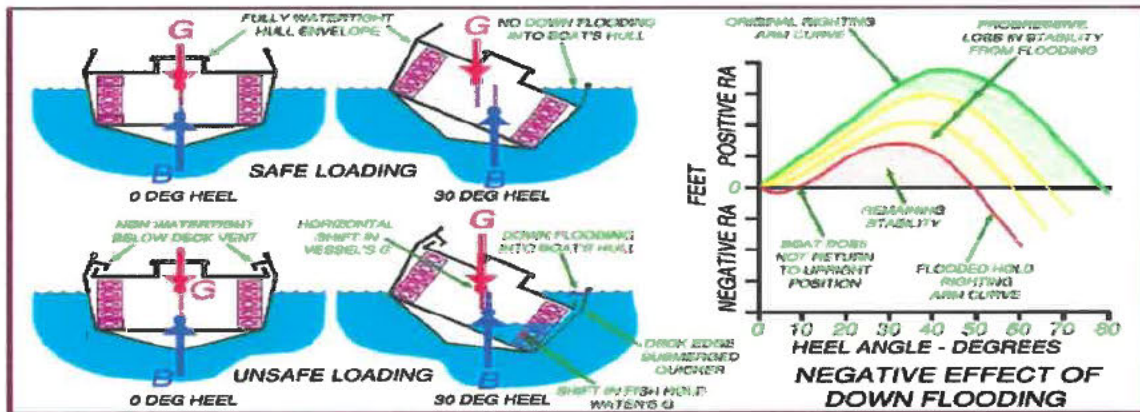
Figure 77: Negative Effect of Down flooding. Image courtesy of "A Best Practices Guide to Vessel Stability- Second Edition", USCG.

Failure to maintain the integrity of a fishing vessel's watertight envelope can significantly reduce the overall stability due to unintentional flooding. After down flooding occurs, the vessel's overall stability is reduced because:

- The center of gravity "G" is shifted farther outboard as the water sloshes to the low side.
- The freeboard is reduced because of the added weight, causing the deck edge to submerge faster.
- In cases of severe down flooding, the vessel may not return to the upright condition, but will hang or "loll" at the angle of heel where the new righting arm curve goes through zero (about 10 degrees in the example).

Down flooding of the EMMY ROSE is supported by the position and orientation of the EMMY ROSE and its rigging gear as it is situated on the sea floor. The sonar survey revealed that the paravanes are paid out forward of the vessel from the tips of the outriggers, indicating that the vessel moved aftward into its final resting place. This would support a stern first sinking possibly caused by the initial down flooding in the lazarette compartment and fish hold. Had the EMMY ROSE secured all through hull openings with watertight hatches, the water would have run off the deck through the open freeing ports and over the bulwarks, allowing the vessel to maintain its watertight integrity.

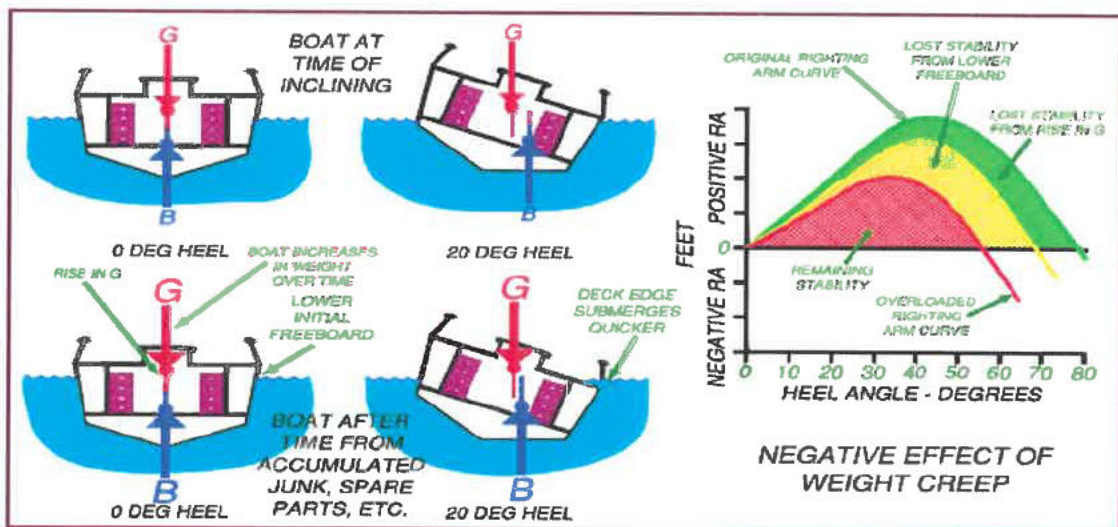
Figure 78: Negative Effect of Weight Creep. Image courtesy of "A Best Practices Guide to Vessel Stability-Second Edition", USCG.

Since the stability analysis in 2002, the vessel had made changes to its configuration which were not accounted for when the vessel stability was assessed in 2002. Based upon imagery available, it has been determined that the net reels were expanded to accommodate larger nets, a 500-gallon lobster tank (approx. 4,000 lbs) was added to the starboard side of the uppermost deck, and just prior to the departure for the final trip, new trawl doors (approx. 1,300- 1800 lbs) were also added to the vessel.

Weight creep from these known modifications and the accumulation of extra spare parts, fishing gear or a series of seemingly small modifications to the vessel or its fishing gear can significantly reduce a fishing vessel's overall stability. The weight creep often occurs over long periods of time in small amounts so the crew may not notice reduced initial stability levels. The vessel's overall stability has been reduced from the accumulated total weight because the center of gravity "G" is raised from the added weight higher above the center of gravity (net reels, nets, lobster tank, larger trawl doors) and the freeboard is reduced because of the added weight that causes the deck edge to submerge at smaller heel angles.

On November 23, 2020, it had been 18 years and 9 months since the EMMY ROSE had its stability analyzed in 2002. We have been able to identify numerous weight additions associated with modifications in the images obtained. The Operating Instructions from the 2002 Stability Analysis of the SASHA LEE states that no weights shall be added, removed, or relocated without determining the effect on the stability of the vessel. To our knowledge, the initial Stability Analysis was the only one ever conducted on the hull of the EMMY ROSE. The Coast Guard's Voluntary Safety Initiatives and Good Marine Practices for CFV published in January 2017 recommends the owner have the stability instructions reviewed by a qualified individual at least every five years, or after the vessel has been modified or altered in any way that changes its stability or handling characteristics. Had there been a periodic or

6.6.1. Implement new regulations under 46 CFR Part 28 that Commercial Fishing Vessels 79 feet and over undergo vessel stability verification, by a qualified individual, every 5 years and/or after a major modification to ensure the vessel is still in compliance with their required stability booklet. (Safety Recommendation 1 and 3)

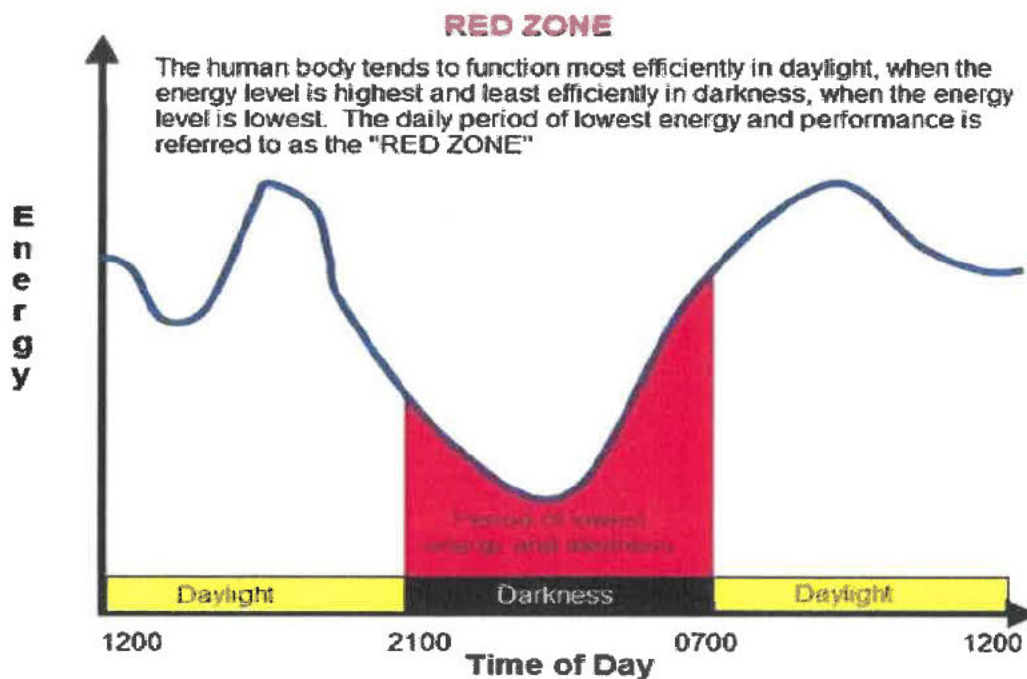
Figure 79: Fatigue energy levels throughout the day. Image courtesy of FishSafeWest.info.

It was typical for the vessel to have one person on the helm, while the other crewmembers slept on the return trip to Gloucester, MA. The crew of the EMMY ROSE had been conducting non-stop fishing operations for approximately 6 days with little to no uninterrupted sleep. It has been determined that the crew of the EMMY ROSE may have been chronically fatigued, detrimentally affecting their performance, attention to detail, and their ability to react to stimuli. Furthermore, the EMMY ROSE return voyage to Gloucester, MA began at 1900 on November 22, 2020, and was scheduled to arrive at Fisherman's Wharf at 0600 November 23, 2020. The vessel sank at approximately 0129 on November 23, 2020, which is the time frame at which the human body has the lowest level of energy and alertness.

It is suspected that the crew of the EMMY ROSE would have been experiencing the symptoms of being chronically fatigued while on the return trip to Gloucester, MA. Three of the crewmembers are suspected to be in their bunks asleep with one person on the helm. The crewmember on the helm would have reached extreme exhaustion during this period (Red Zone) of lowered energy and alertness exacerbated by the work routine of the previous 6 days fishing operations. The helmsman at the time of the sinking may have had a loss of situational awareness caused by extreme exhaustion. The loss of situational awareness was a contributing factor to not identifying the weight shift and excess water on deck and properly responding to the hazards aboard the EMMY ROSE. Had the helmsman received sufficient sleep and rest prior to taking the overnight helmsman watch, they may have had a better chance to remain vigilant and able to identify the hazardous situation, possibly correct the list, and communicate the situation via a MAYDAY call to the Coast Guard and other vessels.
