REPORT OF INVESTIGATION INTO THE TOWING VESSEL KRISTIN ALEXIS (O.N. 596468) AND CRANE BARGE MR ERVIN (O.N. 1282567) Allision with the Sunshine Bridge Involving an Overhead Strike ON October 12, 2018

THE ALLISION OF THE UNINSPECTED TOWING VESSEL KRISTIN ALEXIS' TOW, THE CRANE BARGE MR ERVIN, WITH THE SUNSHINE BRIDGE ON THE LOWER MISSISSIPPI RIVER NEAR DONALDSONVILLE, LA ON OCTOBER 11, 2018

TOWING VESSEL KRISTIN ALEXIS (O.N. 596468) AND CRANE BARGE MR ERVIN (O.N. 1282567) ALLISION WITH THE SUNSHINE BRIDGE INVOLVING AN OVERHEAD STRIKE

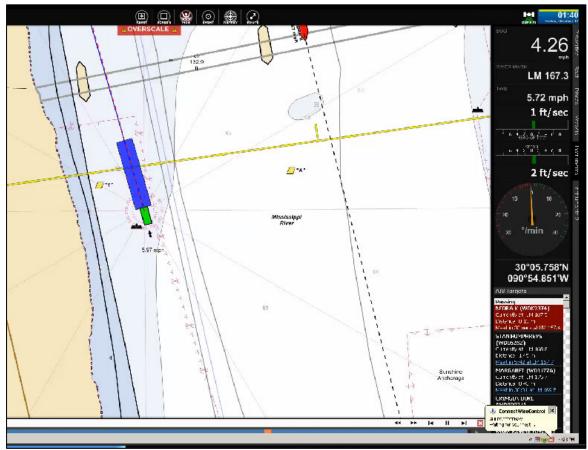
Figure 4. Image captured from the Rose Point screen from the towing vessel KRISTIN ALEXIS during the accident voyage. Image shows KRISTIN ALEXIS (green) pushing the MR ERVIN (blue), immediately before transiting under the Sunshine Bridge. You will note the down bound towing vessel NEDRA K (red) on the top right portion of the screen. NEDRA K's 11-Barge tow not depicted on image. Provided by Marquette Transportation

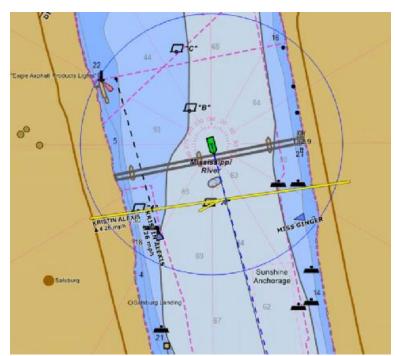
Figure 5. Image captured from the Rose Point screen from the towing vessel NEDRA K as they passed KRISTIN ALEXIS underneath the Sunshine Bridge during their accident voyage. Provided by Excell Marine.

Some of the factors that went into the decision making to proceed onward with the transit of the alternate West span – Course of Action two (with the lower vertical clearance), was a lack of available information (as noted in the watch relief section in paragraph 4.1.3. and voyage plan information in 4.2.4.). This decision to choose the alternate West span was reaffirmed by the presence of marine traffic, and the Pilot's previous history of successfully pushing different crane barges through alternate spans of other bridges in the past. According to testimony, those previous transits all included pushing smaller cranes and occurred during times of lower water conditions. Restricted visibility played a factor

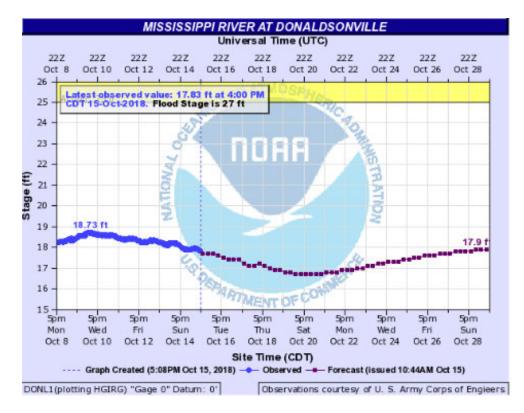
The gage reading at the time of the accident at the Donaldsonville gauge was 18.37 feet. This measurement is taken from a specific datum and does not reflect how much remaining water is in the river at that point in time. In fact, at Donaldsonville, Louisiana, the river depth is deeper than sea level and if that reading was at "zero", deep draft ship traffic would still be able to navigate the river.

Figure 6. A graphic from NOAA's website, taken shortly after the accident occurred depicting the observed river stages before, and the predicted river stages after the accident at the Donaldsonville, Louisiana gauge, provided by NOAA

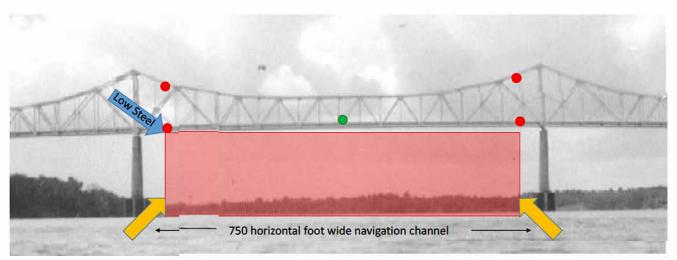
Testimony revealed that what the Bridge Branch permits is an area that is safe for vessels to transit through, given a horizontal clearance area and a vertical clearance limit. Important to note, this permitting process fixes the vertical clearance's point of measurement on the bridge to wherever the "low steel" point is on the bridge, within that horizontal clearance (the channel width). This essentially creates an invisible rectangle that, if viewed from the water while approaching a bridge, would be as wide as the channel and as high as the lowest point on the bridge within the reaches of the channel.

Every bridge is designed differently, however this gives the best safety margin for the mariner, to know that you can safety transit anywhere on that channel under a bridge and know that you will have that charted vertical clearance for the entire channel span. It was also noted, that they only permit the main channel; any alternate or auxiliary channels are not permitted in this same manner. The only key variable that the mariner would need to focus on when performing vertical clearance calculations in this case is the river stage.

Figure 7. Not to scale, and for demonstrative purposes only. This picture is intended to depict the concept of a safe navigation "box" or area *permitted* by the Coast Guard. Yellow arrows depict the extent of the navigation channel; Green light marks center channel while red lights mark outer extend of navigation channel. Blue arrow shows where the "low steel" could be on the bridge; if you were to go across the channel width, you would see that there are some areas where one portion of the bridge could be higher than the "low steel". Photo provided by USCG D8 Bridge Branch.

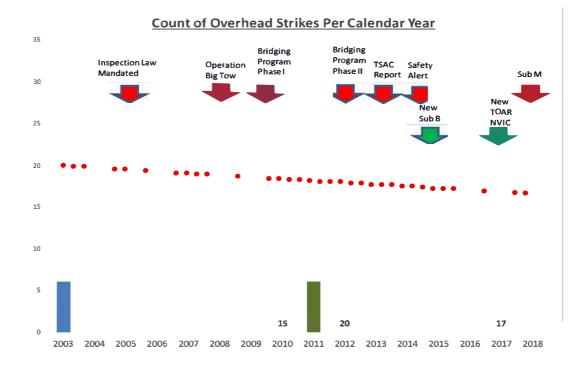
To date, there is a positive downward trend in reductions, however that number is not as reducing as quickly as one would ideally come to expect. It started out with an occurrence rate of roughly 20 overhead strikes per year, and has improved to an average of 18.25 incidents per year. While that is an improvement, 15 years in time has elapsed which is more than enough time to reduce the occurrence rate a greater amount than that. At the equivalent reduction/improvement rate without any additional changes, it would take roughly 4 more decades to eliminate all overhead strikes¹⁸.

Figure 12. This is a graph that shows the number of marine casualties that were allisions and involved an overhead strike. This data runs 16 years, and includes the information provided to TSAC for their 13-10 Report as well as new information on those same type of incidents since then. A trend line has been added as well as arrows indicating a place in time where those major Coast Guard initiatives took place, provided by USCG Office of Investigations.

Two large initiatives the Coast Guard has implemented regarding personnel are also highlighted above on figure 12 and displayed with Green Arrows. In 2010, the International Convention of Standards, Training, Certification and Watchkeeping (STCW) that was originally held in 1978 and again in 1995, had a significant update in 2010. This 2010 amendment was very far reaching, and required the Coast Guard to make a significant change to its regulations for merchant mariners and licensing, found in 46 CFR Subchapter B. That rulemaking process affected both its mariners traveling internationally as well as its mariners working domestically. The change was so vast that it had to issue over 2 dozen Navigation and Vessel Inspection Circulars to help successfully implement the regime. Of that, came a NVIC for towing vessel certification in 2016²⁰ that improved and clarified how Designated Examiners were required to perform their role. These two items constituted significant changes to the program. Over time, we should start to see continued improvement as the new mariners that are now beginning to earn their credentials through this new oversight come up through the ranks.
