# **UNITED STATES COAST GUARD**

## **Report of Investigation Into the Loss of Life During the Thunder On The Narrows Race Event Near Kent Narrows, MD on June 28, 2015**

**ALLISION OF THE POWER BOAT THIS IS HEAVEN WITH SPECTATOR VESSELS  
DURING THE THUNDER ON THE NARROWS RACE RESULTING IN LOSS OF LIFE  
AND MULTIPLE INJURIES IN PROSPECT BAY NEAR HOG ISLAND, MD  
ON JUNE 28, 2015**

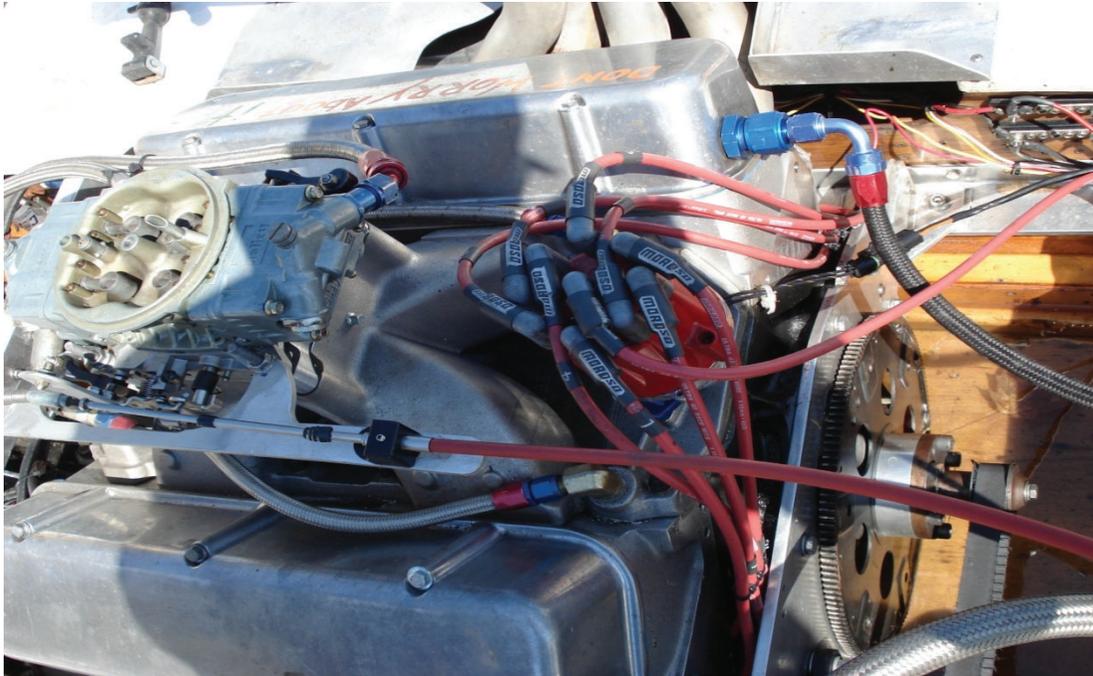
b. As it relates to conclusion #1.c.1, it should be noted the post-casualty inspection of the damaged GNH-12 showed moisture, rot and mold on structural members and the hull, including signs of delamination and rusted fasteners. This evidence along with testimony

provided by both the boat's primary driver and the driver involved in the collision indicate its weight and structural condition may have negatively impacted the hydroplane's performance characteristics, making it more difficult to remain on plane and more susceptible to sea spray, thus obstructing the driver's visibility. The degree this contributed to the cause of the casualty is unknown.

35. The GNH-12 was equipped with a 468 cubic inches Big Block Chevy racing engine with single four barrel carburetion. The engine is approximately 800 horsepower and was capable of reaching speeds in excess of 150 mph. The lubrication oil system consisted of a dry sump system where pressurized oil is delivered to the engine through a reservoir and returned to the reservoir through the sump pan.

Figure 4 - Image of the GNH-12's engine. Image taken on June 29<sup>th</sup>, 2015

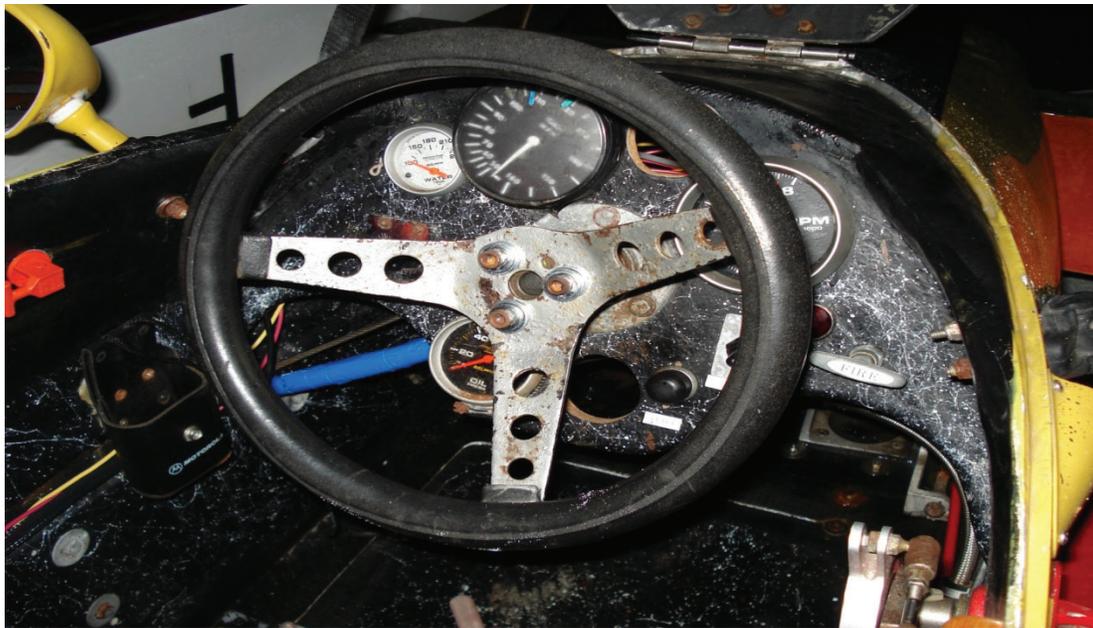
37. The cockpit of the GNH-12 was a fully enclosed type cockpit. It housed the vessel's steering control, ignition controls, water temperature, oil pressure, and RPM gauges. An inoperable speedometer was also mounted. The operator could energize the fixed fire fighting system in the engine compartment. The GNH-12 was not equipped with a radio, but had the means to connect a portable radio. Additionally, there were two foot pedals; one for acceleration and the other was to control the pitch of the canard.

Figure 4.1- Image of the GNH-12's cockpit and controls taken on June 28<sup>th</sup>, 2015

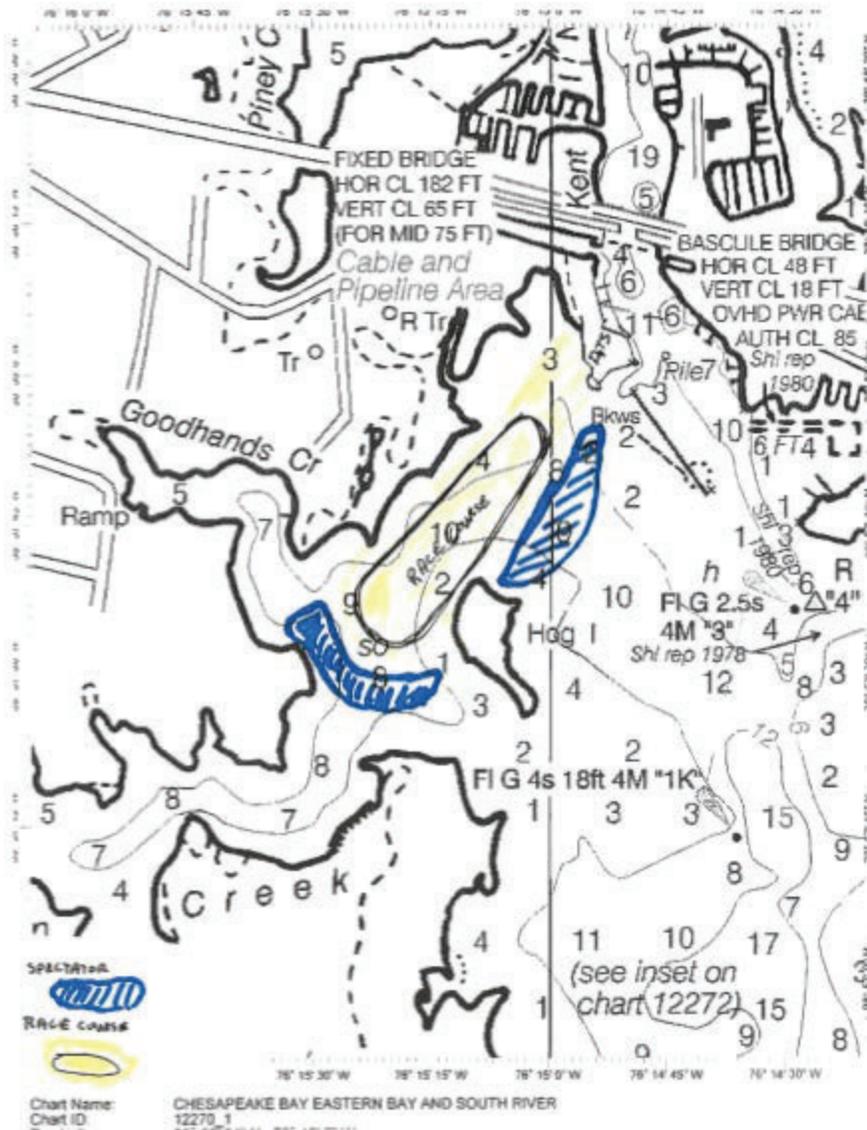
49. The application package submitted by the KNRA consisted of the marine event application, a diagram of the proposed race course and spectator areas hand drawn on an image of a section of a navigational chart (chartlet). The hand drawn image did not contain any specific geographical coordinates of the race course, approximate location of inside and outside course markers and minimum safe spectator distances for spectator vessels. The application did not contain a safety plan, a copy of the approved APBA Insurance application which ensured that the event was sanctioned by the APBA, or a diagram of the race course which contained minimum safe spectator fleet distances.

Figure 6.1 – Image of the chart diagram of the Thunder on the Narrows course with spectator areas submitted with the application by Kent Narrows Racing Association.

application met the requirement, analysis of the spectator areas drawn on the chartlet were not accurately portrayed in comparison to the incident location and the course diagram (see figure 10) submitted with the APBA insurance application.

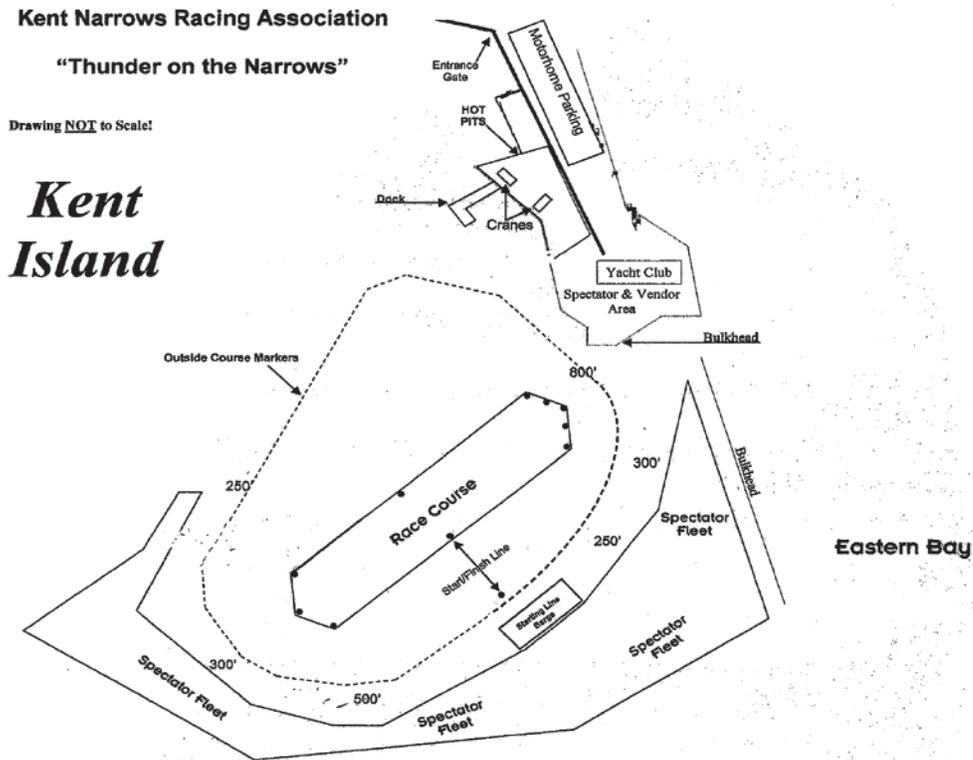
Figure 8- Diagram of race course layout that was not received in the Marine Event Application

30. The course diagram submitted with the APBA Regatta Insurance application illustrated an approximate 250’ clear zone from the outside course marker to the start of the spectator area where the incident occurred (see Figure 8). The 250’ clear zone was the shortest distance from the outside course marker to the spectator zone for the entire course. The basic minimum distance standards set by the APBA Regatta Insurance application is 120’ from the outside marker to an unprotected spectator area and that the spectator fleet area **should** be 250’ when a barrier of some sort is not being utilized; however, the description of the event course layout in the APBA insurance application stated: *The course will be controlled by using outside course buoys a minimum of 120 feet from any fixed spectator area when an acceptable barrier is in place. This **must** include docks/piers and a minimum of 250’ from any floating spectator area including boats.* There was not a barrier of any sort in place protecting the spectator fleet so distance factors had to be used. The investigation found the APBA Regatta Insurance application minimum distance requirements to be ambiguous. The difference between **should** and **must** be 250’ is significant. One description appeared to be a requirement and the other a recommendation. In either case, the event course diagram submitted to the APBA by KNRA for sanctioning approval listed the minimum spectator fleet distance as 250’ from the outside course markers.

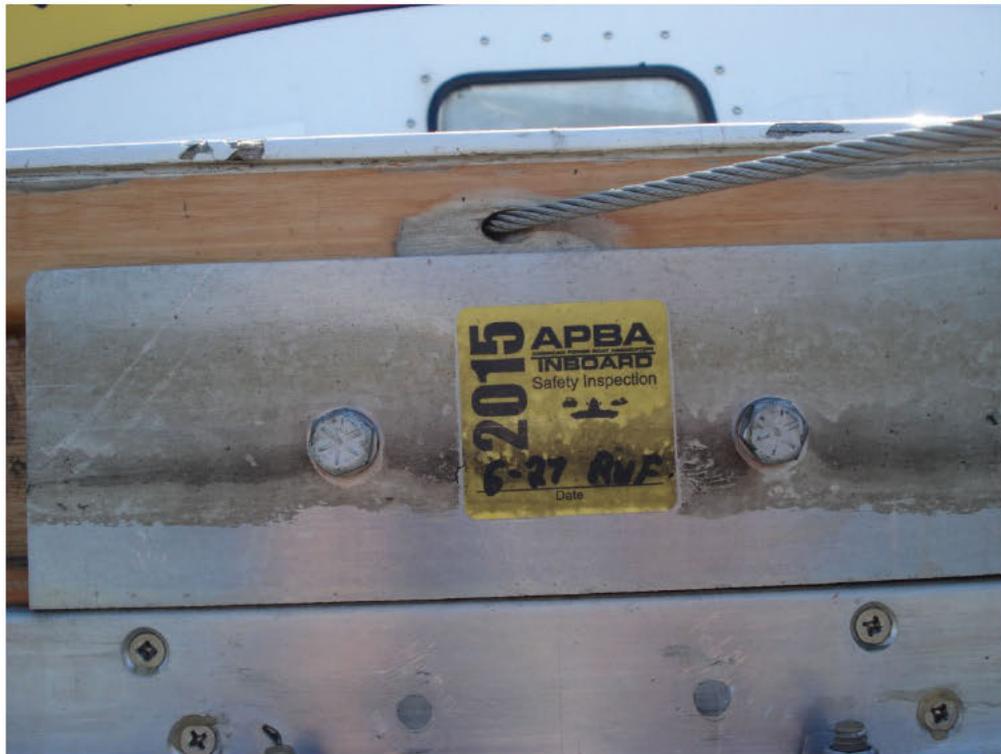
81. On June 27, 2015, a safety inspection of the GNH-12 was conducted by APBA approved safety inspector, [REDACTED] utilizing the APBA Inboard Safety Inspection Checklist. [REDACTED] was assisting the APBA Chief Inspector [REDACTED]. There were no deficiencies noted or safety concerns identified. A safety inspection decal was placed on GNH-12's stern

which indicated the vessel successfully passed the examination. The inspection report was submitted to the Inboard Racing Commission for approval.

Figure 6 – Safety Inspection decal issued to the GNH-12 on June 27, 2015

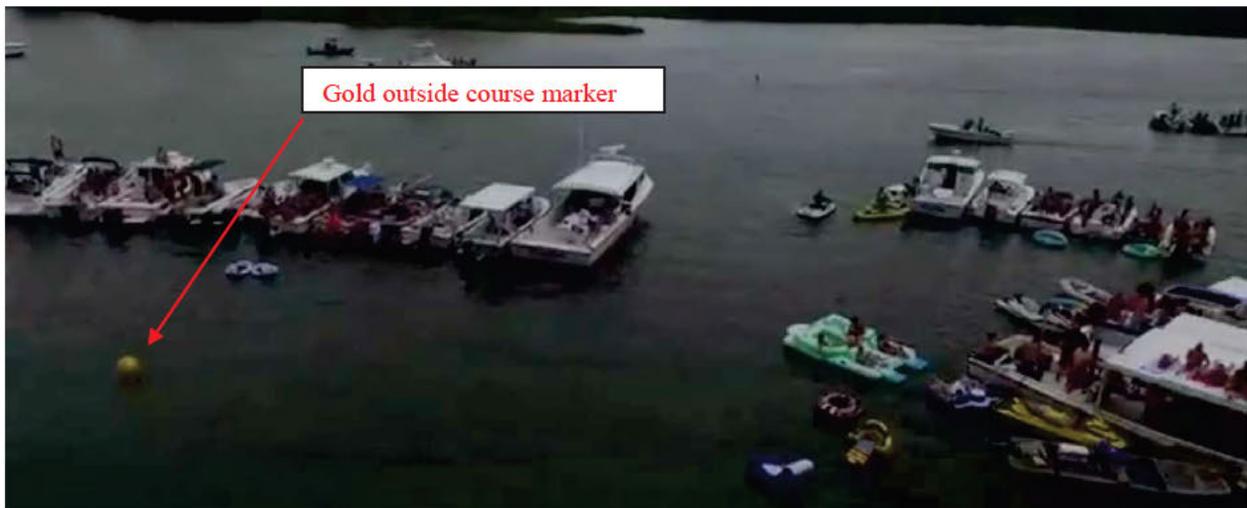
Figure 17.1 – Image of spectator vessels observing the Thunder on the Narrows race and gold outside course marker. Image was taken from spectator drone video footage on the day of the incident.

31. When a USCG Sector Baltimore Investigator arrived on-scene directly following the casualty, the event organizers had cancelled the rest of the race and subsequently removed the inside and the outside course markers as a result of the incident. The event course layout and location of the outside course markers were not available for post casualty examination as a result. The USCG obtained footage from a video sharing website taken by a spectator who filmed a portion of the race that day utilizing an unmanned aircraft system (UAS); however, UAS footage of the actual incident itself was not available. The UAS footage obtained as evidence for the investigation showed the spectator fleet in relation to the location of outside course markers including the string the of spectator vessels where the incident occurred. In the footage obtained from the drone, it appeared that the spectator fleet was not at the required minimum of 250' from outside course markers as required by the APBA Regatta Insurance application's course diagram submitted to the APBA for sanctioning approval. The 250' spectator fleet distance is equivalent to approximately 86 yards. In comparison the overall length of a football field is equivalent to approximately 120 yards. The minimum spectator distance should have been approximately  $\frac{3}{4}$  of a length of a football; however, the UAS footage obtained during the investigation did not appear as though the spectator fleet maintained the 250' distance requirement.

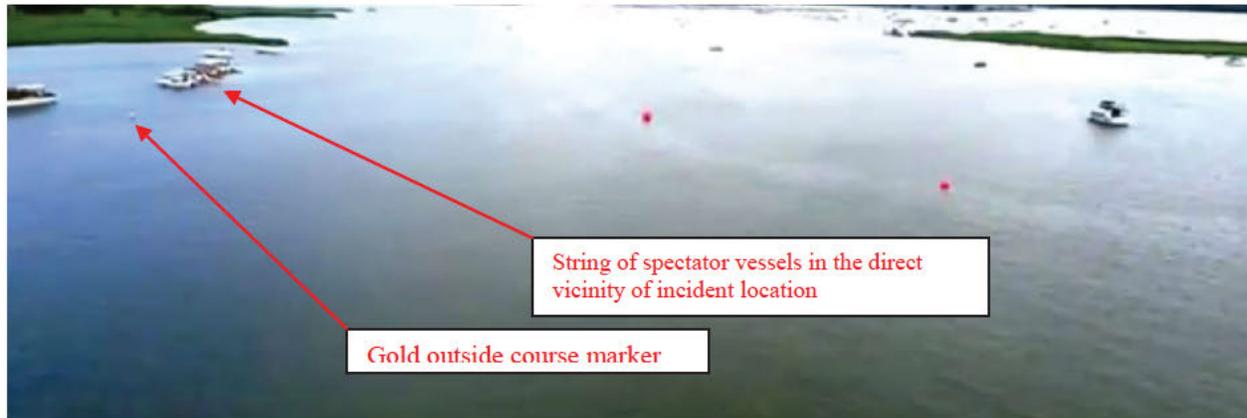
Figure 17.2 – Image of the string of spectator vessels in the vicinity of the incident location observing the Thunder on the Narrows race and gold outside course marker. Image was taken from spectator drone video footage on the day of the incident.

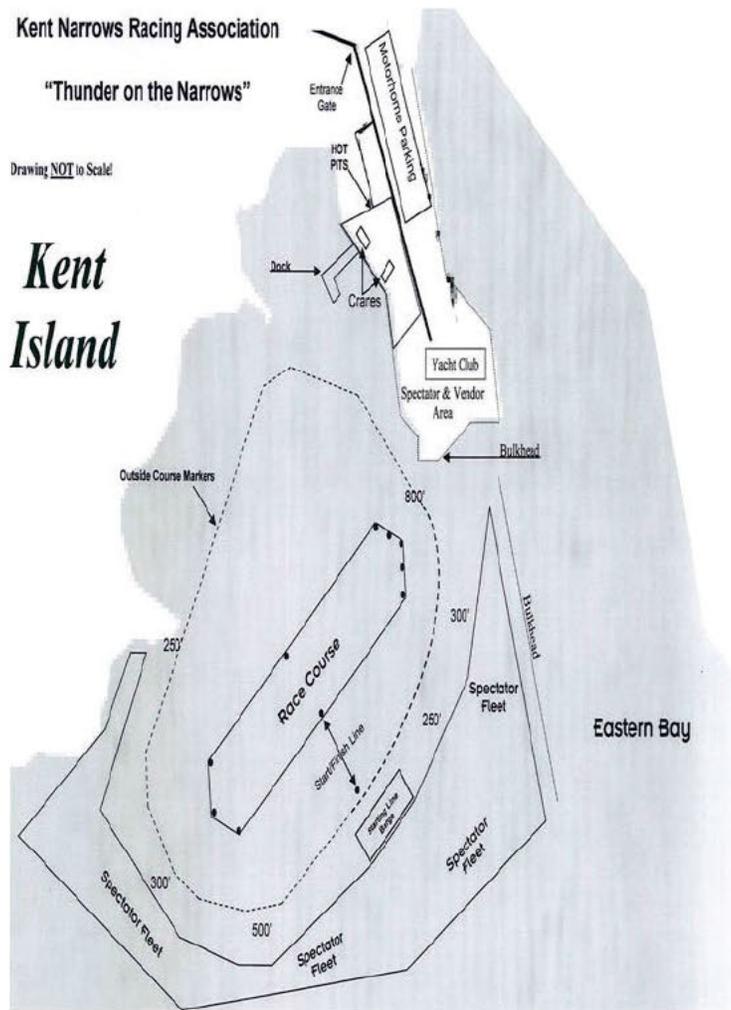
Figure 19- Diagram of race course layout that was submitted with insurance application to the APBA, but not submitted with the Marine Event application
