**BERMUDA SAFETY BULLETIN**

**Failure of Large Planetary / Reduction Gear Components of LSA Winch Equipment**

Notice to all Ship and Vessel Owners, Ship Operators and Managers, Masters and Officers of Bermuda Registered Ships Incorporating Davit Launched Lifeboats and Rescue Boats

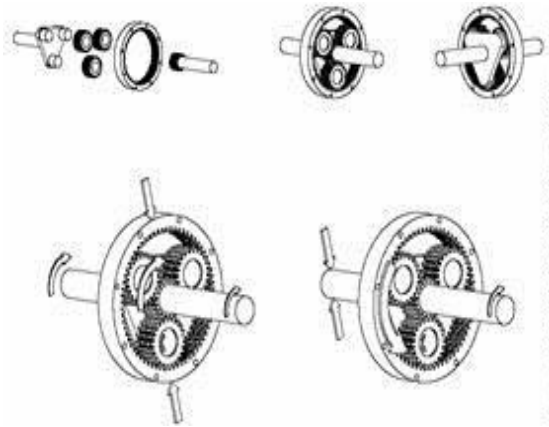
The reason for this is understood to be due to the planetary gear fill plug either falling out or leaking, leading to the gears running in a dry condition. These large Planetary/ Reduction gears are located in an inaccessible area and oil levels can only be monitored by either fully dismantling the winch or performing an internal video inspection of the drum.

Fig. 1: Planetary Gear Schematic
